AVIATION INVESTIGATION REPORT

A02O0406

ROLL OSCILLATIONS ON LANDING

AIRBUS 321-211, C-GJVX AND C-GIUF

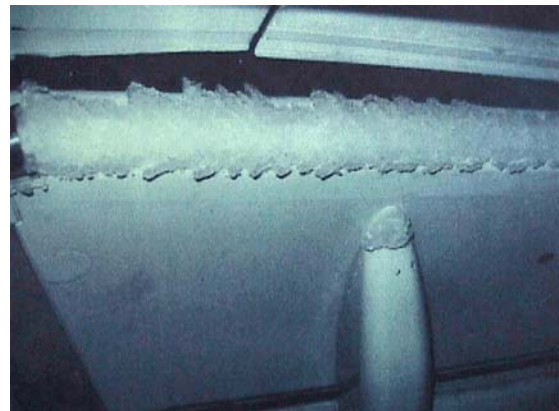
In December 1998, two similar events occurred involving a foreign carrier's A321 aircraft landing in CONFIG FULL in icing conditions. The roll oscillations were attributed to ice accretion, particularly on the flap leading edges, affecting the slot between the main flaps and wing box. Because the main flaps are similar on the A320 and A321, and no events of this nature were ever reported on the A320, the icing conditions were considered to have caused the events and no changes to the

Photo 1. Ice accretion on main flaps leading edges from a December 1998 A321 event

Analysis of the post-occurrence icing trials concluded that ice accretion on the leading edge of the flaps of both the A320 and A321, and on the flap tabs of the A321, contributed to unusual roll behaviour by modifying the aerodynamic characteristics. Flights performed in roll direct laws on both aircraft showed that both A320 and A321 ice accretion with flaps extended induces an increase in roll spoiler efficiency in both CONFIG 3 and CONFIG FULL. This increase was higher in CONFIG FULL than in CONFIG 3.
