The Transportation Safety Board of Canada (TSB) investigated this occurrence for the purpose of advancing transportation safety. It is not the function of the Board to assign fault or determine civil or criminal liability.

1.0 Factual Information

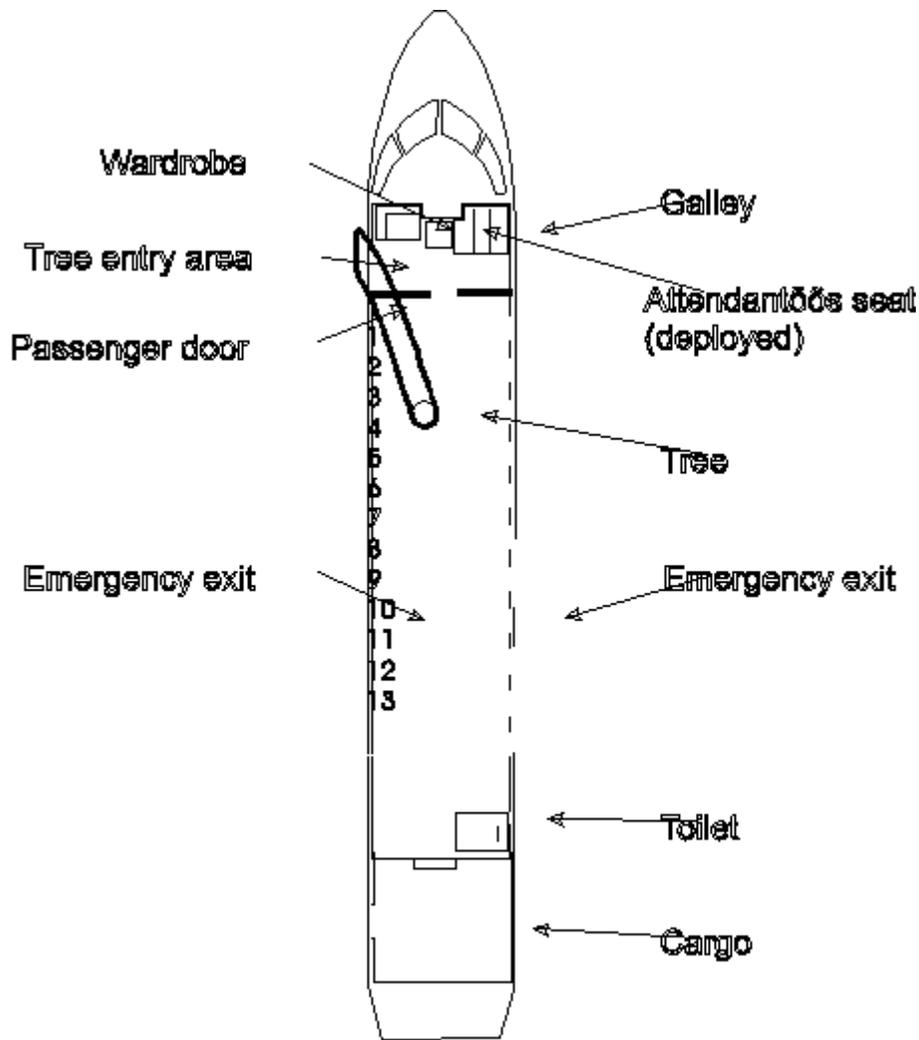
Figure 1 - Aircraft Interior

The aircraft remained generally intact, with no damage to the empennage and damage to the top of the aircraft limited to the tear caused by the large tree. Damage to the wings was limited to an indentation on the leading edge of the left wing, caused by striking either the ground or a tree, and the inboard flaps were damaged by ground contact. The winglet of the right wing bent upwards on runway contact but remained attached to the wing until just before the aircraft stopped. The underside of the cockpit and nose area, back to the avionics bay door, was demolished by the departing nose gear and contact with the runway and ditch. The wreckage trail was strewn with electronic equipment and structure from the nose area, and with the three landing gear and associated structures. The underside of the aircraft, from the landing gear area aft to the rear fuselage equipment bay door, was damaged by the separating landing gear and by impacts with the ditch and the hill. The aircraft struck the tree at the passenger door, the tree remaining intact. As the aircraft moved forward, the tree cut through the aircraft cabin to a point about nine feet aft of the door, just left of the centre line of the aircraft. Apart from damage where the tree had torn through the aircraft, the rest of the cabin floor, seat rails, seats, and overhead bins showed no signs of deformation or damage. The area of the aircraft ahead of the galley, looking forward, was twisted counter-clockwise a significant amount.

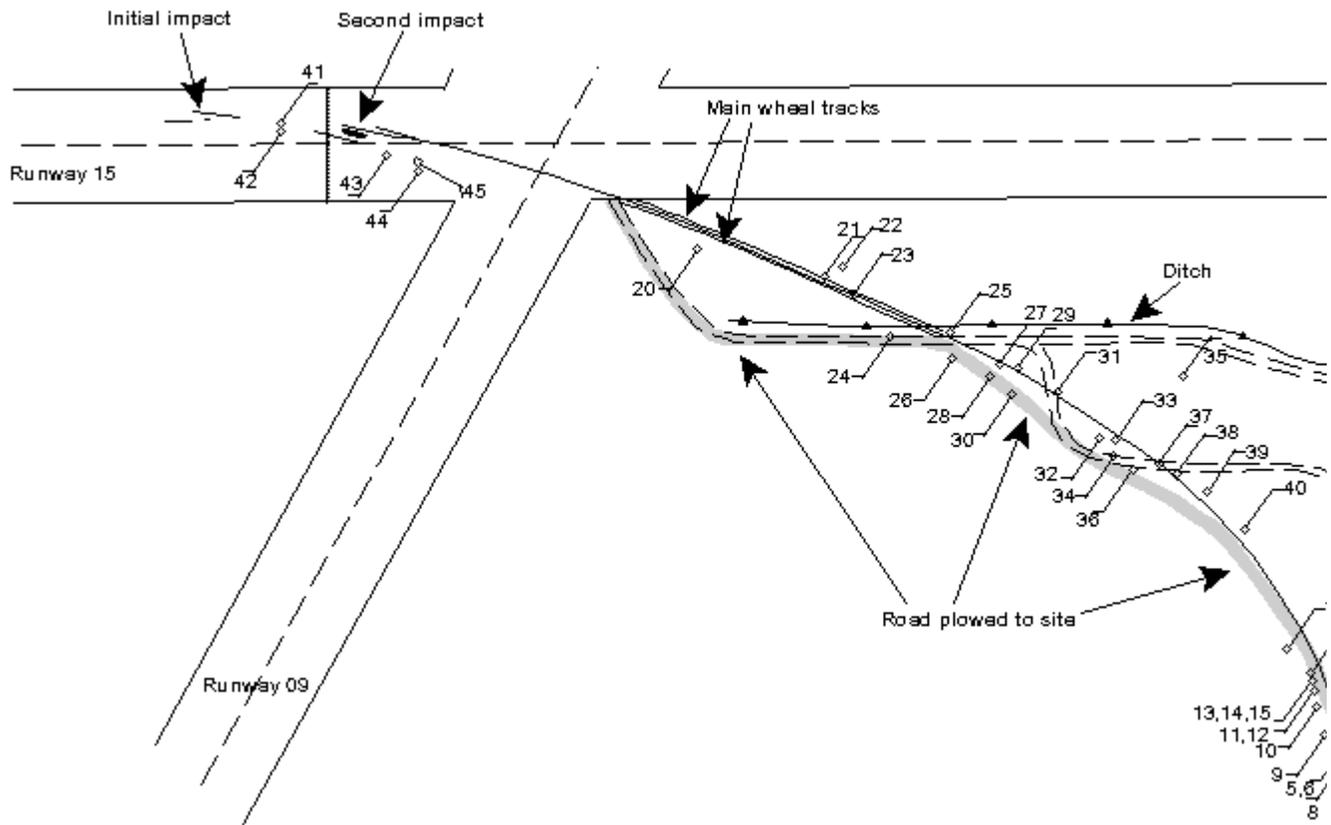
Appendix B1 - Aircraft Wreckage Plot

Number	Description	Number	Description
1	large fibreglass panel aft between main gear	25	601R31178-2/N01 CL601R s/n 70—left main fixed gear door
2	left wing movable vane	26	6013803* white skin panel
3	fibreglass panel	27	fibreglass panel (3 ft x 3 ft)
4, 5	pieces of wheel-well tub	28	right main gear pivot
6	left main gear	29	panel aft between wheel wells (3 ft x 1.5 ft)
7	pieces of wheel-well tub	30	part of nose gear door
8	fibreglass panel (2 ft x 1 ft)	31	601R85001-95 (Dowdy 17008-109) s/n 00169 side stay actuator
9	metal panel (~1 ft sq.)	32	m/n 15ERG501 p/n 721863C s/n 0463 air driven generator uplock
10	brake metering valves	33	type RTA-844 weather radar antenna s/n 1304
11	transformer rectifier units	34	600-33253 1/R air driven generator door
12	mangled part of landing gear	35	right side aft wing root fillet panel
13	nose wheel well with maintenance light	36	m/n 15ERG502 p/n 756652A s/n 0223 ram air turbine

14, 15	skin with hydraulic lines	37	right main gear
16	part of gear with spring	38	600-33039-3/F—captain side accessory door
17	fibreglass panel (6 ft x 3 ft)	39	piece of avionics bay floor (1 ft x 1 ft)
18	601R101527/01—RNCC026526—flap track fairing	40	piece of wheel well
19	metal part	41	right aileron tip
20	spring from front gear	42	piece of aluminum
21	600-3201-71/A	43	piece of lens
22	601R31178-1/N01—CL601R s/n 68 right main fixed gear door and external power services panel	44	antenna
23	white fibreglass panel	45	honeycomb material with pin
24	600-33039-4/F forward accessory compartment right side door
