Aviation Occurrence Report
Unstabilized Approach/ Hard Landing
Alberta Citylink
British Aerospace Jetstream 31 C-FBIE
Lloydminster, Alberta
20 January 1998

Report Number A98W0011

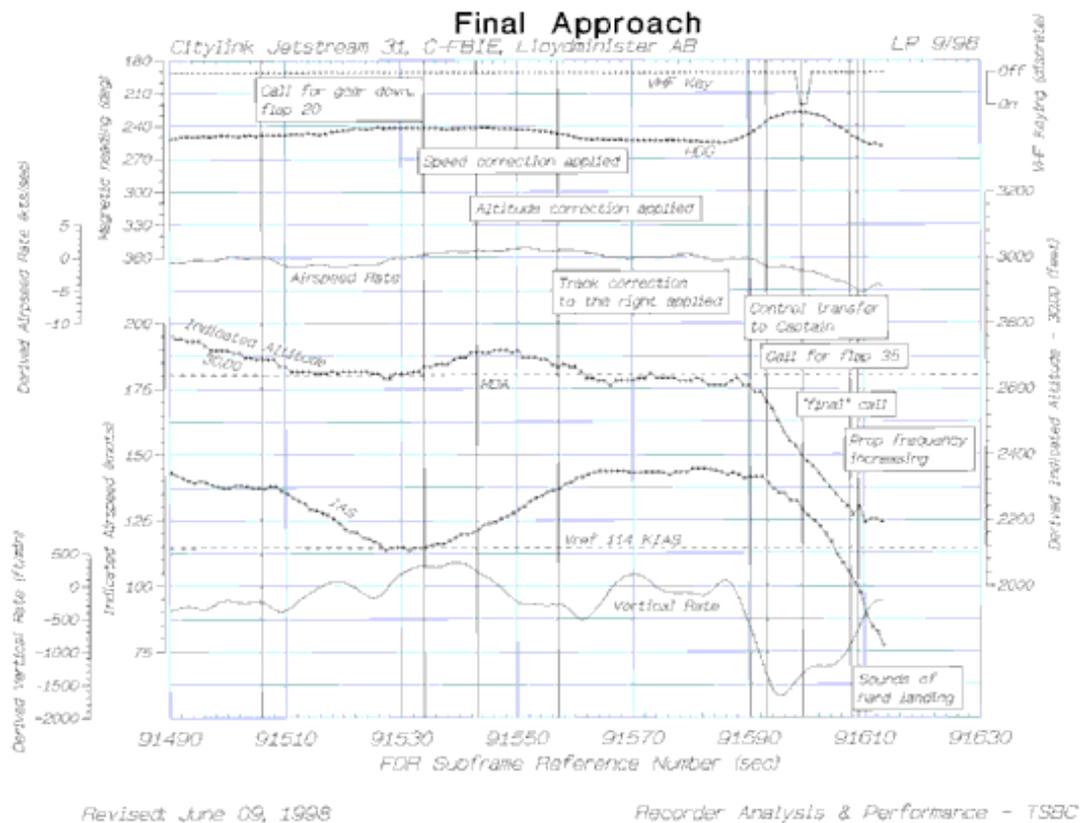
Appendix A - Plot of Approach and Landing

During the gear and flap extension, the speed decreased by 24 knots, from 138 knots indicated airspeed (KIAS) to the V_{ref} speed of 114 KIAS (Appendix A). The crew corrected for the decrease in speed, accelerating to 144 KIAS. During the acceleration, the aircraft briefly climbed approximately 70 feet, then descended back to the MDA.

Approximately three miles back from the runway threshold, and before visual contact was established, the aircraft was left of the inbound track. A track correction to the right followed, as evidenced by a 15-degree increase in heading. When the final descent to the runway commenced, the aircraft began to decelerate from 140 KIAS at an initial rate of 1.5 knots per second. The captain requested flaps 35; a high sink rate subsequently developed, reaching a peak of approximately 1 700 feet per minute (fpm) as the heading briefly reached about 230 degrees magnetic; the runway track is 253 degrees. Meanwhile, the rate of deceleration increased, eventually reaching 5 knots per second at the time of the hard landing. The first officer reported the flight on final when the recorded altitude, speed, and heading were approximately 200 feet agl, 129 KIAS, and 228 degrees, respectively. Following the FINAL call, the heading began to increase, suggesting a track correction to the right, and the descent rate reduced to approximately 1 200 fpm. Approximately 1½ seconds prior to the landing, the pitch of the engine/propeller sounds increased, indicating an increase in power. The descent rate was not arrested prior to touchdown, resulting in a hard landing with a high vertical deceleration of approximately 2.25 g, at 99 KIAS, and on the approximate runway heading of 252 degrees. The FDR
