AVIATION INVESTIGATION REPORT

A03O0302

ELEVATOR CONTROL RESTRICTION AT TAKE-OFF

de HAVILLAND DHC-8-102 C-GONJ

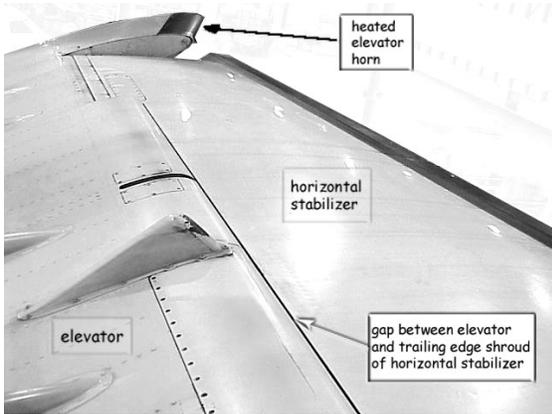
Photo 1. Left horizontal stabilizer with elevator trailing edge down

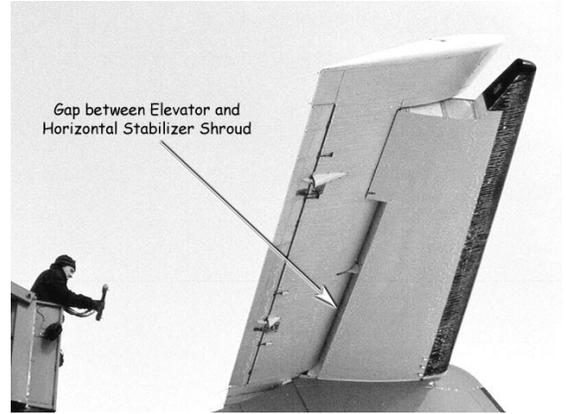
- Ice may have been present in the gap between the elevator and the shroud at the trailing edge of the horizontal stabilizer. Previous occurrences have shown that contamination in this location can interfere with elevator movement by jamming between the elevator and the shroud. This was considered the most likely method of interference in this occurrence.

Photo 2. Underside of stabilizer showing gap, controls in locked position

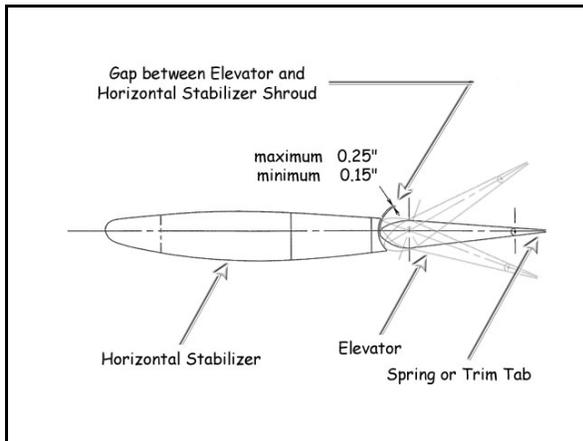
Figure 1. Horizontal stabilizer and elevator cross section

1. A remnant of clear ice most likely migrated into the gap between the nose of the left-hand elevator and the shroud at the rear of the stabilizer when the elevator was moved trailing edge up during control checks and interfered with movement of the elevator when the pilot attempted to rotate for take-off.

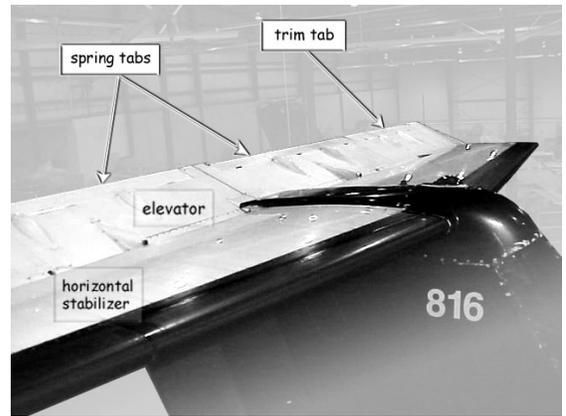
Photo 3. Horizontal stabilizer with elevator in trailing edge up position

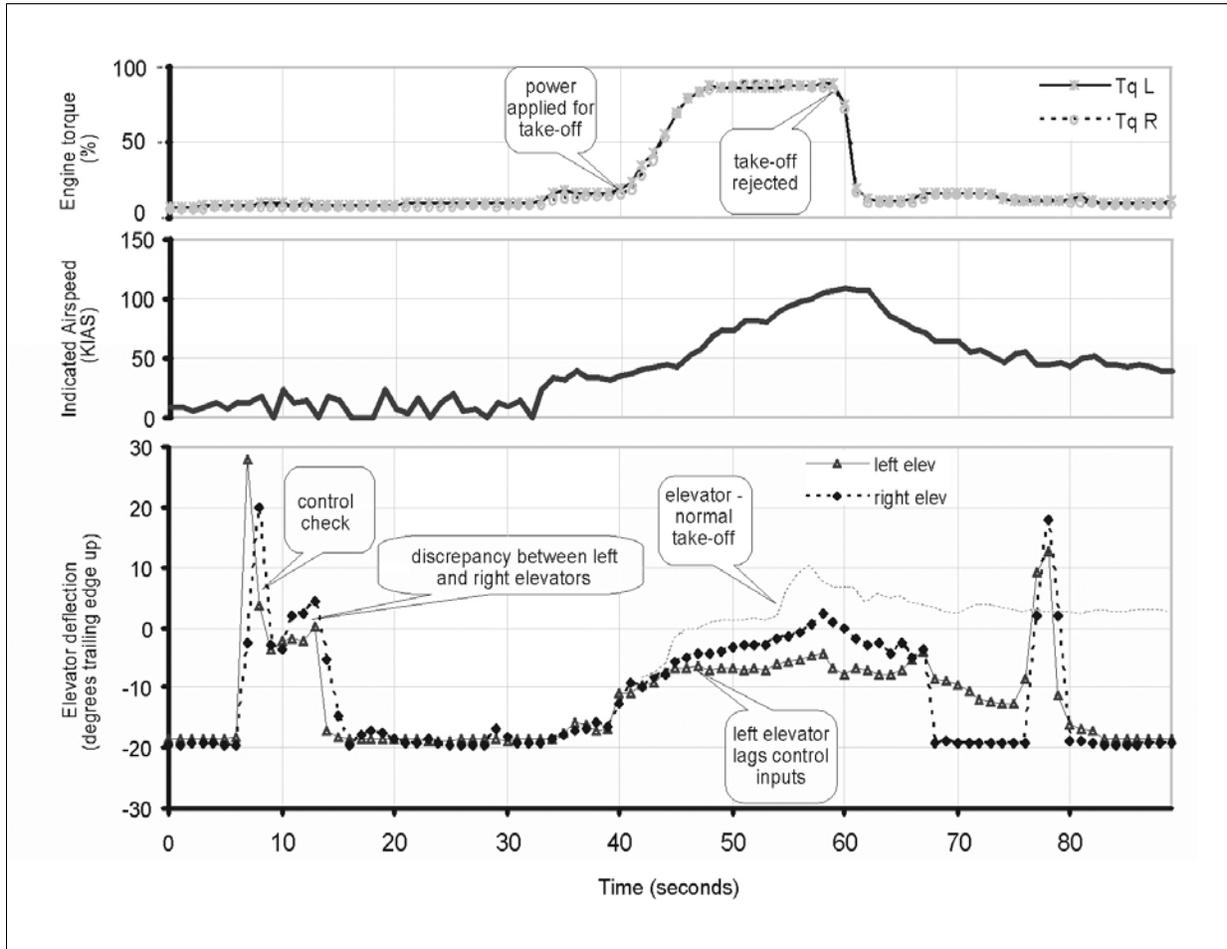
Appendix A – Flight Data Recorder Information

2. At the beginning of the take-off run, both elevators moved in unison to approximately 7.5° trailing edge down at 45 knots indicated airspeed (KIAS). As the aircraft accelerated, a split developed, the left elevator essentially not moving while the right elevator continued to move trailing edge up to a maximum of 2.2° up. The maximum split was 8° at 107 KIAS.

3. After the take-off was rejected, as the aircraft decelerated through 65 KIAS (the speed at which the PF normally releases the control yoke to use the tiller), the right elevator went full trailing edge down while the left elevator hung at about 10° trailing edge down for 10 seconds. At 50 KIAS, the elevators both moved abruptly to about 15° trailing edge up and back to full trailing edge down, consistent with the PNF locking the controls in accordance with normal rejected take-off procedures.
