CIVIL AERONAUTICS BOARD

AIRCRAFT ACCIDENT REPORT

CONTINENTAL AIR LINES, INC.
VICKERS VISCOUNT 812, N242V
MUNICIPAL AIRPORT, KANSAS CITY, MISSOURI
JANUARY 29, 1963

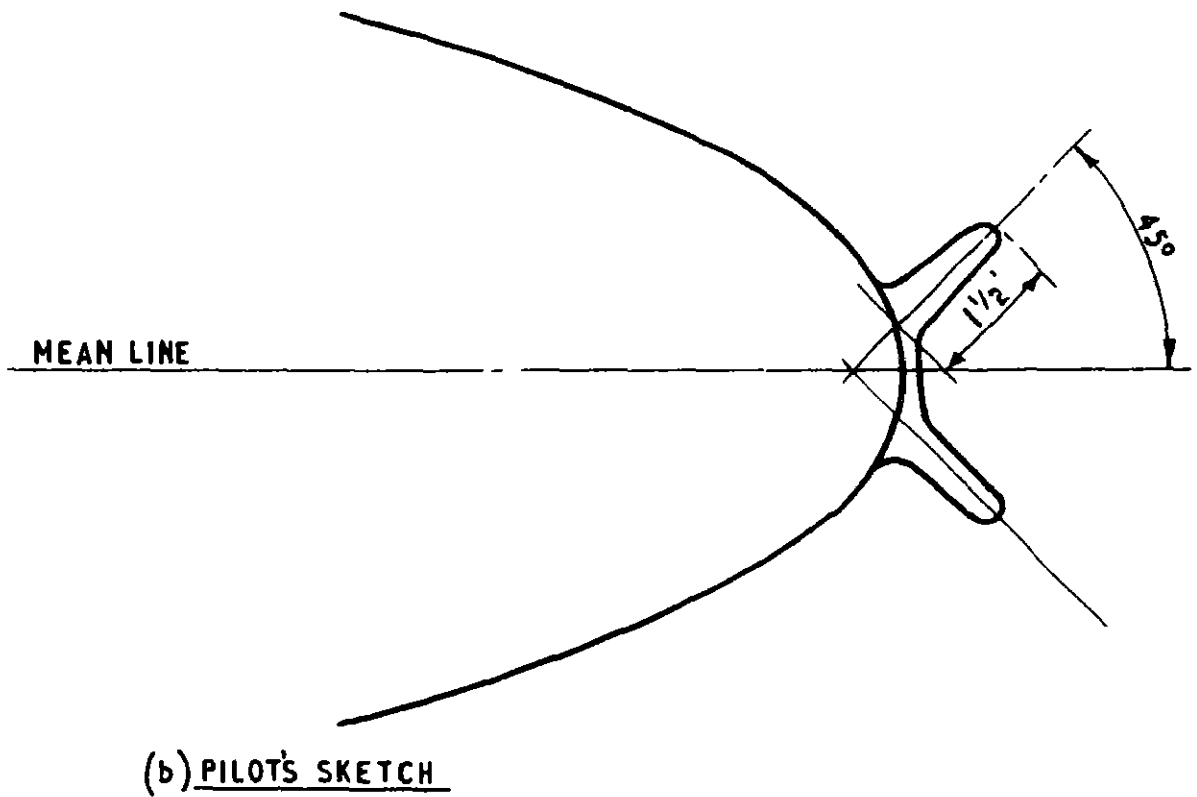
FIG 1

THE TAILPLANE AEROFOIL AT STN 76
