INCIDENT

Aircraft Type and Registration:	Dornier 328-110, D-CPRW	
No & Type of Engines:	2 Pratt & Whitney PW 119B turboprop engines	
Year of Manufacture:	1998	
Date & Time (UTC):	28 November 2005 at 0923 hrs	
Location:	Isle of Man (Ronaldsway) Airport	
Type of Flight:	Public Transport (Passenger)	
Persons on Board:	Crew - 3	Passengers - 16
Injuries:	Crew - None	Passengers - None
Nature of Damage:	None	
Commander's Licence:	Airline Transport Pilot's Licence	
Commander's Age:	53 years	
Commander's Flying Experience:	5,575 hours (of which 310 were on type) Last 90 days - 150 hours Last 28 days - 30 hours	
Information Source:	AAIB Field Investigation

Synopsis

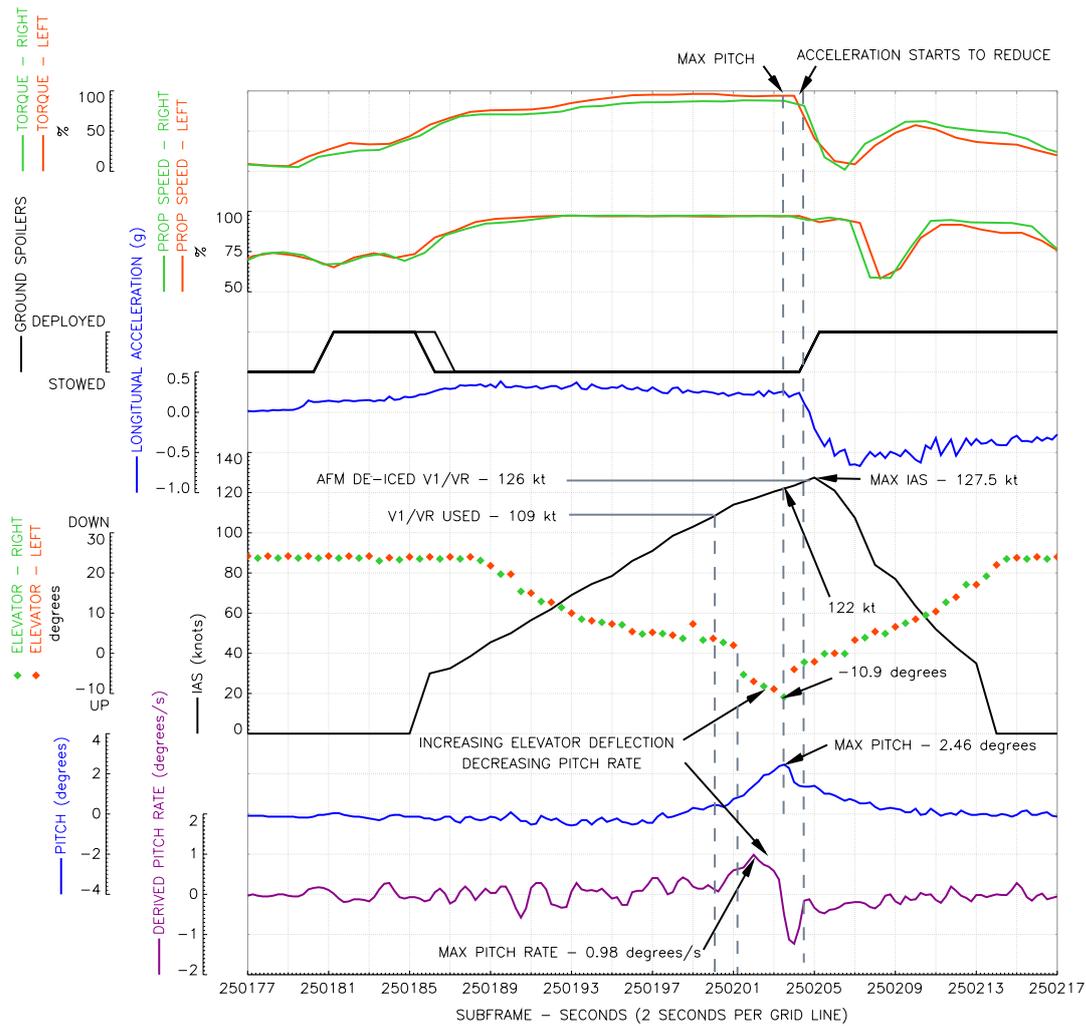
Figure 1
Pertinent Recorded Parameters for the Event

The gust locks were found 'in' just after the aircraft was declared configured for takeoff. The pertinent recorded parameters for the event are shown in Figure 1.

stowed during the final increase in propeller speed as the indicated airspeed parameter came ‘on line’ with a value of 30 kt. With the indicated airspeed passing 90 kt the aircraft pitch slowly increased by a small amount. Approximately 1 second after the aircraft reached the nominated rotate speed of 109 kt the elevator was brought to the 5° trailing edge up position. The aircraft pitch carried on increasing and the elevator angle was slowly increased. One second after the initial elevator input, the pitch rate of the aircraft peaked at just under 1°/sec with the aircraft pitch at 1.4° degrees and the elevator at 7°. By this time the aircraft had reached 117 kt.

One and a half seconds after the peak pitch rate was achieved, the pitch attitude peaked at just under 2.5° with a maximum elevator deflection of 10.9° and an air speed of 122 kt. A further second later the aircraft acceleration and engine torques started to reduce, the elevator was brought to a more neutral position and the aircraft pitch reduced. Within the next second the aircraft speed peaked at 127.5 kt and then started decelerating with the ground spoilers deploying.

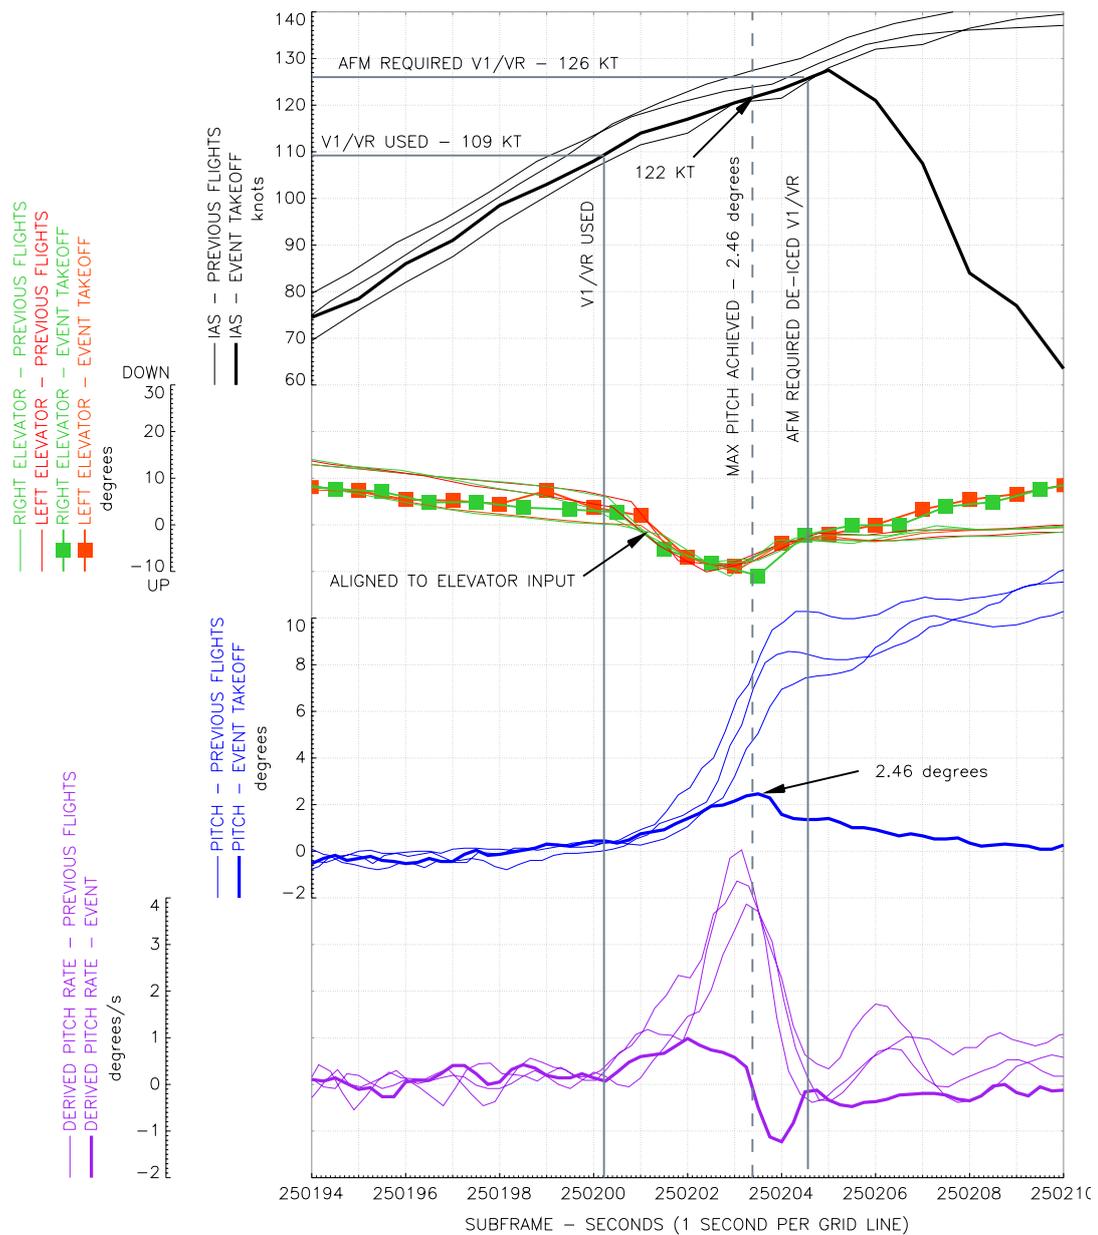
Figure 2
Comparison of Speed, Elevator Input, Pitch & Pitch Rate With 3 Other Flights

A comparison of speed, elevator input, pitch and pitch rate with three other flights is shown in Figure 2. The recordings are aligned to elevator movement at the point of rotation. This diagram further illustrates the abnormality of the aircraft's pitch response to elevator movement during the incident takeoff.

The FDR data showed that the aircraft was rotated significantly before the AFM stated rotation speed for the given weight and conditions. A comparison with previous flights indicates that the effect of the given elevator input did not result in the normal aircraft pitch behaviour. The comparison flights did not match the event flight with regards to the speed at which the elevator input was initiated so a comparison of elevator effectiveness at a given speed cannot be made from this limited data.
