# INVESTIGATION REPORT

INCIDENT

OH-LYX

Douglas DC-9-51

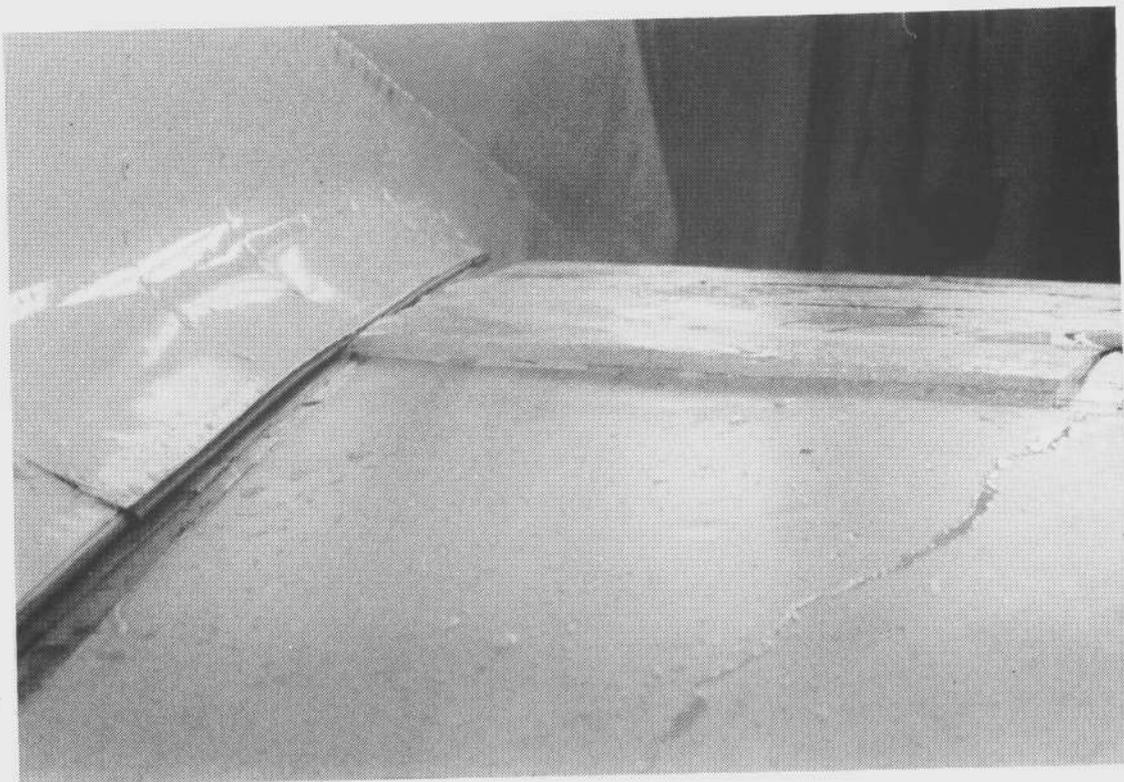
After the aborted take-off run inspection of the wings was carried out by Finnair first at the apron and then continuing in the hangar. Ice on the wing root area was about 20 mm thick (still while measured in the hangar it was 17 mm thick) and it was extending outwards of about 80 cm from the wing roots getting thinner on the way so that thickness in the far end of the layer was about 10 mm.

According to weather briefing during 0000-0300 hrs it had been raining and during 0300-0430 hrs there was wet snow fall and further on from 0430 hrs to 0600 hrs it was snowing. Because of the cold fuel the water on the wing root area transformed into a clear ice. The ice layer grew thicker because of the wet snow fall and afterwards it was covered by the snow.

1. Ice layer on the right wing, seen from the back of the wing. Observe the dent at the rear wing spar. (Photographed in the hangar).

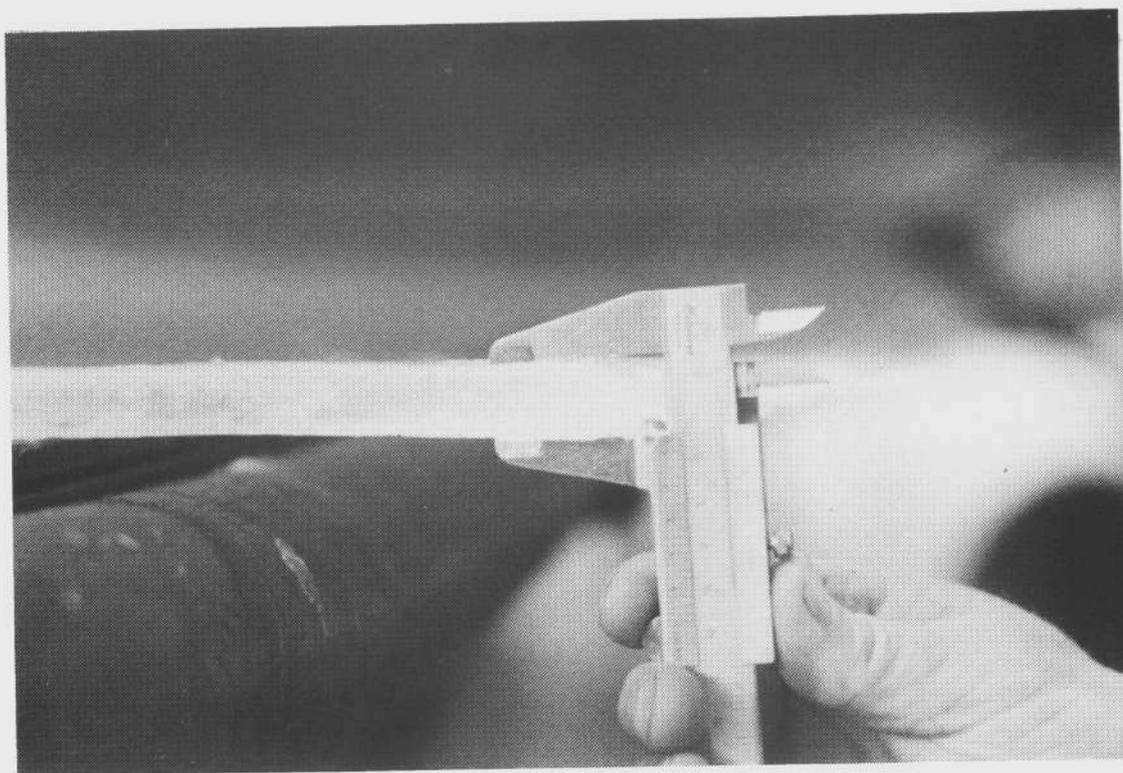
2. Ice layer at the wing root, thickness 17 mm. (Measured and photographed in the hangar).

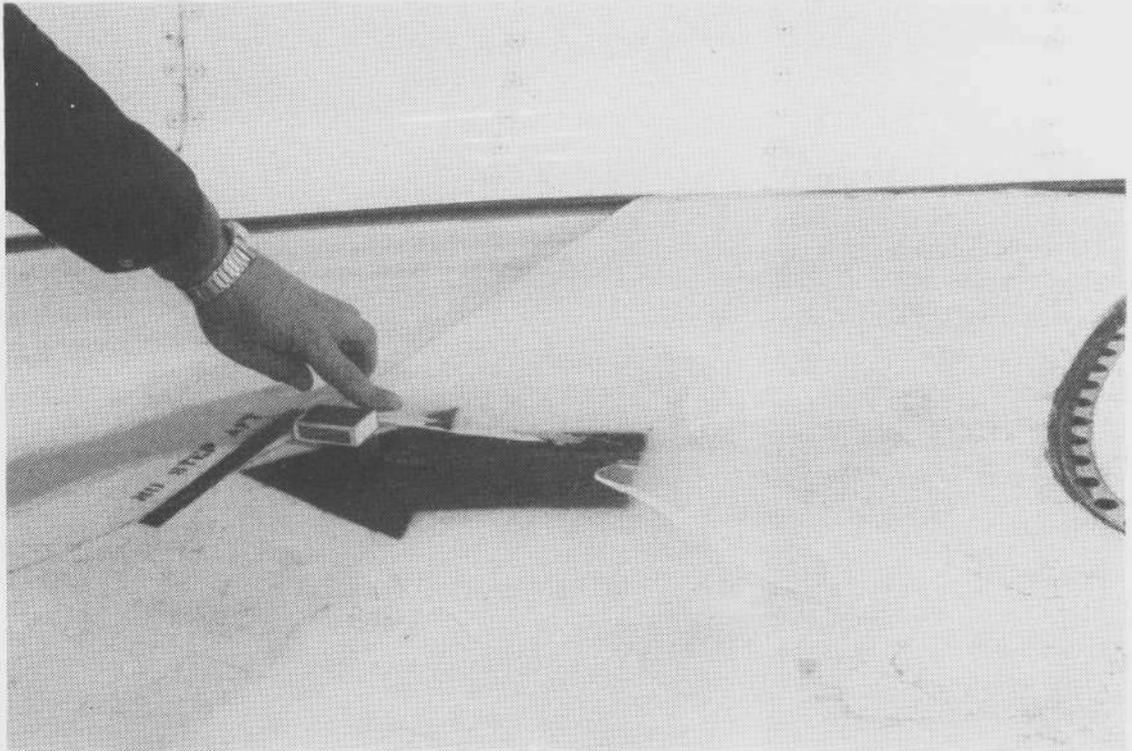
There was at least 1 square meter of ice remaining on top of both wings. Now the ice layer was very easy to detect because some of it was broken away and the remaining ice had come loose. Ice broken away had gone into the engines during the take off run. About 1/5-1/4 square meters of ice might have broken away. Ice thickness in this area has been about 10 mm. From the right wing a bit bigger piece of ice had broken away than from the left wing.

3. Ice layer on the right wing (photographed in the hangar).

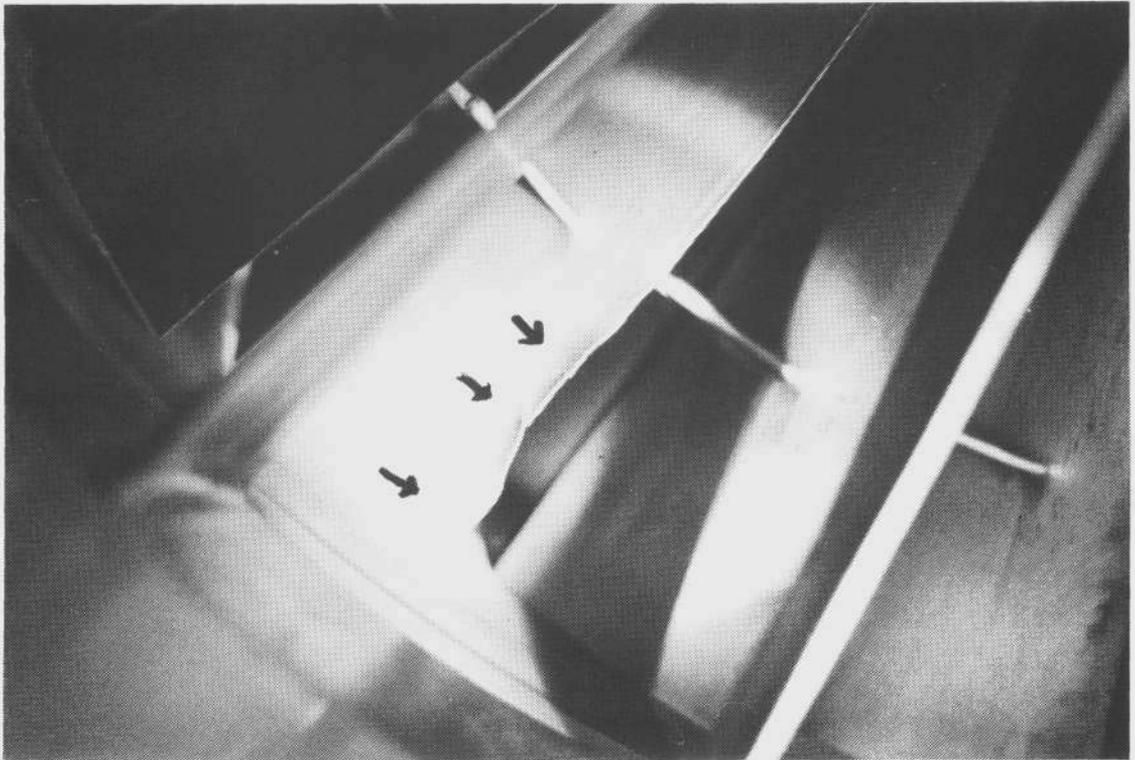
Six of the 1st stage low-pressure compressor fan blades were bent so that one blade had also three cracks. In addition to that a few of the midspan shrouds had been interlocked obviously as a result of compressor stall.

4. Compressor blade cracks in the right engine. (Arrows).

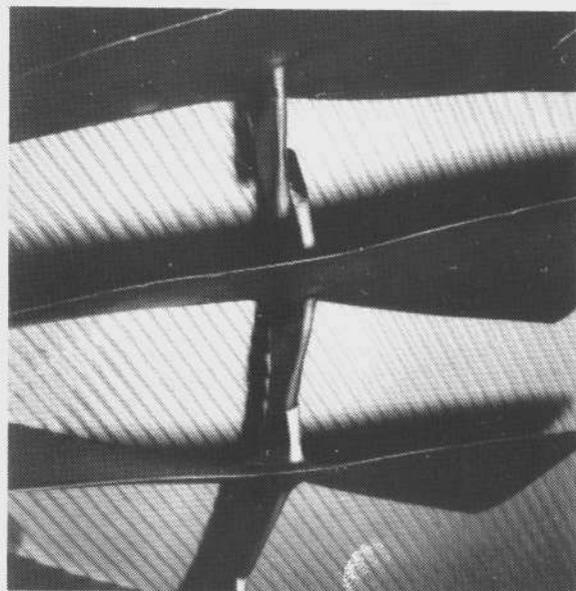
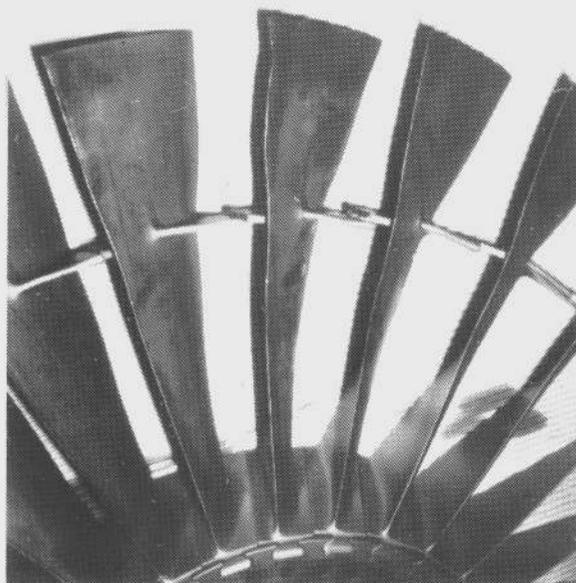
5. Compressor blades in the right engine. Some of the blades show bends and some of the midspan shrouds have been interlocked.
