# AIRCRAFT ACCIDENT REPORT

OZARK AIR LINES, INC.

DOUGLAS DC-9-15, N974Z

DECEMBER 27, 1968

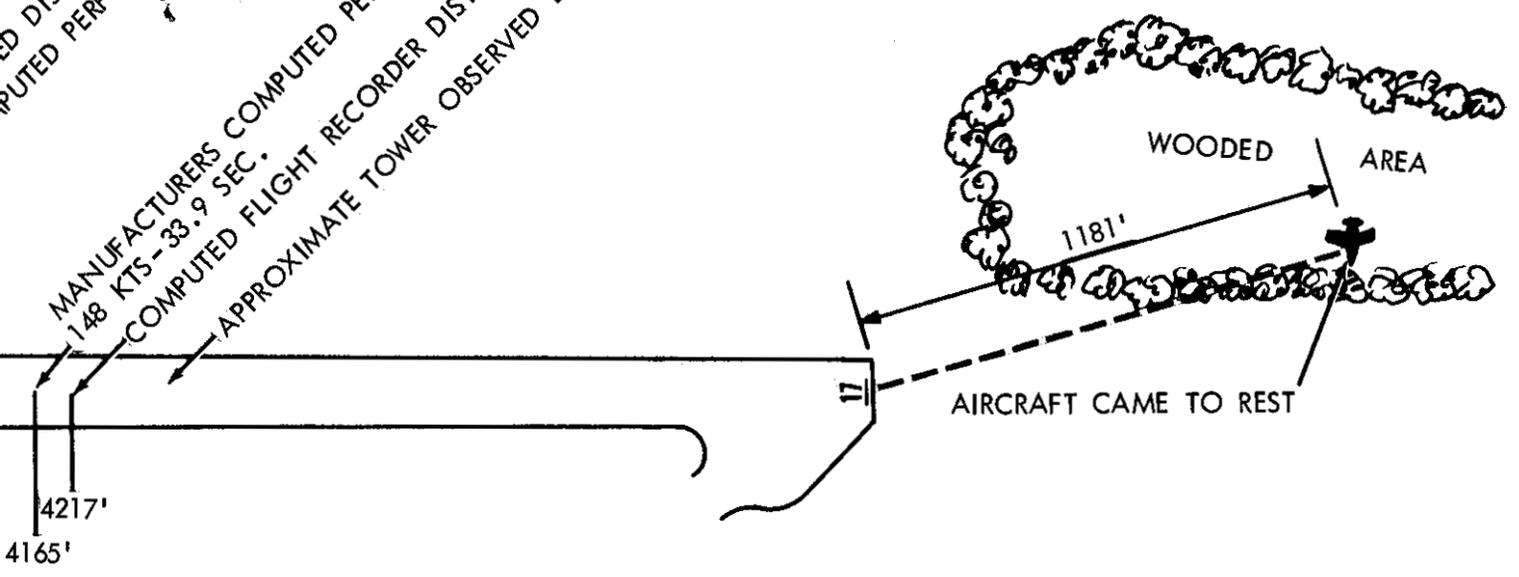
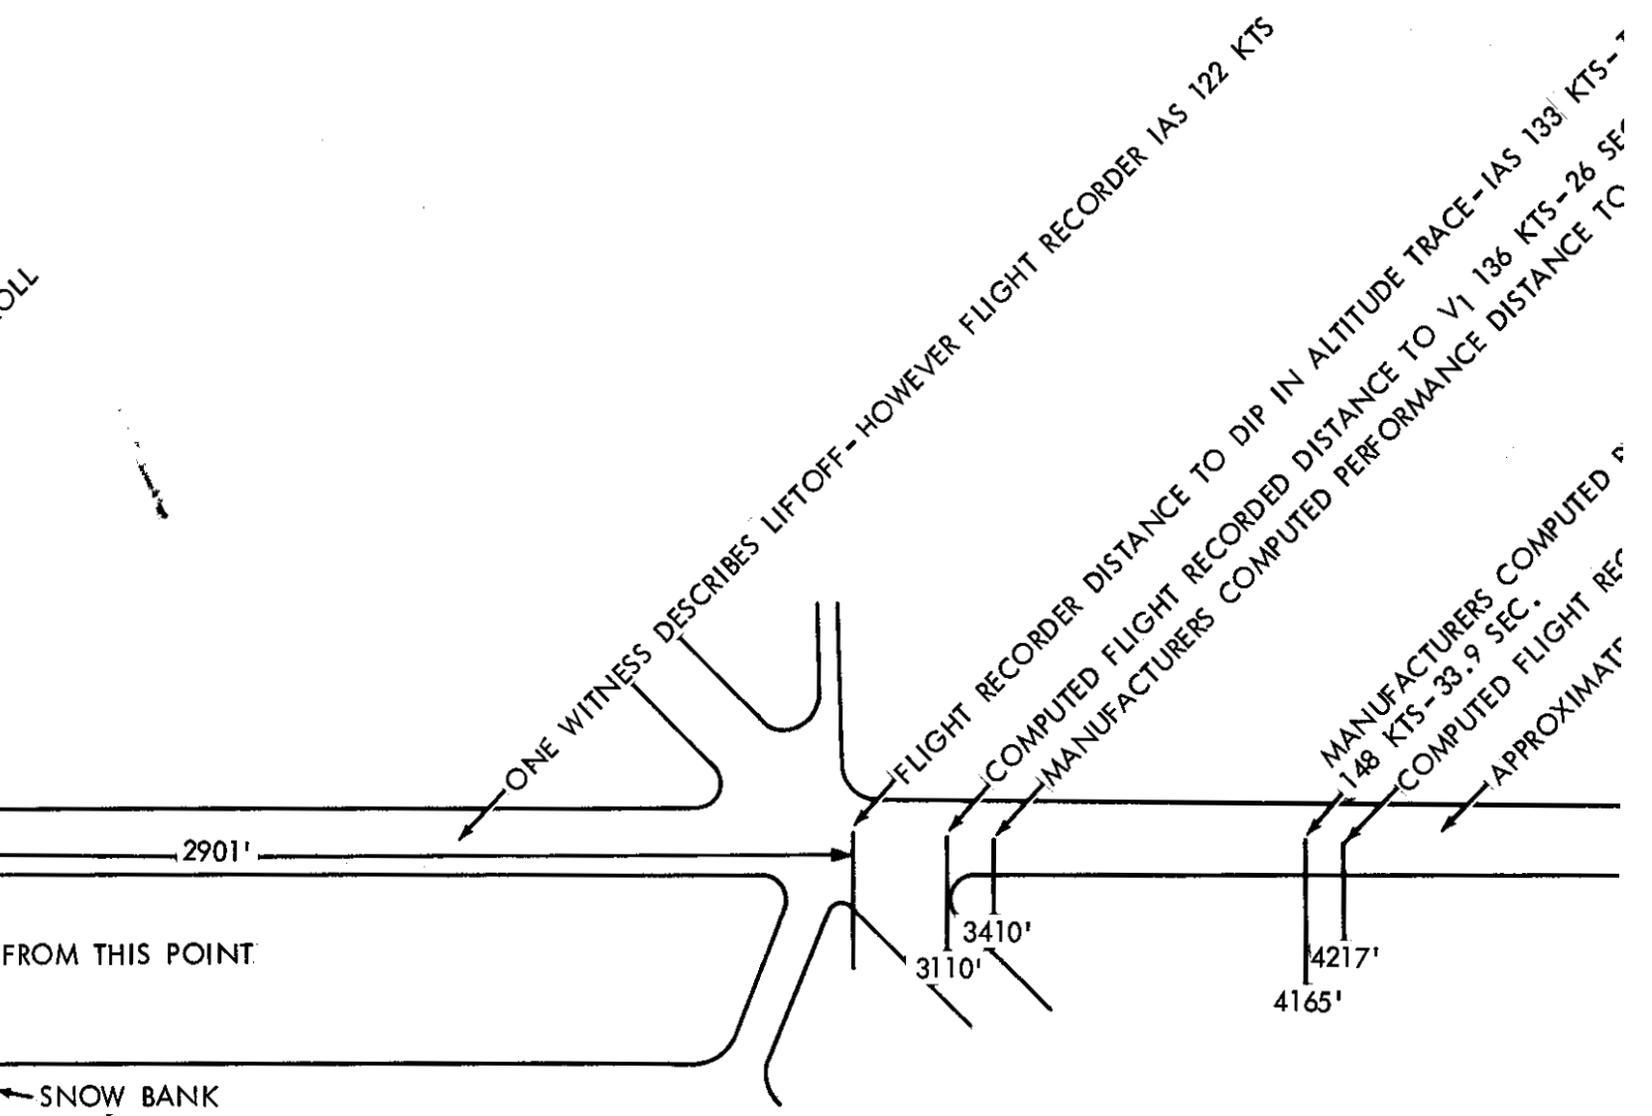
TAKEOFF ACCELERATION CHART  
 OZARK AIRLINES INC., DC-9, N974Z  
 SIOUX CITY, IOWA  
 December 27, 1968

a.	Flight recorder time from beginning of increase in the airspeed trace to $V_1$ (136 KIAS)	28	sec.
	Computed performance time required to $V_1$ (136 KIAS)	30.3	sec.
b.	Computed flight recorder distance to $V_1$	3,110	ft.
	Computed performance distance required to $V_1$	3,410	ft.
c.	KIAS at dip in flight recorder altitude trace	133	KIAS
	Recommended rotation speed, $V_R$	139.3	KIAS
d.	Computed performance $V_{LO}$	148	KIAS
	Computed performance distance to $V_{LO}$	4,165	ft.
	Flight recorder computed distance to 148 KIAS	4,217	ft.
e.	Flight recorder time from beginning of increase in airspeed trace to 148 KIAS	31	sec.
	Computed performance time required to $V_{LO}$ (148 KIAS)	33.9	sec.

IN ALTITUDE TRACE--IAS 133 KTS--TIME 25  
 ED DISTANCE TO V1 136 KTS--26 SEC.  
 PUTED PERFORMANCE DISTANCE TO V1 - 31.2 SEC.  
 MANUFACTURERS COMPUTED PERFORMANCE DISTANCE TO LIFTOFF--IAS  
 148 KTS--33.9 SEC.  
 COMPUTED FLIGHT RECORDER DISTANCE TO VLO 148 KTS--31 SEC.  
 APPROXIMATE TOWER OBSERVED LIFTOFF
