PB91-910410
NTSB/AAR-91/09

AIRCRAFT ACCIDENT REPORT

RYAN INTERNATIONAL AIRLINES

LOSS OF CONTROL ON TAKEOFF

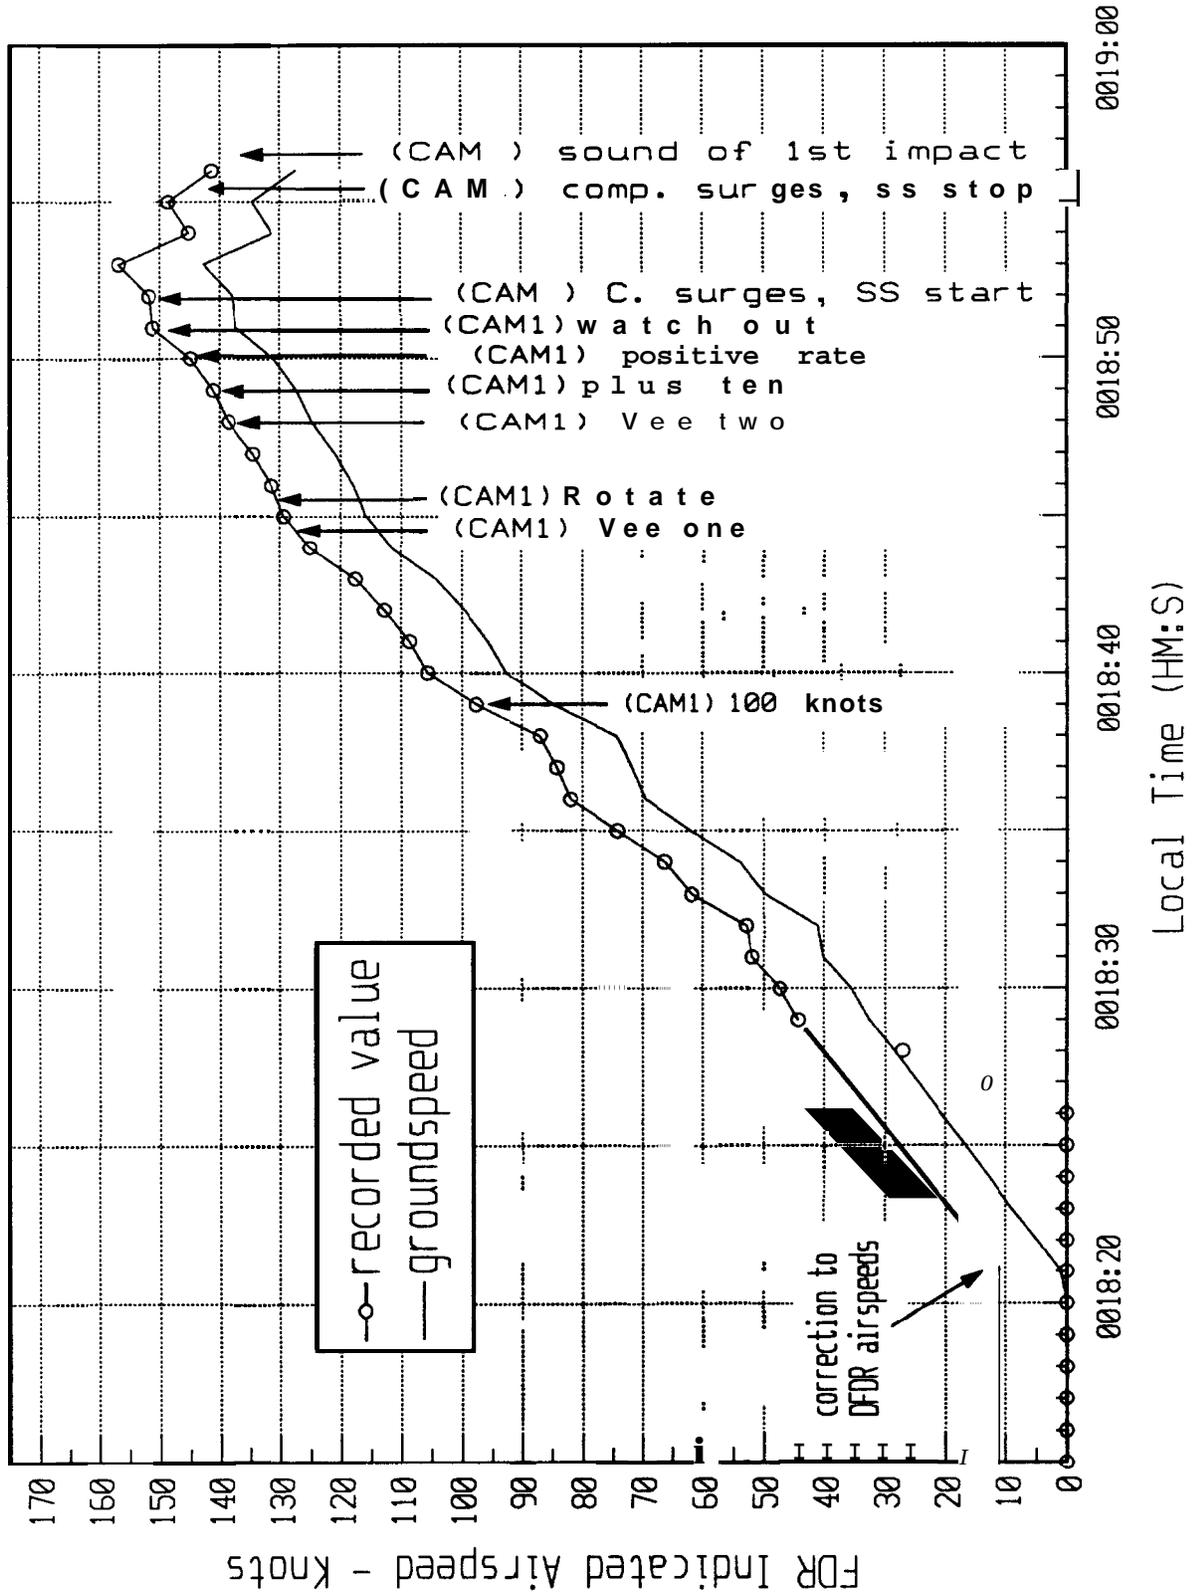
Figure 2.--Indicated airspeeds versus time.

The resulting correlation of airspeed, pressure altitude, normal acceleration, and airplane heading as a function of the common time reference is shown in figures 2 through 5 respectively. It is noted in figure 4 that the scatter of the normal acceleration values recorded on the FDR made the data difficult to interpret and of limited reliability. Consequently, a moving average technique was used to smooth this data. The resulting normal acceleration plot was considered as the best one obtainable for evaluation of the airplane's flight performance.

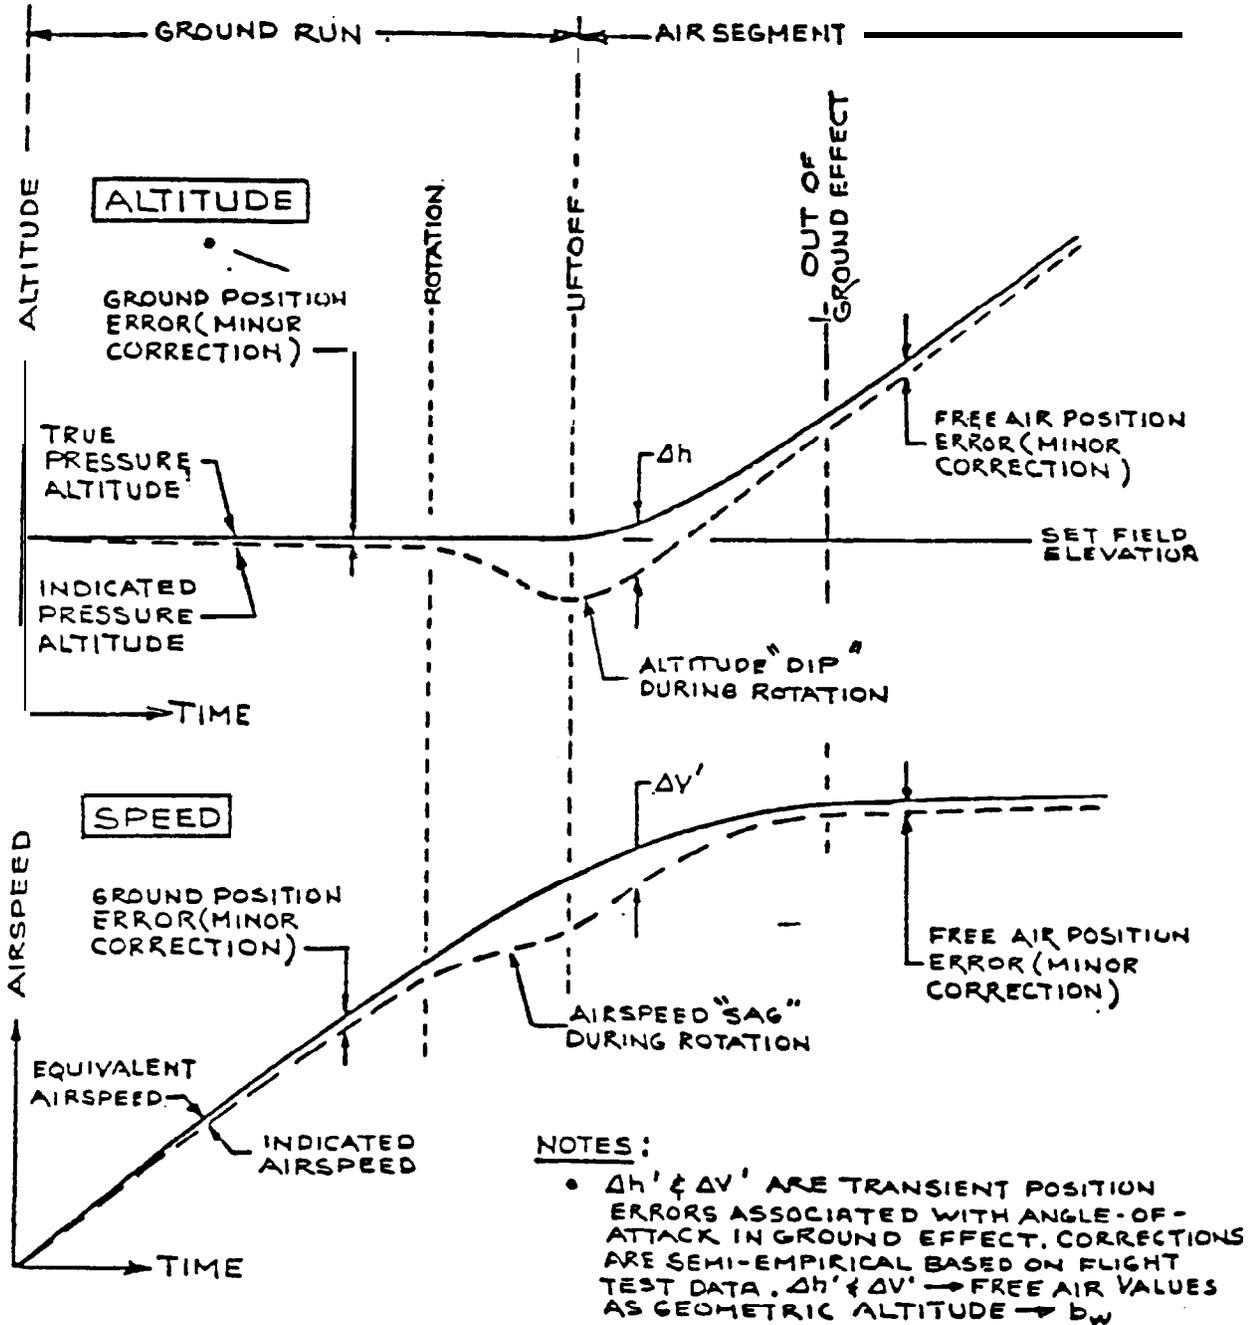
Figure 7.--Air data parameters during takeoff.

Figure 7 shows the typical altitude and airspeed variations from the start of the takeoff roll until the airplane leaves ground effect. Rotation of an airplane during takeoff changes the airflow patterns across the static ports, resulting in a static pressure measurement that is higher than the actual static pressure. The difference between the measured and the actual pressure is called the static position error and is apparent by corresponding errors in the recorded altitude and airspeed. On Figure 7, "delta H" and "delta V" represent the transient position errors associated with angle-of-attack (AOA) in ground effect. The measured values of altitude and airspeed as recorded on an FDR decrease below actual values during this time, with liftoff occurring near the bottom of the altitude dip. According to the manufacturer, the normal indicated altitude dip that occurs during the takeoff rotation of a DC 9-10 airplane is about- 50 feet (below field elevation).

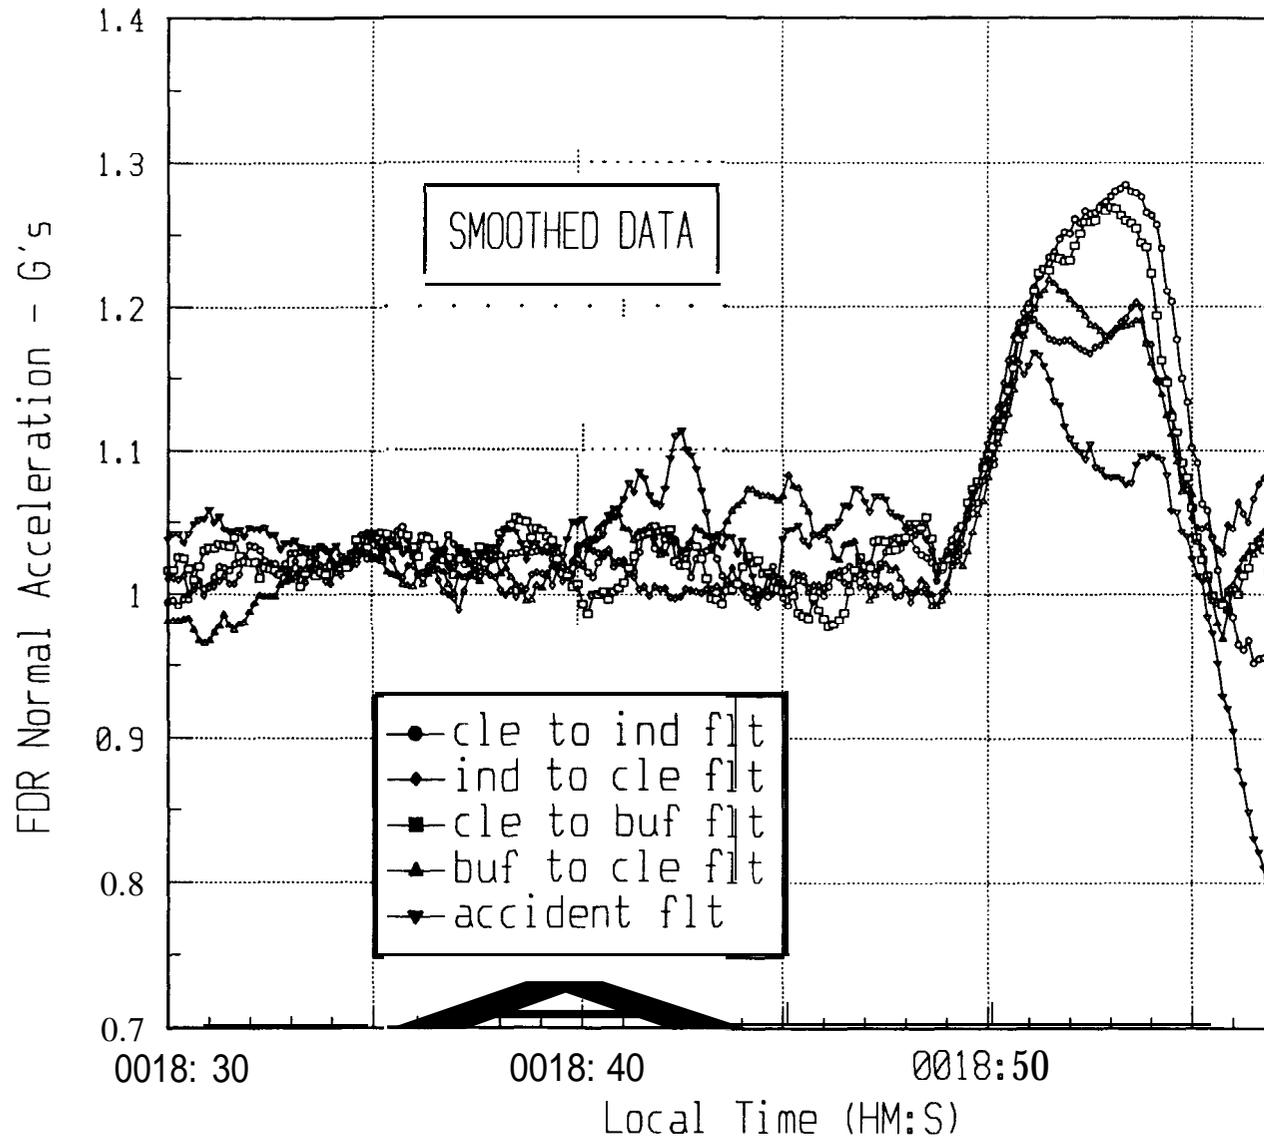
Figure 8. -- Normal acceleration data for previous takeoffs.

As the airplane transitioned to climbing flight on previous takeoffs, there was a buildup in normal acceleration, followed by a return to near 1 g values. A comparison of the accident takeoff to the previous four takeoffs is plotted in figure 8. Smoothed acceleration curves for the previous takeoffs were offset so that the beginning of each buildup coincides with that of the accident flight. All five takeoffs display an increase in normal acceleration early in the transition phase, except that the buildup in g values during the accident takeoff abruptly ended after reaching about 1.17 g, and then decreased prematurely. On the previous flights, the positive normal accelerations were sustained for 3 to 5 seconds reaching peak values between 1.2 g and 1.3 g.

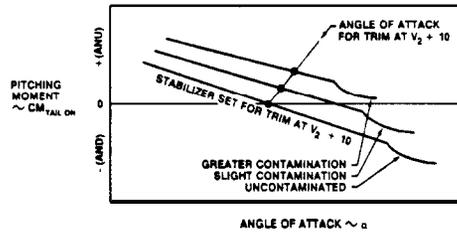
Figure 4. Effect of Wing Ice Contamination on Pitching Moment

Figure 4 depicts a typical total airplane pitching moment curve. For an airplane trimmed for takeoff, the stabilizer is set to balance the moments due to both aerodynamic forces and center of gravity location so that the stick force at climb-out speed ranges from none to a slight pull. This balance is upset by wing ice contamination, particularly on contemporary aircraft with tapered, swept wings. With contamination on the wings, the aircraft will increasingly behave as if it was mistrimmed in the

airplane nose-up direction as the angle of attack is increased. This will result in the aircraft's pitching up more rapidly than normal during the takeoff rotation, and will require an abnormal push force to maintain the desired airspeed during climb. As with other effects, this pitch-up tendency becomes more pronounced as the amount of ice contamination increases.

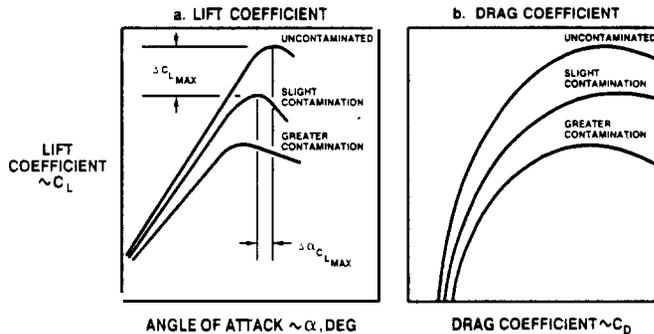
Figure 3. Effect of Wing Ice Contamination on Lift and Drag Coefficients

Wing ice contamination can also significantly affect the airplane drag as shown, again typically, in Figure 3b. The effects on drag can be large enough that the difference between available thrust and drag can adversely affect the airplane's climb capability. This not only would make it difficult for the airplane to clear obstacles by the required distances, it could possibly result in the airplane's inability to climb at all if an engine fails during takeoff.

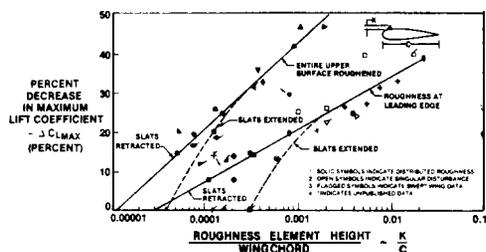
Figure 6. Correlation of the Effect of Wing Surface Roughness on Maximum Lift Coefficient

Figure 6 shows an empirical correlation of lift loss due to wing surface roughness, including ice contamination. It is interesting to note that this simple correlation encompasses data representing a Reynolds Number range from 6×10^5 up to 29×10^6 and airfoil shapes ranging from simple symmetrical sections to those representative of second-generation turbojet aircraft (see Table 3).

The lower line in Figure 6 shows the lift loss due to a localized strip or narrow band of contamination on the leading edge. Much of the data for the lesser amounts of contamination have been obtained from maintenance or flight training experience where some form of contamination such as insect debris, chipped paint, or burred rivets caused premature stall when the slats were retracted, but caused little or no noticeable effect when the slats were extended. Wind tunnel data indicate that as the contamination on the leading edge becomes larger, such as for in-flight ice

Although Figure 6 shows a significant difference in lift loss between a narrow band of roughness at the leading edge and roughness over the entire upper surface. It is worthy to note that recent unpublished data for slight roughness extending aftward from the leading edge to about 7-percent chord on both the upper and lower surfaces (as might occur during a mild icing encounter) can cause lift losses similar to those caused by a fully roughened upper surface.

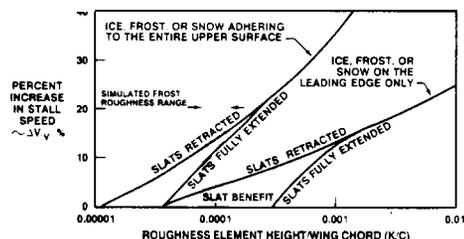
Figure 7. Approximate Effect of Wing Ice Contamination on Airplane Stall Speed

Figure 7 expands the data from Figure 6 into an operationally meaningful percent increase in stall speed. From this figure, the importance of maintaining the "clean wing" philosophy begins to show, because it becomes readily apparent that it takes only a relatively small amount of roughness on the wing upper surfaces to cause large increases in stall speeds even with slats extended. Further expanding the data to compare the measure of roughness (K/C) with various grades of abrasive paper, an estimate can be made (Figure 8) of the stall speed increase that would occur on an aircraft about the size of a DC-9, 737, or BAC-111 if the wing upper surface was contaminated by ice having the roughness of various grades of abrasive paper. Those familiar with the icing roughness that can occur during a freezing drizzle or when snow has partially melted and then refrozen to a surface will probably agree that this range of roughness is not at all unusual under such conditions. With the stall speed increases shown in Figure 8, stall warning margins and margins to stall decrease markedly or disappear altogether.

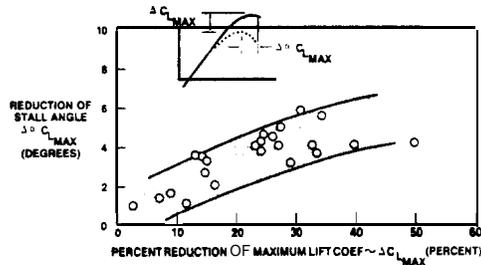
Figure 9. Reduction of the Angle of Attack at Stall Due to Wing Surface Roughness

As noted earlier, the increases in stall speed also occur at much lower than normal angles of attack (Figure 9). This can have at least two adverse effects. First, many contemporary stall warning systems **are actuated** at prescheduled angles of attack. **If** wing ice contamination causes a stall **before** this prescheduled angle is reached, the flight **crew** will receive no warning of impending stall. Second, the reduced stall angle of attack compounds the problem of the tendency of an ice-contaminated airplane to pitch up during **rotation**, increasing the risk of overshooting the stall angle shortly after liftoff.

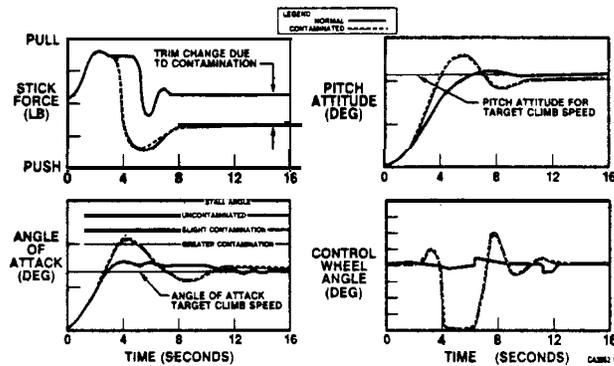
Figure 10. Effect of Wing ice Contamination on Longitudinal Control Characteristics

The overall effects of wing ice contamination on various flight characteristics of an aircraft during takeoff are summarized in Figure 10. In this figure, stick force is the amount of push or pull on the control column required to manage the pitch attitude of the aircraft. Pitch attitude is the angle of the airplane with respect to a horizontal reference plane; angle of attack is the angle of the airplane with respect to its flight path; and wheel angle is the rotation of the control wheel **required** to manage the bank, or roll attitude, of the airplane.

From an aerodynamic viewpoint, there is no such thing as "a little ice." Strict attention should be focused on ensuring that critical aircraft surfaces are free of ice contamination at the **initiation** of takeoff.
