AIR SAFETY INVESTIGATION REPORT  
BO/200203074

# Inflight Loss of Control due to Airframe Icing

**SAAB 340B, VH-OLM**  
28 June 2002

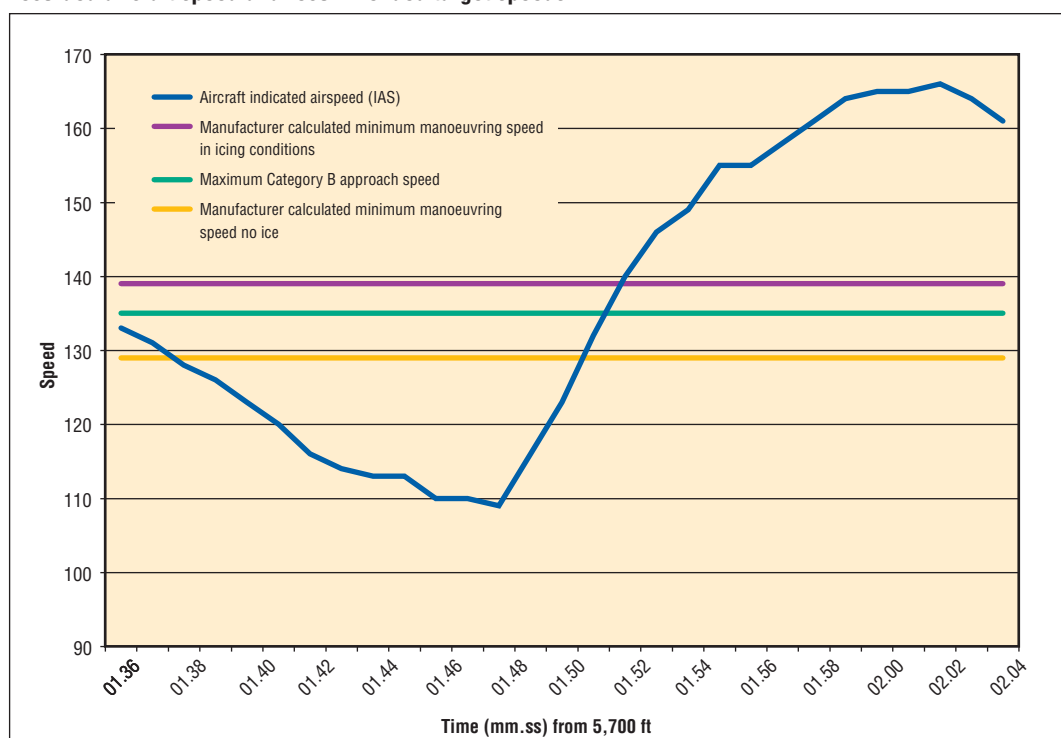
**FIGURE 1:**  
**Recorded aircraft speed and recommended target speeds**

The PIC indicated that he had intended to slow the aircraft to 130-135 kts, during the descent and level off at the MDA.

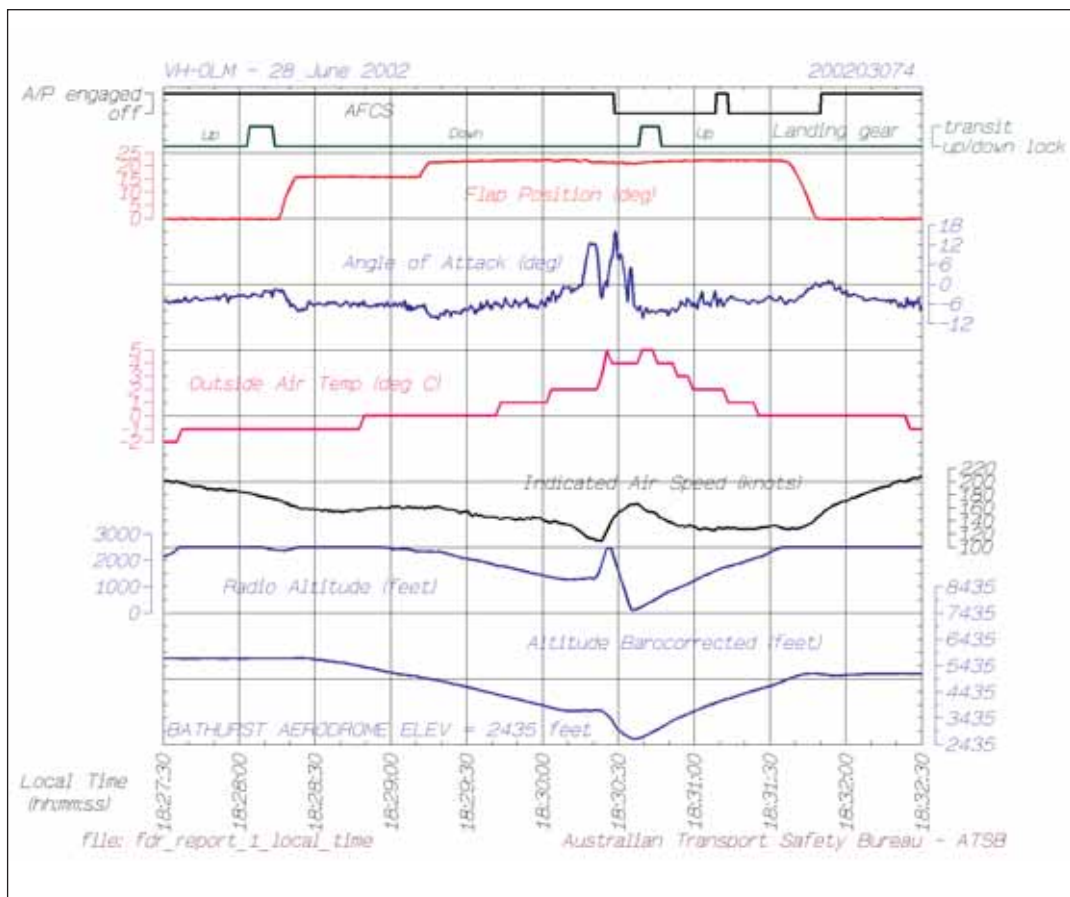
**FIGURE 5:**  
Recorded data, five minute period

Figure 5 shows a graphical representation of the recorded values of pressure altitude, radio altitude, indicated airspeed, outside air temperature, angle of attack, flap position, landing gear position and autopilot engagement. This information is for a five-minute period leading up to and after the departure from controlled flight. Figure 6 shows the same information for the one-minute period immediately surrounding the occurrence.

At 1828:28 the flight crew commenced descent from 5,712 ft AMSL with the landing gear extended, flaps at the 15 degrees setting, and the autopilot engaged. At the commencement of the descent, the recorded aircraft speed was 158 KIAS, engine torques 40 per cent and an OAT of -1°C.

At 1829:22, 54 seconds into the descent, the flaps were extended to the 20-degree setting, propellers set to approximately 1,400 rpm and the engine torques reduced to around 16–22 per cent respectively.

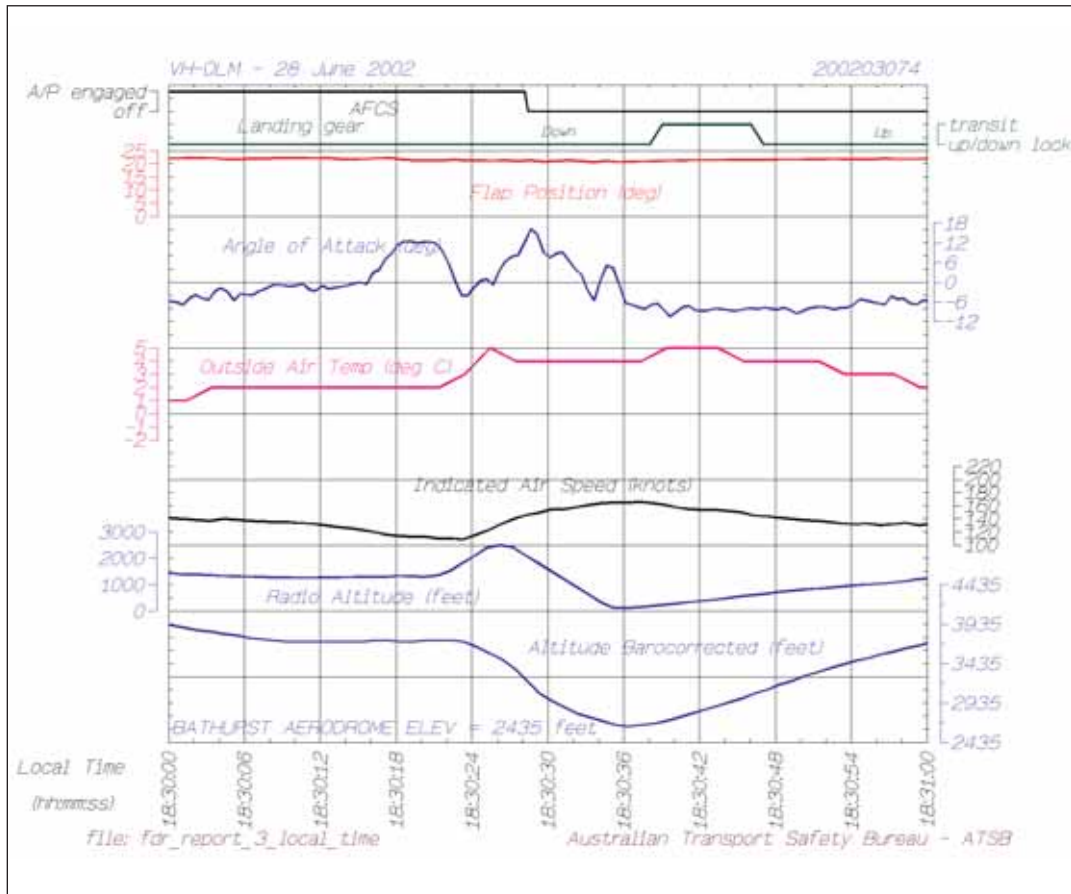
**FIGURE 6:**  
Recorded data, one minute period

Approximately 1 second later, at an angle of attack of 12.35 degrees and speed of 114 KIAS the aircraft commenced a roll back to the left in response to autopilot driven aileron deflection and the engine torques were increased through 28 per cent.

An angle of attack of 12.55 degrees was recorded 1 second later. The speed at this time was 113 KIAS, pitch angle 10 degrees noseup. The left roll continued through 8 degrees right bank and the engine torques continued to increase through 38 per cent.

An uncommanded left roll then commenced, with the aircraft rolling rapidly and reaching 109 degrees left bank at 1830:23. At this time the speed was 109 KIAS, the engine torques

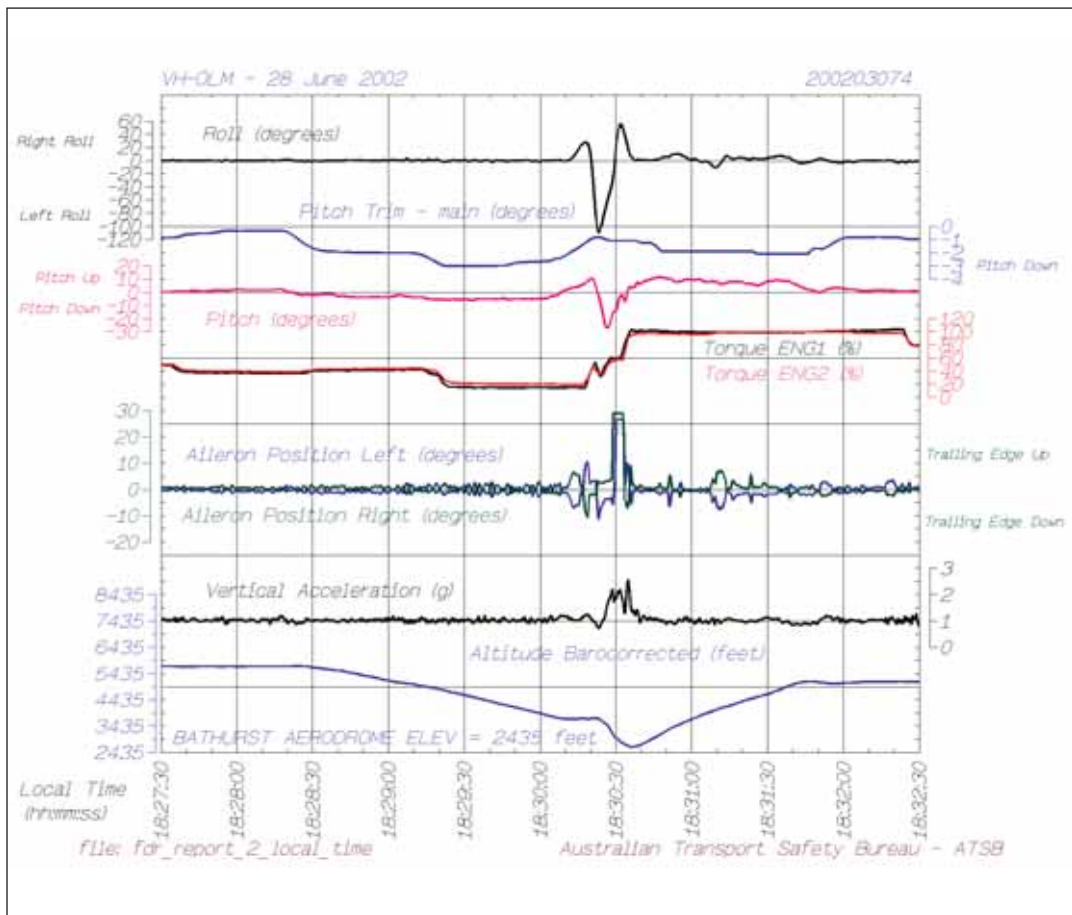
**FIGURE 7:**  
Recorded data, five minute period

Figure 7 shows a graphical representation of the recorded values of pressure altitude, vertical acceleration, pitch, roll, pitch trim, engine torques and aileron positions. This information is for a five-minute period leading up to and after the departure from controlled flight.

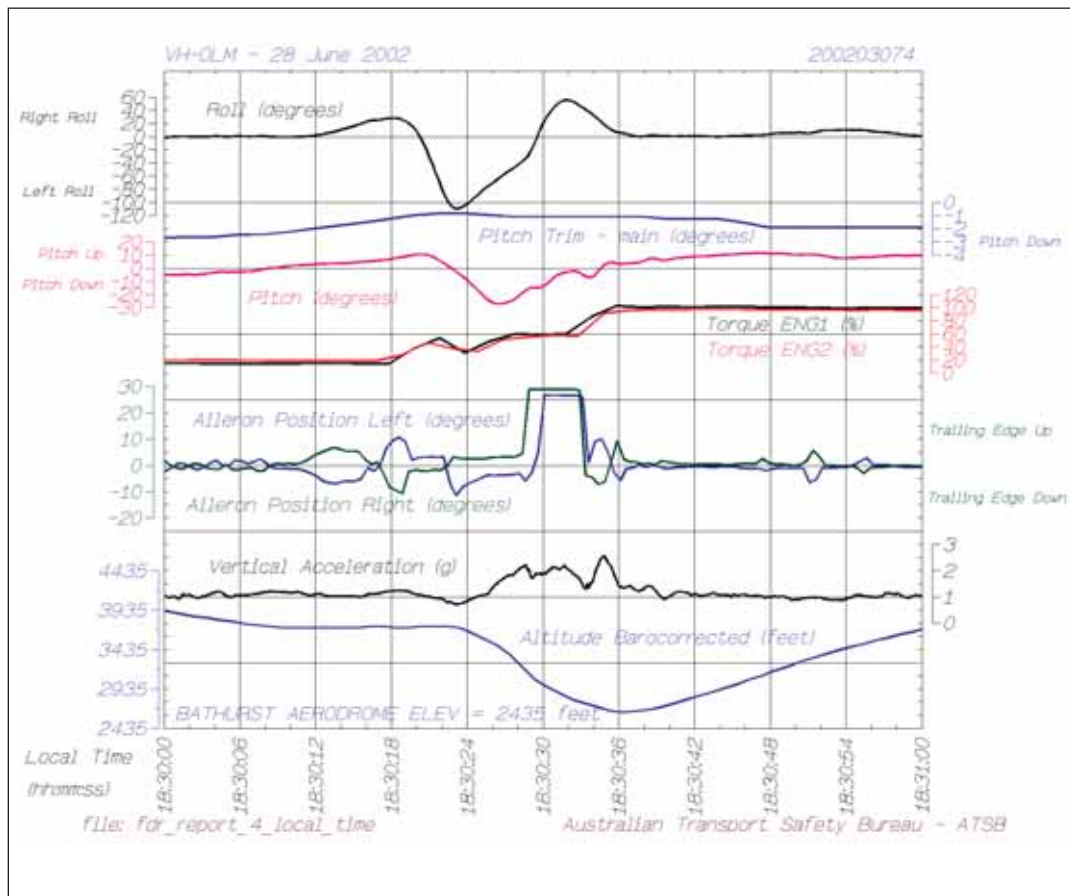
**FIGURE 8:**  
Recorded data, one minute period

Figure 8 shows the same information for the one-minute period immediately surrounding the occurrence.

During the following 3 seconds the aircraft descended a further 336 ft to 2,880 ft AMSL (estimated 352 ft AGL), while rolling right through wings level to 56 degrees right wing low. Both ailerons were simultaneously in the maximum positive position (trailing edge up) of 27 degrees (left) and 29 degrees (right) for this period (see para 1.16.1)

During the following five seconds the aircraft continued to descend, rolling back to almost wings level and nose-up pitch in response to pilot commands. The engine torques increased towards 100 per cent and a vertical acceleration of +2.56g was recorded. The minimum altitude during the stall recovery was recorded at 1830:36. The altitude AMSL was 2,640 ft, 112 ft AGL and speed 165 KIAS.

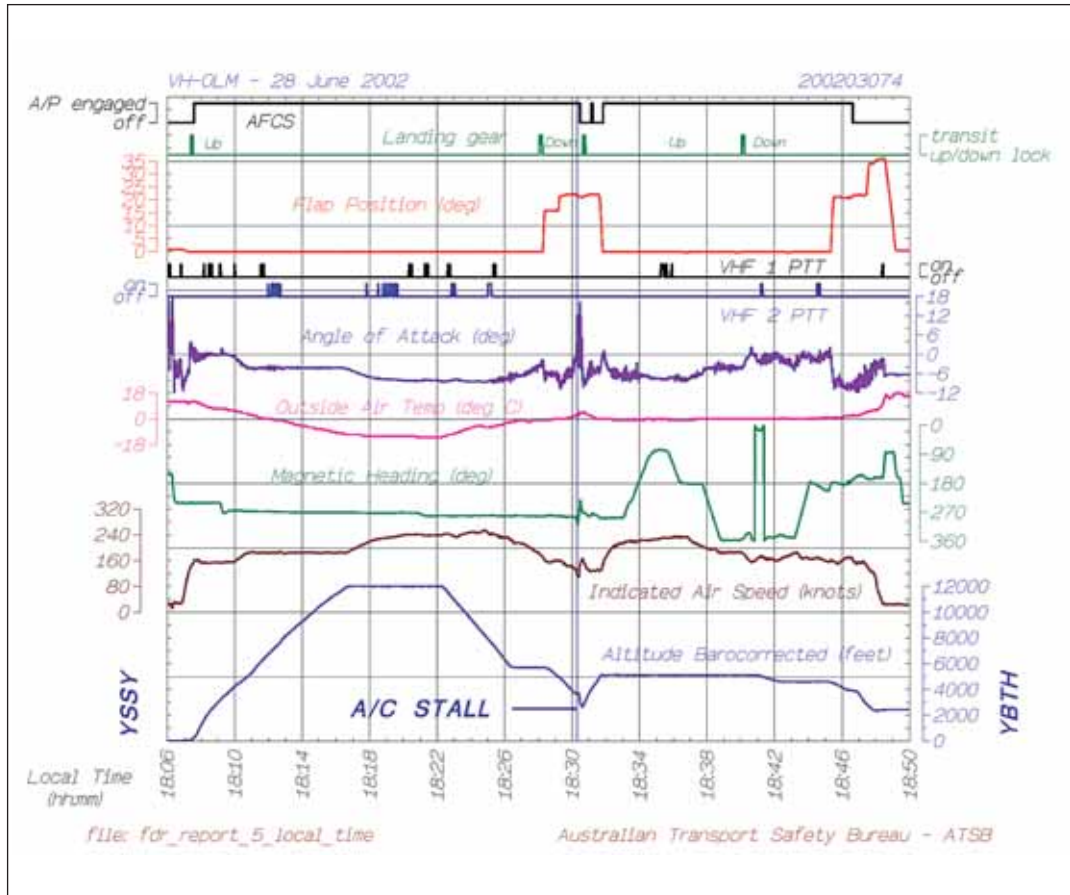
**FIGURE 9:**  
Recorded data, Sydney - Bathurst

Figure 9 provides the entire flight profile of altitude, indicated airspeed, magnetic heading, OAT, angle of attack, VHF 1 & 2, PTT, flap position, landing gear and autopilot.
