CIVIL AERONAUTICS BOARD
ACCIDENT INVESTIGATION REPORT

Adopted: June 24, 1954

ZANTOP FLYING SERVICE, NEAR KANSAS CITY,
MISSOURI, JANUARY 20, 1954The Accident

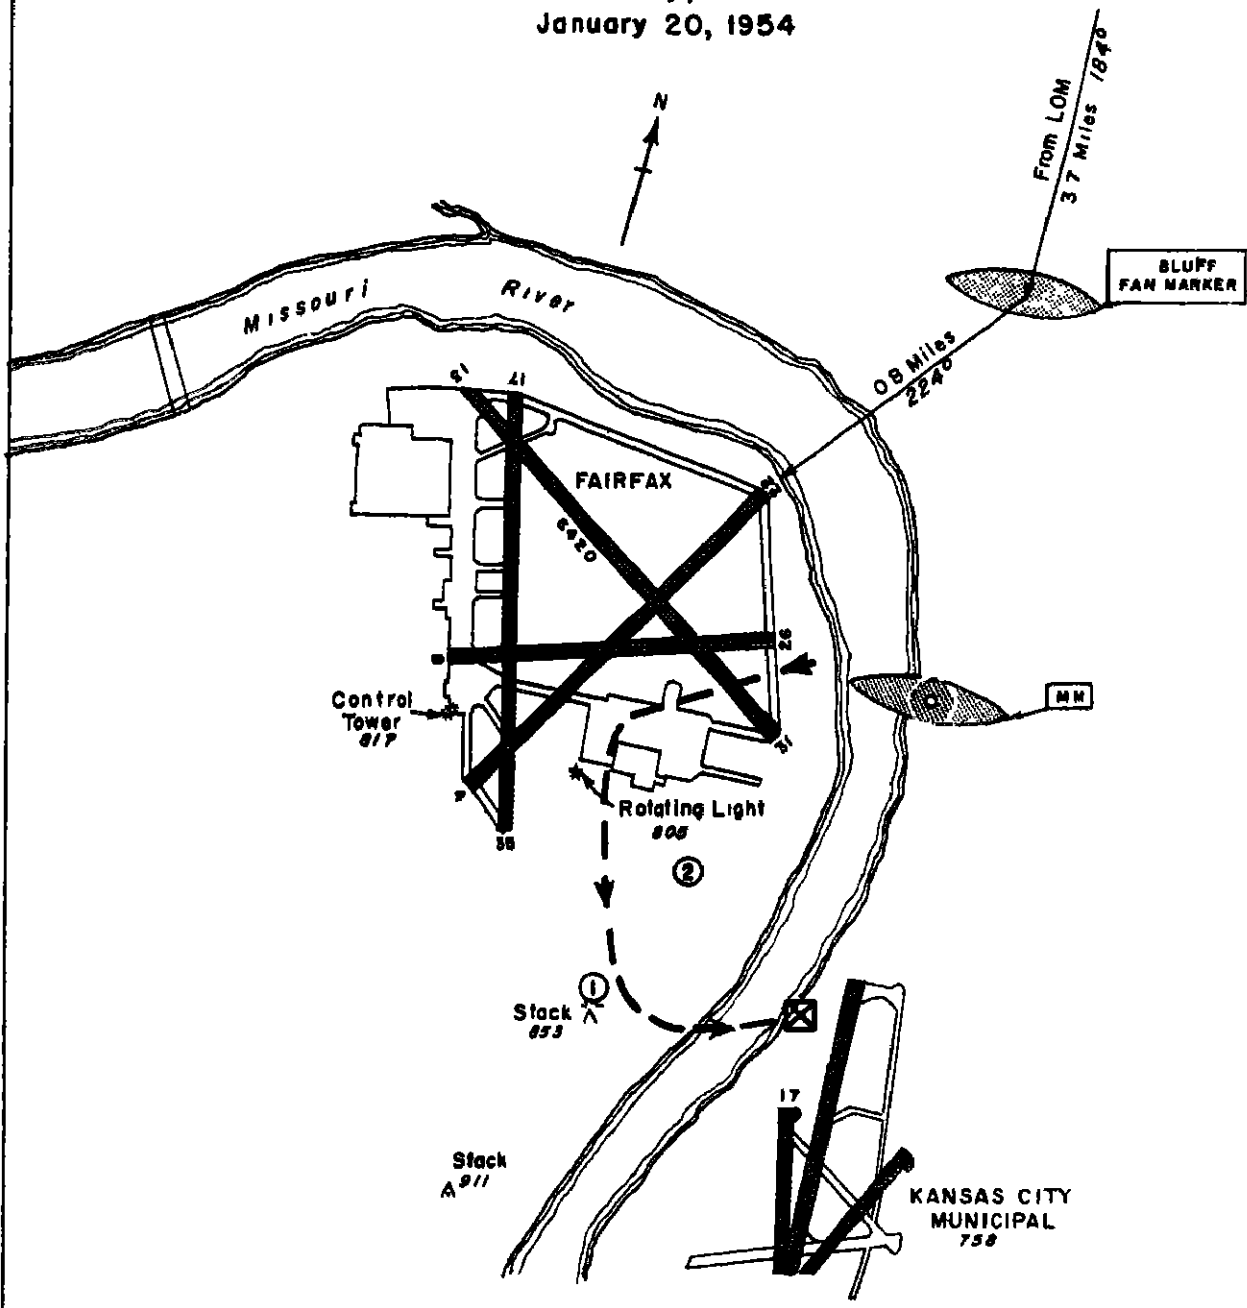
PROBABLE FLIGHT PATH AND LOCATION OF WRECKAGE

At approximately 0755 the wreckage was located by the Kansas City Municipal Airport patrol 400 feet north and 156 feet west of the approach end of Runway 17 of that airport.^{2/}

Two ground witnesses south of Fairfax Airport observed the aircraft flying overhead at an estimated altitude of 100-200 feet above the ground. These witnesses observed the aircraft making a left-hand pattern rolling violently from side to side while descending. They described the motion of the aircraft as wallowing. One witness, an aircraft mechanic, stated the aircraft appeared to be out of control.

The other witness, located farther along the pattern, stated he thought the aircraft would crash before getting back to the airport. Both witnesses testified to the freezing drizzle, slippery ground conditions, low ceiling and poor visibility. They lost sight of the aircraft when it disappeared to the east behind ground structures.
