# **NATIONAL TRANSPORTATION SAFETY BOARD**

## **AIRCRAFT ACCIDENT REPORT**

**CONTINENTAL AIRLINES, INC., FLIGHT 1713  
McDONNELL DOUGLAS DC-9-14, N626TX  
STAPLETON INTERNATIONAL AIRPORT  
DENVER, COLORADO  
NOVEMBER 15, 1987**

**NTSB/AAR-88/09**

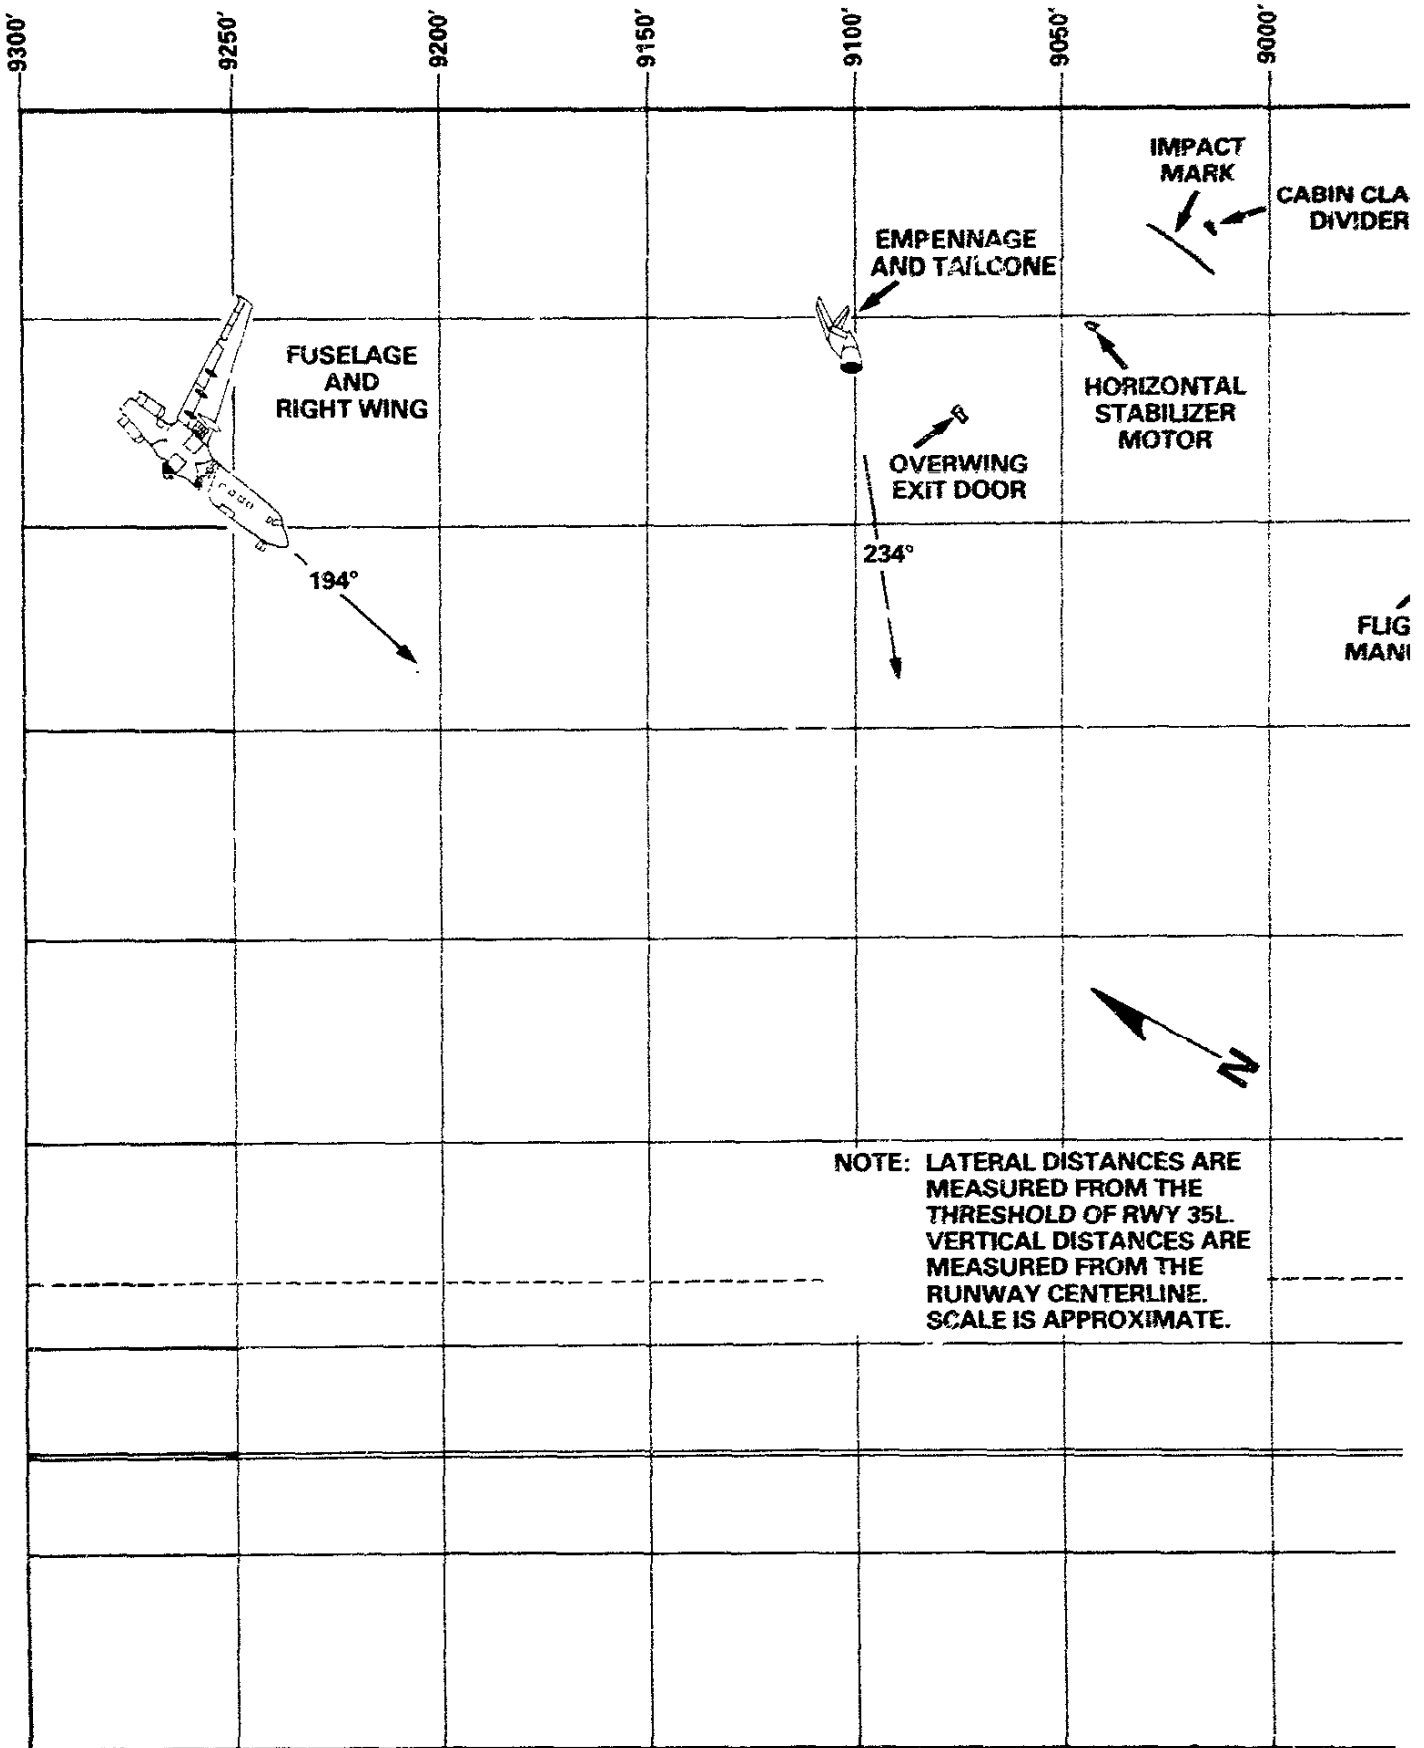
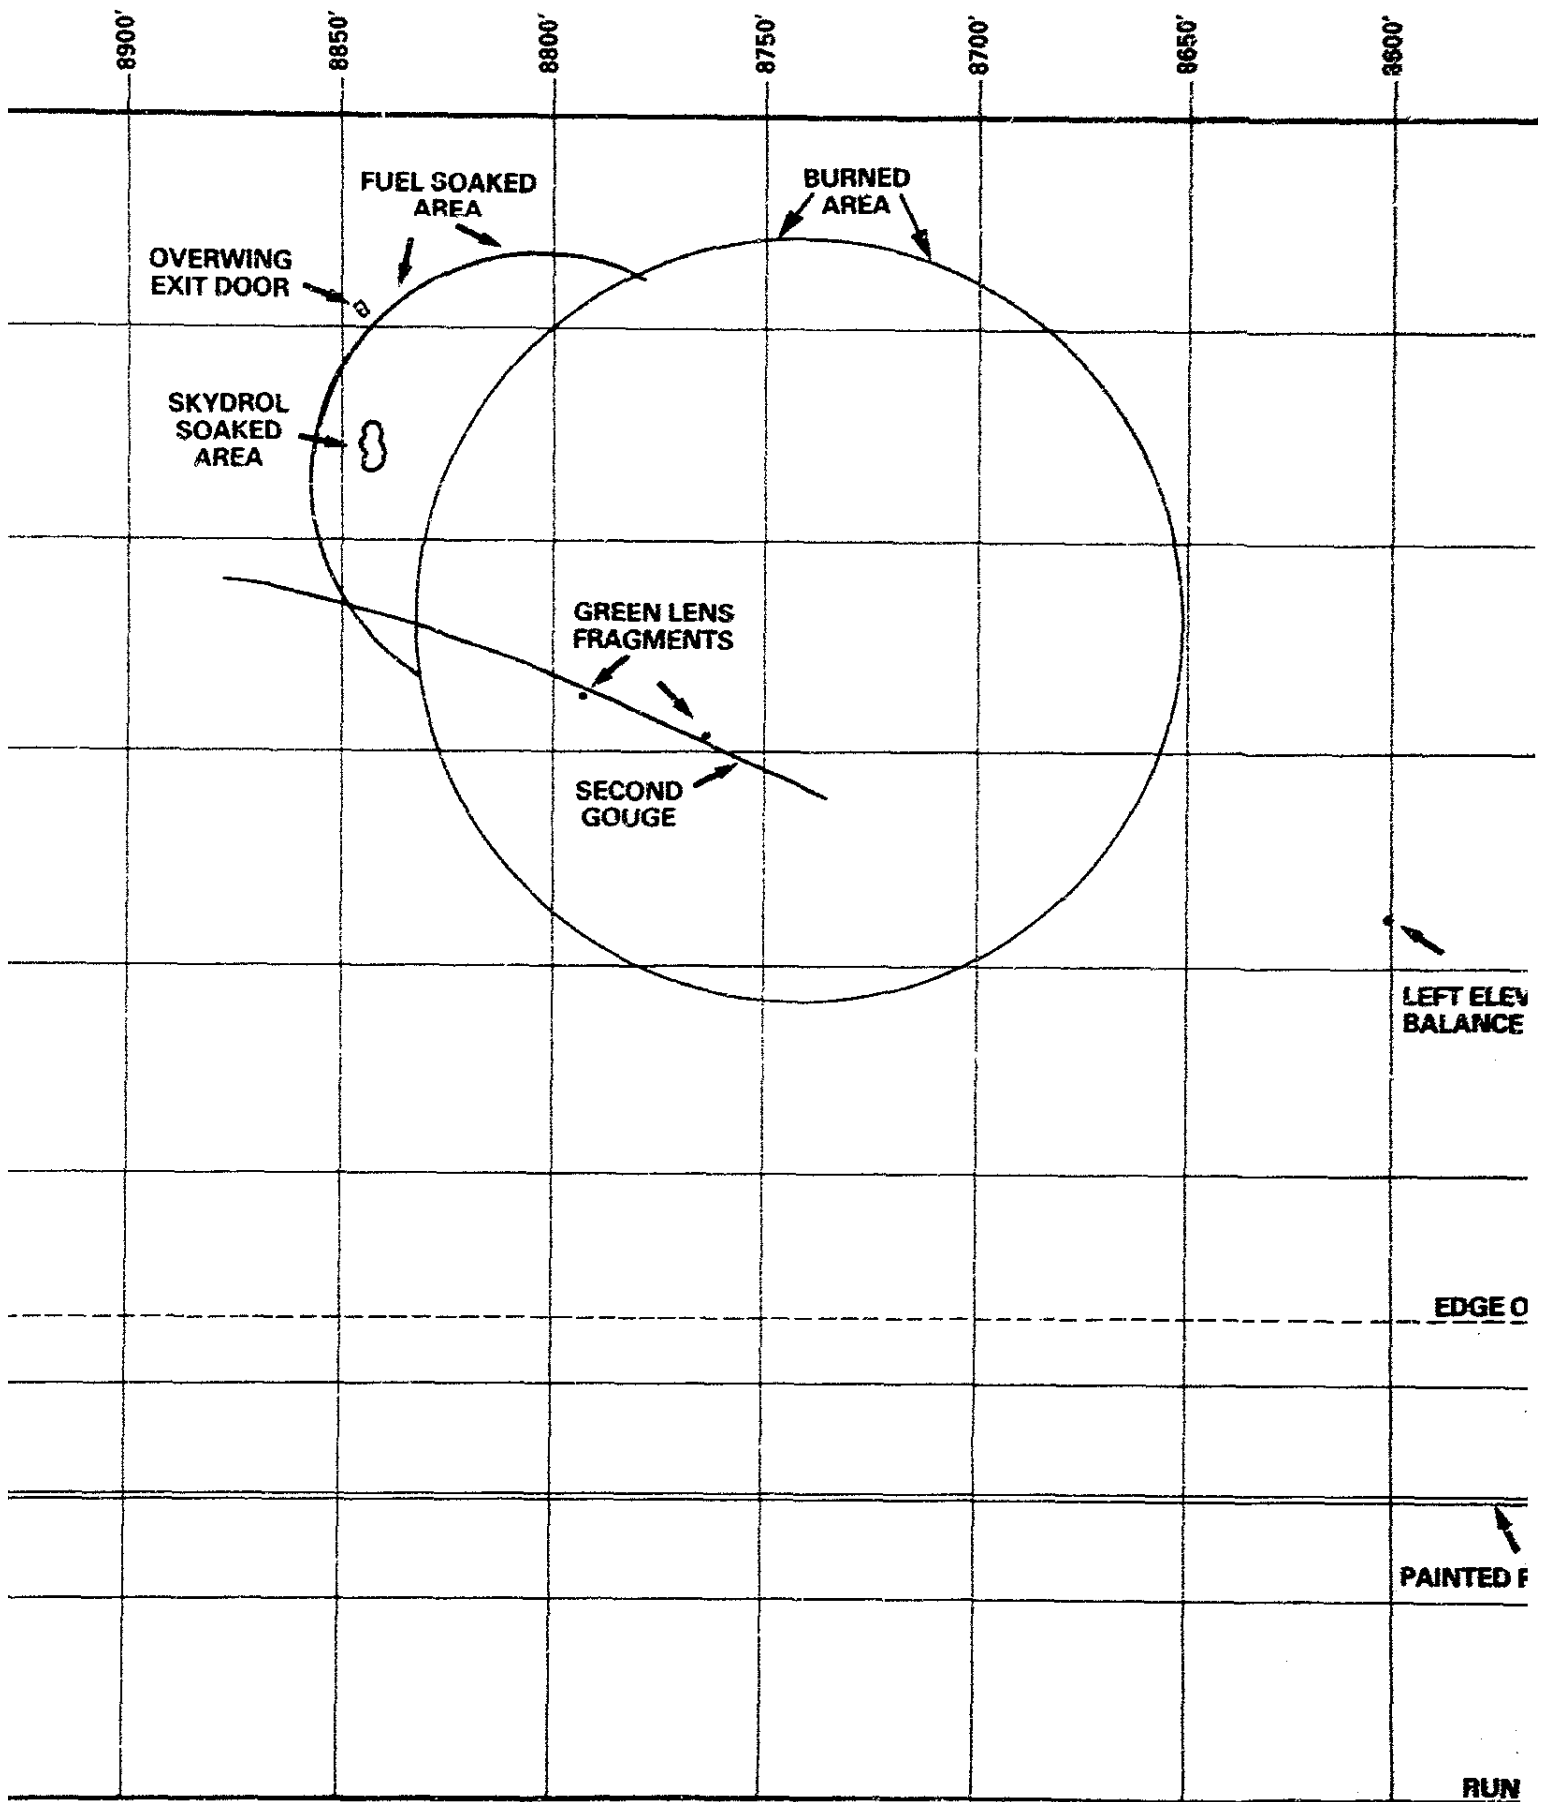
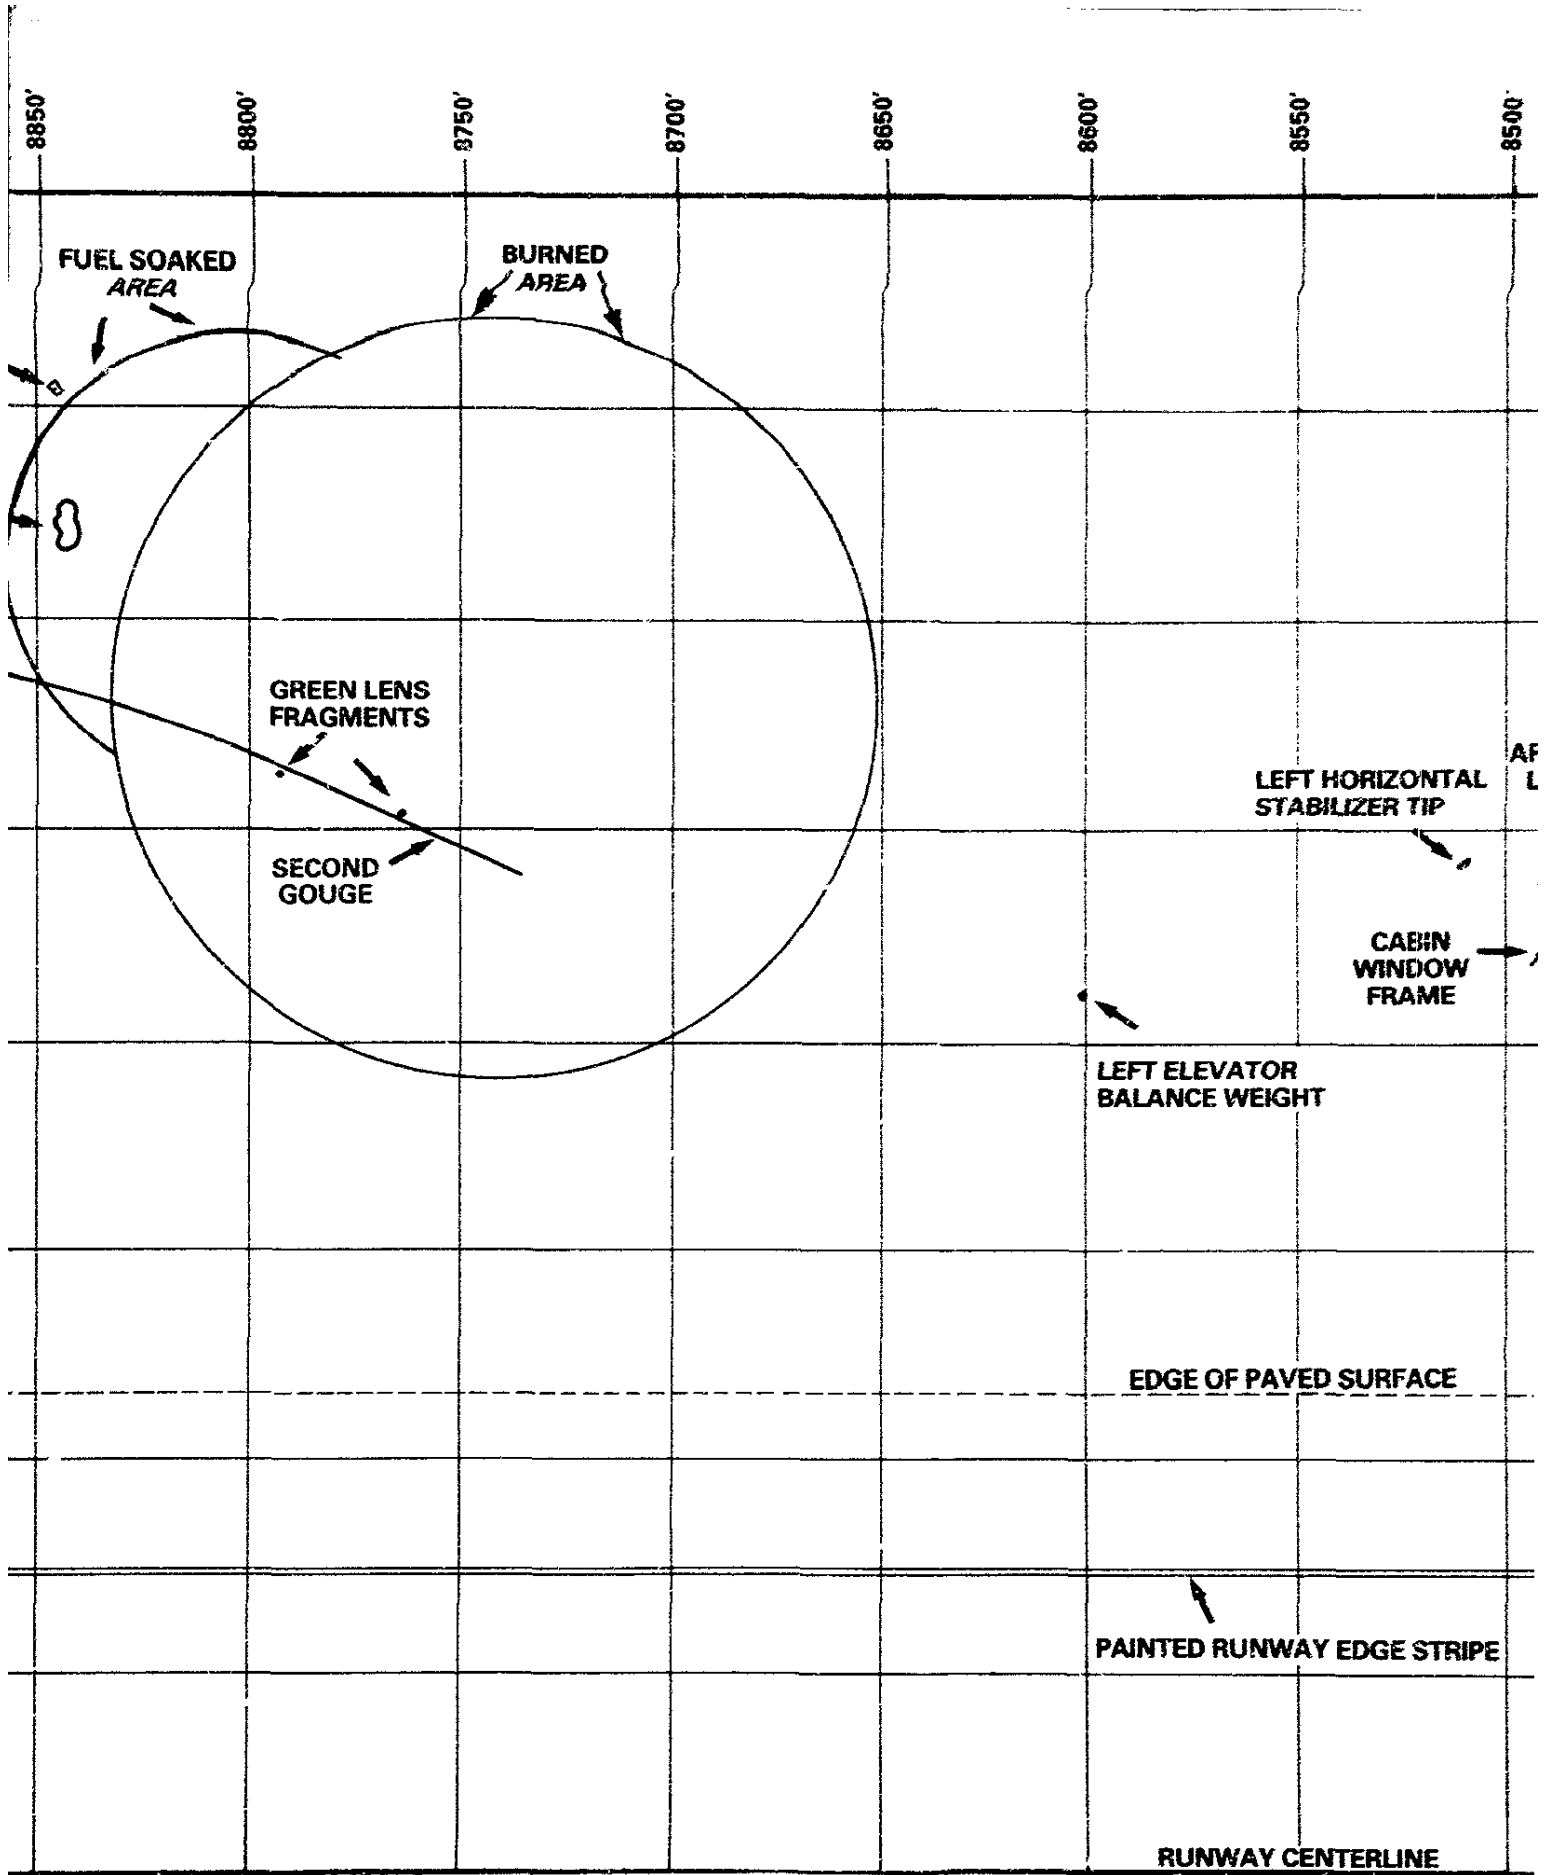
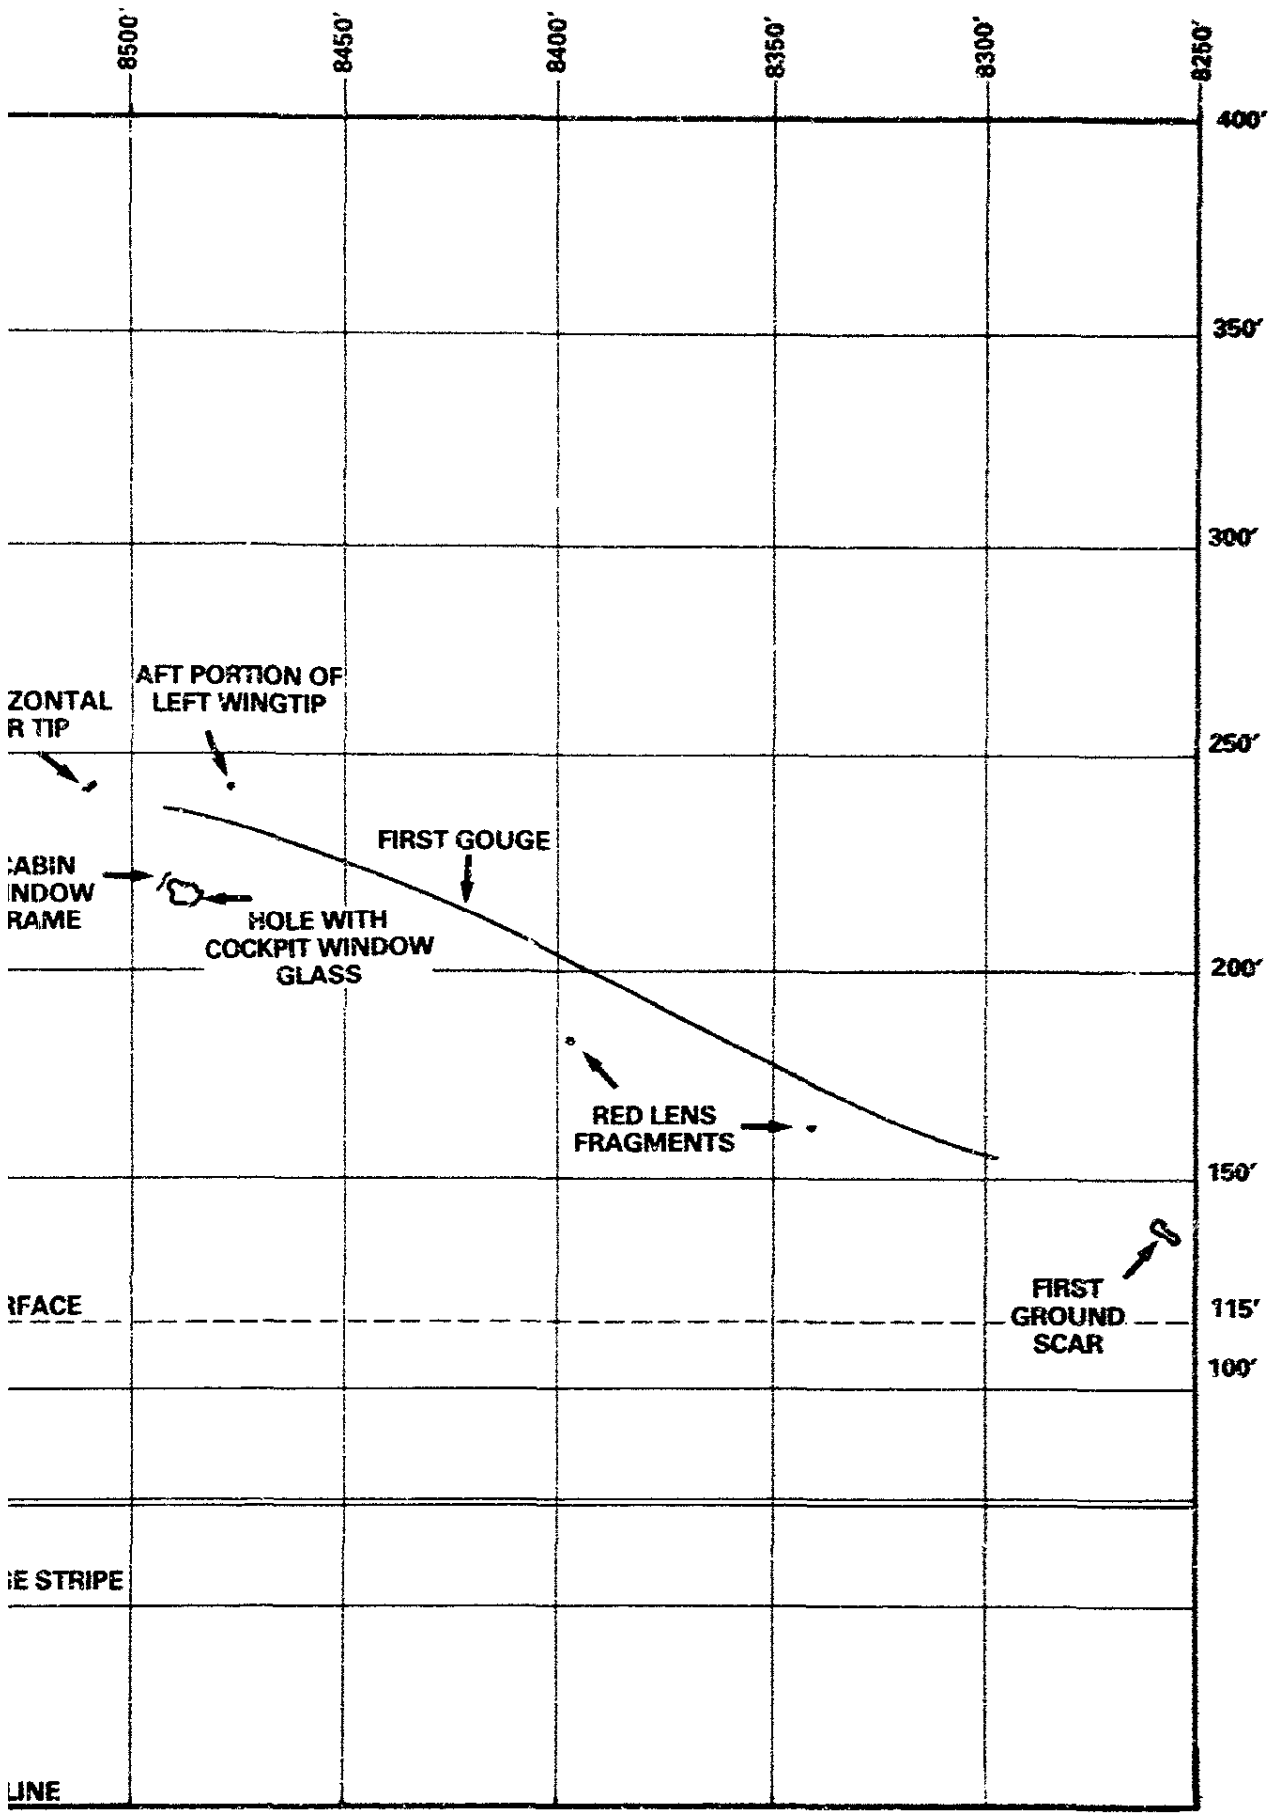
Figure 4. -- Wreckage diagram at accident site.

Three major ground scars were found at the accident site. The first ground scar began 8,244 feet down and 114 feet to the right of the runway 35L centerline. The 214-foot scar angled away from the runway approximately 20° and then turned slightly back toward the runway. The left wingtip landing light lens retaining ring was located 8,257 feet down and 130 feet to the right of the runway centerline. The red glass left navigation light lens also was found in this area. Left wing debris was found in a line between this area and the second ground scar, a crater 11 feet by 11 feet by 9 inches. Examination of the dirt in the crater revealed pieces of glass identified as the outer glass panel of the left cockpit "eyebrow" window. A third major ground scar contained green glass lens material. Other debris in the area of the third crater consisted of various airplane components, including pieces of cabin interior, overhead compartment fragments, and passenger luggage.

The nearly intact empennage/tail cone section of the airplane was located approximately 250 feet down from the third scar. It was inverted and aligned on a magnetic heading of 234°. The empennage was coated with soot but showed no signs of thermal damage. The left horizontal stabilizer tip and left elevator tip were missing. Fragments from these components were located earlier along the wreckage path, south of the empennage.

The fuselage and right wing were located approximately 200 feet down from the empennage. The forward portion of the fuselage, which had split at fuselage station 446, was resting on its left side. Longerons 1R through 15R were intact but severely bent and distorted. This was the only structure connecting the forward fuselage to the rear fuselage. The left side of the forward fuselage was badly damaged. Much of the exterior skin and underlying structure was torn away and found along the wreckage path. The right side of the fuselage was distorted and dented in several areas near the forward baggage door. The aft portion of the fuselage was aligned with the forward half of the fuselage and resting inverted. The section of fuselage just aft of the break was collapsed to within inches of the cabin floor. The portion of the fuselage adjacent to the engines was collapsed to the level where the forward part of the engine was resting on the ground. The right wing remained attached in its proximate correct position. (See figures 4 and 5.)

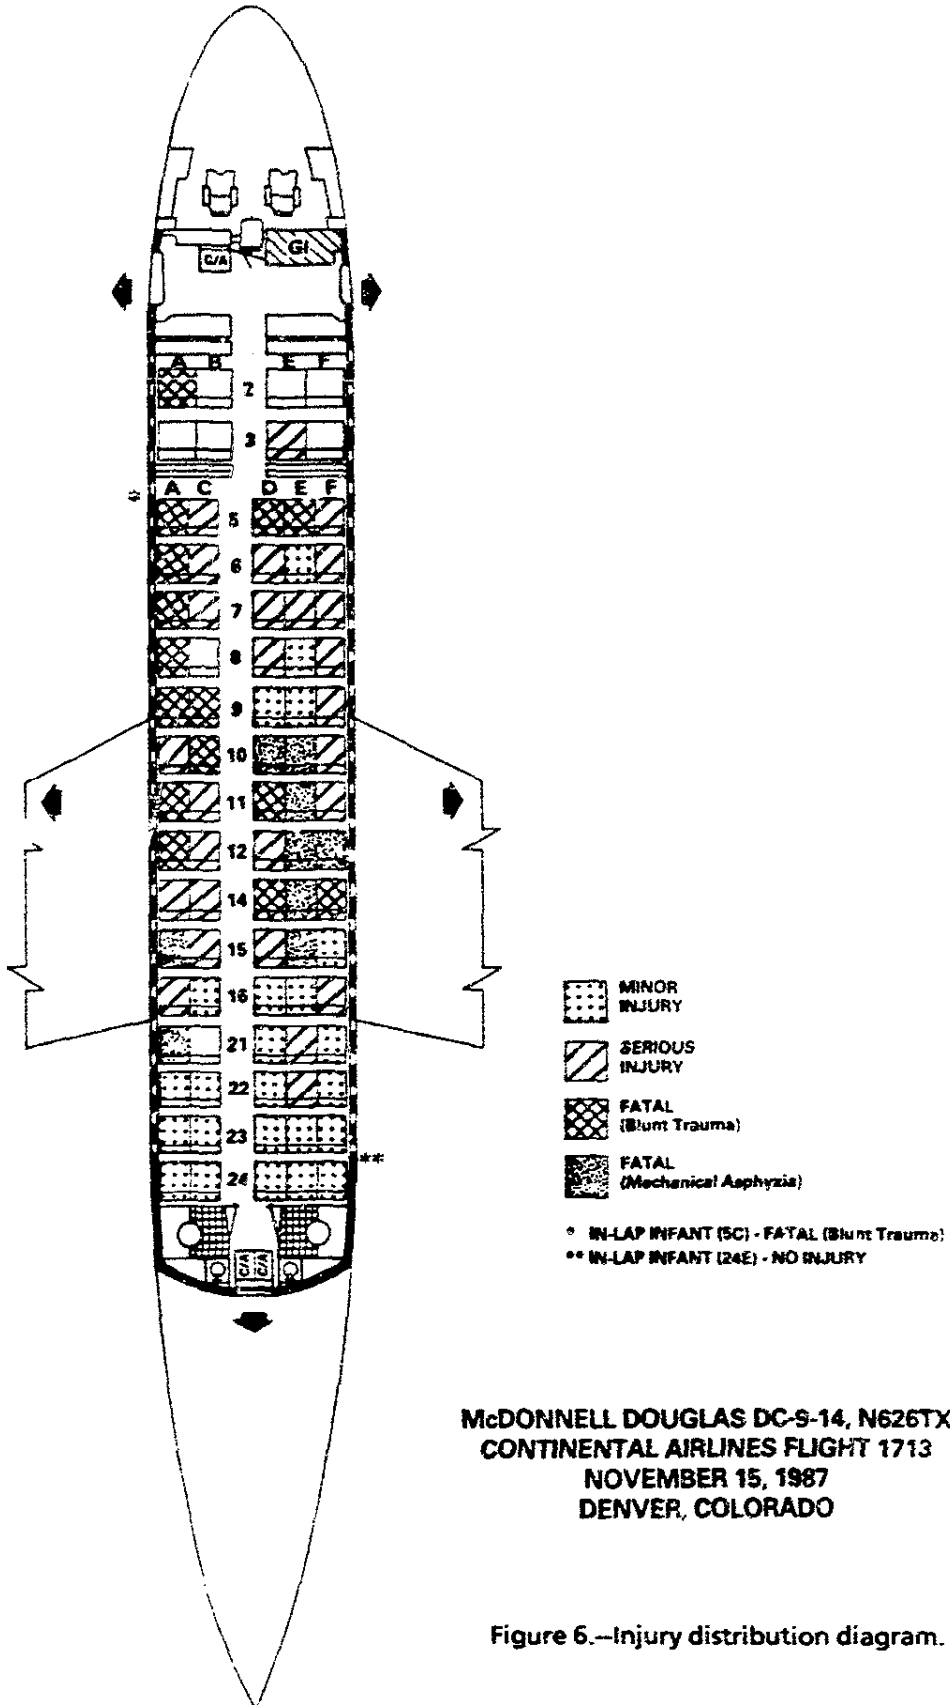
There was extensive damage to the forward left side of the airplane. The fuselage was missing on the left side from aft of the boarding door to about station 466. No one in a window seat in rows 2-9 on the left side survived. Cabin dividers, overhead compartments, and passenger seats were ejected during the impact and were found along the wreckage path. Some survivors in this section were thrown from the airplane while still belted in their seats and other survivors (including a passenger in seat 8E who was asleep and whose seatbelt was not fastened) remained in the fuselage. Several survivors in the forward cabin escaped through breaks in the fuselage while other passengers in this section required extrication. A 6-month old infant who was in his mother's lap in seat 5C died of multiple blunt trauma injuries and his mother survived with serious injuries. (Refer to figure 6 for distribution of injuries.)

Rows 10-15 were inverted and in an area of extreme compression. All occupants in this area required extrication. All survivors in this area had serious injuries and eight of the nine passengers who died of traumatic asphyxia were seated in this section.

Rows 15 aft were also inverted and the fuselage was compressed to within inches of the floor at row 15. There was progressively less fuselage compression toward the rear of the airplane. With the exception of the passenger in 22E who received a serious injury, all of the injuries to passengers in the last three rows were minor. The only occupant who was not injured was a 6-week-old, in-lap infant held by her father in seat 24E. Two flight attendants were seated on the aft jumpseat: one sustained a serious injury, the other minor injuries. Some passengers in the aft cabin were able to evacuate after the tailcone exit hatch was opened while others required extrication.

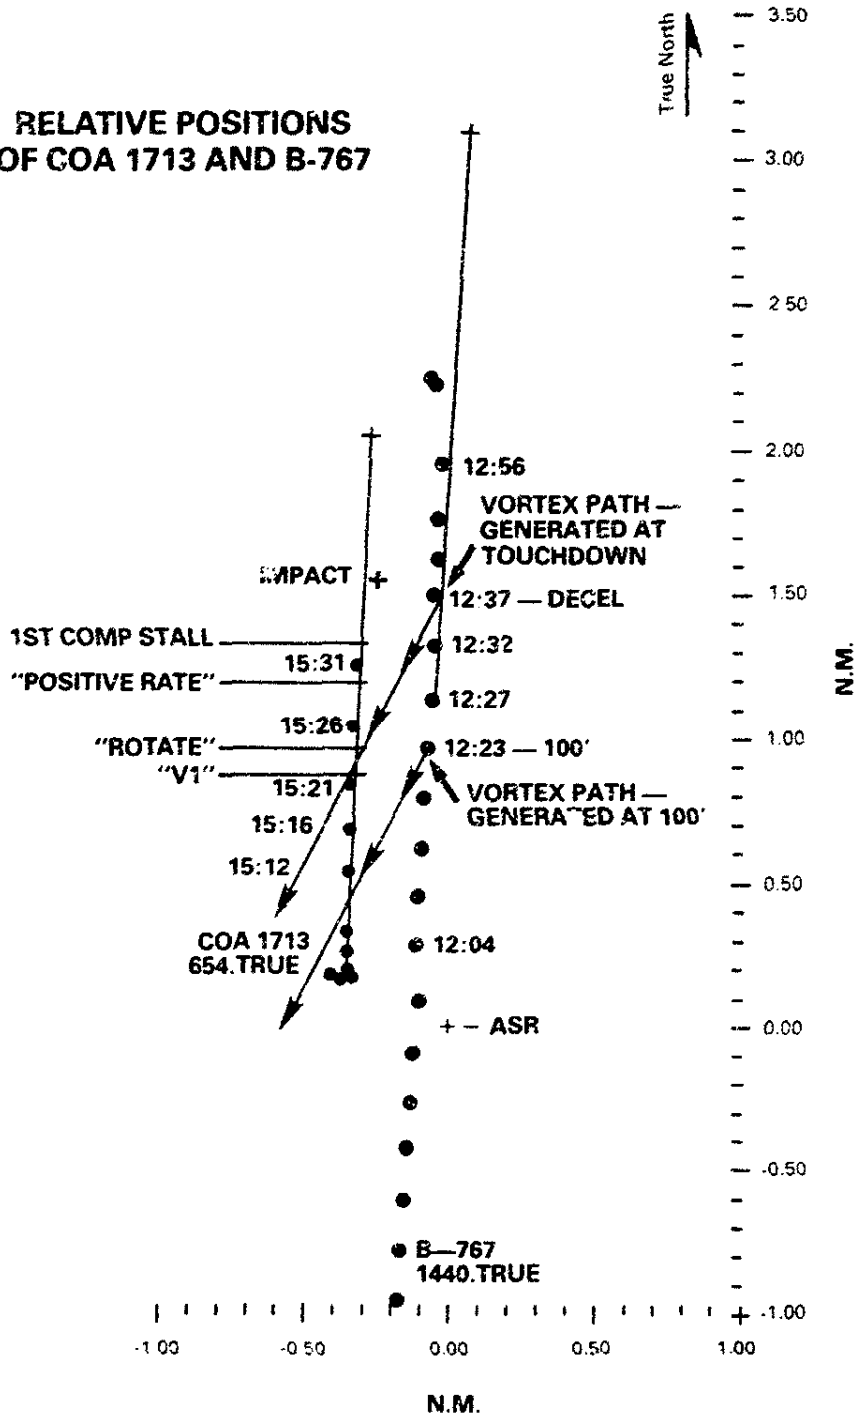
Figure 7.--Vortex path based on LLWAS sensor data.

The points and times on figure 6 were derived from recorded airport surveillance radar plots of the two airplanes and indicate that the Delta Boeing 767 landed approximately 3 minutes before the first sound of a compressor surge from the DC-9. The wind vector, determined from the LLWAS sensor readings, was about 24° from the right of runway heading and is aligned in figure 7 with the diagonal lines. The diagonal line to the south represents the direction of travel of a vortex segment generated at 100 feet above the ground under these wind conditions. The diagonal line to the north represents the direction of travel of a vortex segment generated when the Boeing 767 touched down. Due to the characteristics of wingtip vortices, none are generated after the nosewheel of an airplane is on the ground.

The Safety Board believes that any vortex generated below 100 feet above the ground would have quickly dissipated. Therefore, the south diagonal line on figure 6 is the last possible path of a "strong" vortex, and the north line is the last possible path of any vortex before its complete dissipation. The length of the diagonal lines is not representative of the distance which a vortex may travel before dissipating. The vortex may dissipate at any position along the lines, depending on the atmospheric conditions. Initial abnormal events during the takeoff of flight 1713 occurred about 1415:37 when the airplane had just lifted off the ground. The recorded altitude dip is large, indicating a larger than normal pitch attitude at liftoff and there is also a small uncharacteristic drop in the vertical acceleration trace. Beginning at 1415:39.5, there was a sharp drop in the vertical acceleration trace, an abrupt heading trace change to the left, then an exclamation from one of the pilots, and then the first sound of a compressor surge. For a wake vortex segment from the Boeing 767 to have affected the DC-9 at 1415:39.5, when airplane control became questionable, the vortex segment would have had to have moved from the Boeing to the position represented by the point on flight 1713's flightpath marked "1st COMP STALL." As can be seen, that position is well clear of any expected vortex movement area.

In general, any vortex traveling on lines south of the "strong" vortex line could only have affected flight 1713 while it was still within the first 1,000 feet of its takeoff roll. In fact, it can be seen from the plot that all vortices from the B-767, if they survived the 1,600 feet of lateral movement between the runways at all, would have encountered the DC-9 while it was still on the ground.

Current available information on the generation, strength, life span, and direction of travel of the wingtip vortices from the landing Boeing 767 indicate that they could not have encountered flight 1713 during its short flight. Therefore, the Safety Board concludes that a wake vortex encounter was not the reason for flight 1713's unsuccessful takeoff. It should be noted that little wake vortex data exists for the B-767 and there is some possibility that its wake vortex may be longer lasting than its weight would suggest, although not as long lasting or as strong as the Boeing 747. Therefore, it is conceivable, but unlikely, that the B-767 could have produced a wake vortex strong enough to affect a DC-9 to some unknown degree, from a lateral distance of 1,600 feet. This could have occurred if, and only if, all the other conditions previously cited for potential encounter were present.
