# **GE 791 Occurrence Investigation Report**

**IN-FLIGHT ICING ENCOUNTER AND CRASH INTO THE SEA  
TRANSASIA AIRWAYS FLIGHT 791**

**ATR72-200, B-22708**

**ASC-AOR-05-04-001**

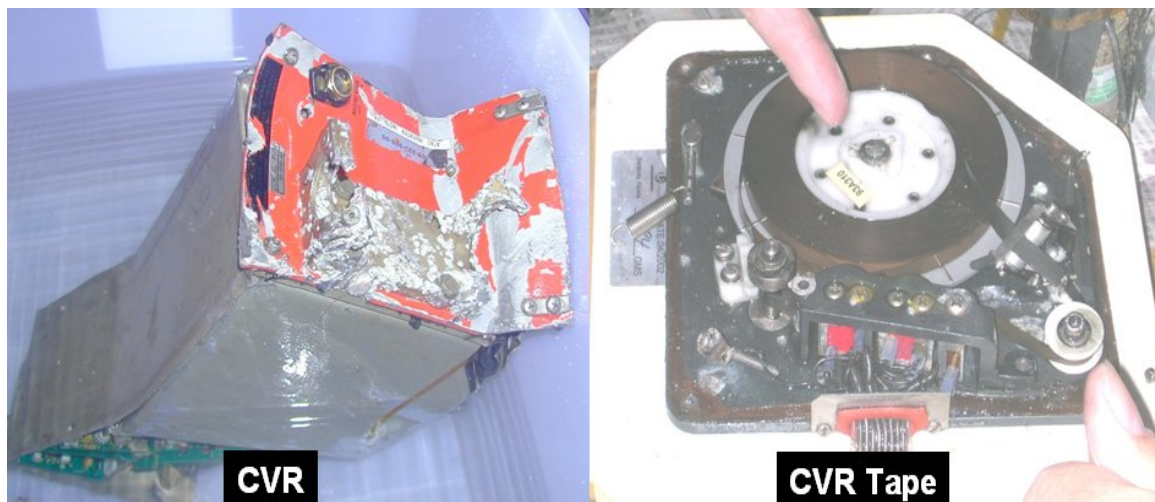
Figure 1.11-1 CVR physical damage and the CVR tape

The exterior of the CVR unit was seriously damaged when it was found. The protective dust cover was separated from the unit. The front panel, without the underwater locator beacon (ULB) and nameplate, was seriously distorted but still attached to the chassis. It arrived ASC lab in a container filled with fresh water. There were several dents and scratches on the interior crash enclosure. The recording assembly appeared to be in good condition except several damages on the plastic reel. The magnetic tape was wet and remained in its original positions without damage. Discoloration and dirt were found on the tape.(refer to figure 1.11-1)

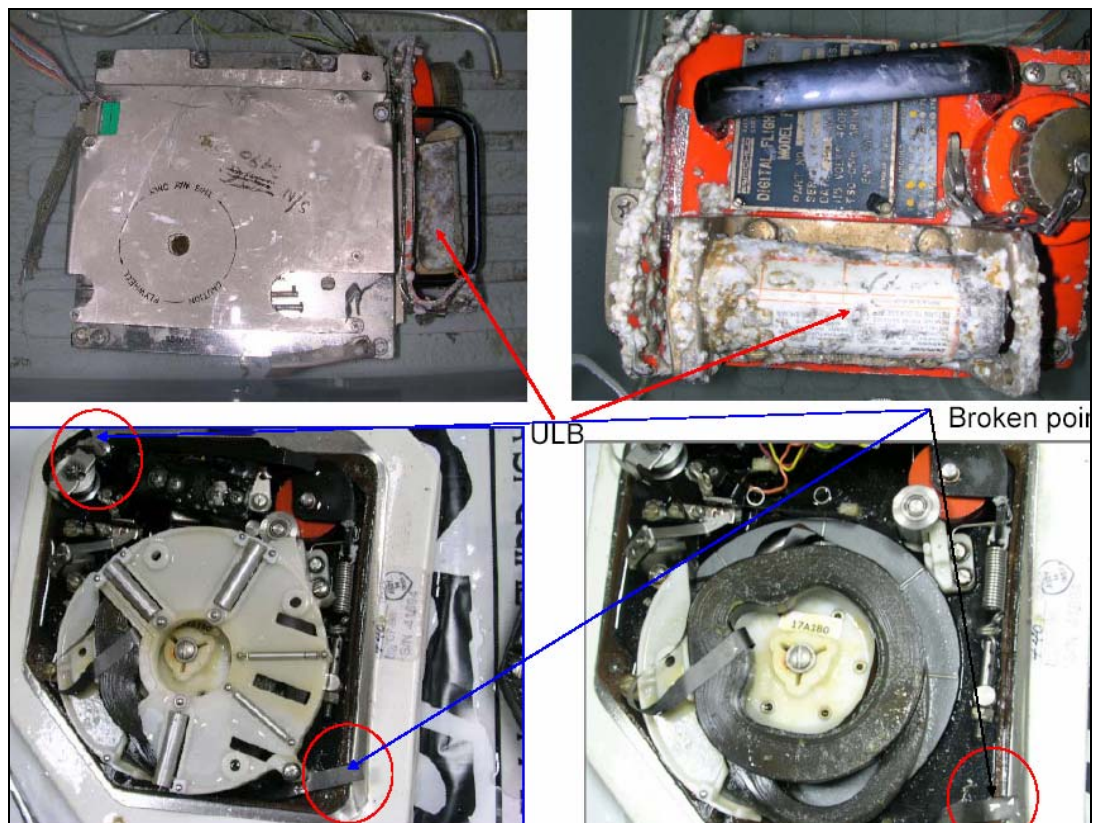
Figure 1.11-2 FDR physical damage and FDR tape

The damaged Loral model F800 FDR, part number 17M800-261, serial number 3490, was brought to the lab in a container filled with water. The protective dust cover and circuit board assemblies were lost while the front panel with the ULB and nameplate was still attached to the unit. The magnetic tape was stained and wet with the inside half squeezed out of the reel. There was a cutting break on the tape between the corner guide roller and the write heads. After it was cleaned and re-reeled, a detail examination showed some discoloration and wrinkle on it, especially the portions exposed to the outside or contacting with the mechanism. Several serious wrinkles were found near the cutting end. (refer to figure 1.11-2)

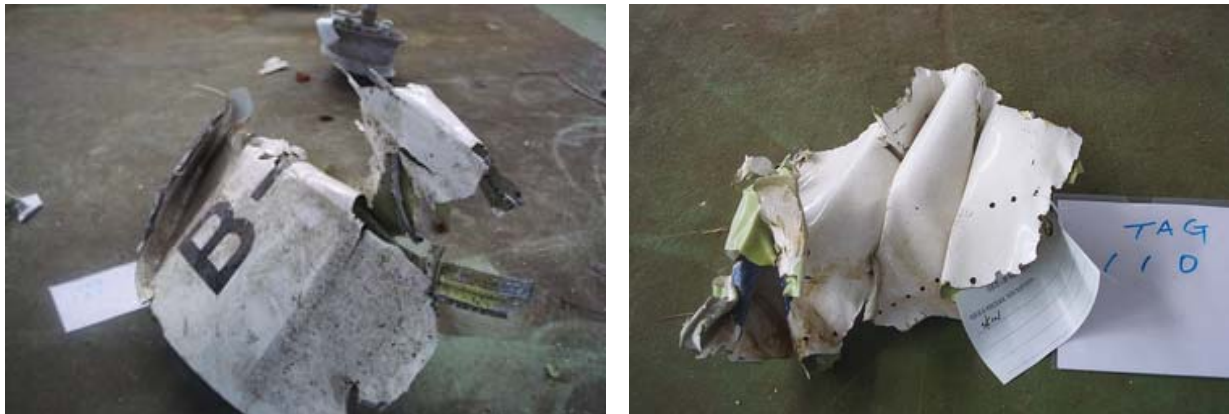
Figure 1.12-1 Fuselage skin

- Fuselage skin: They were seriously wrinkled. The fracture edges were irregular. The painting surface has no any fire phenomenon. The fracture surfaces have no fatigue and corrosion phenomenon(refer to figure1.12-1).

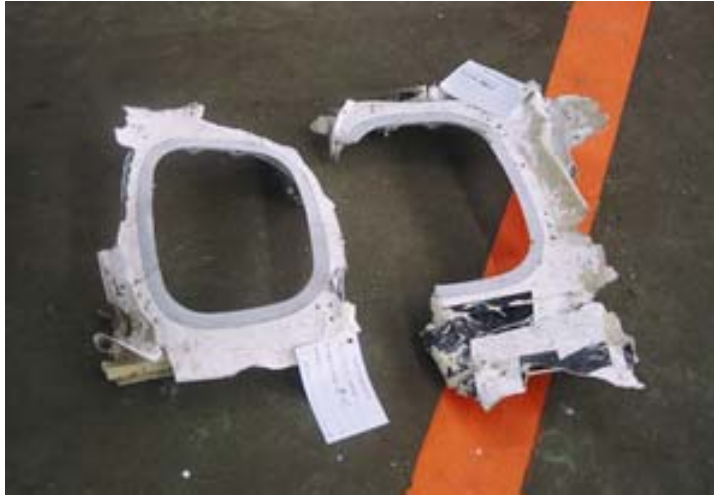
Figure 1.12-2 Window frame

- Window frame were separated from skin. The fracture surface was particular to longitudinal (refer to Figure 1.12-2).

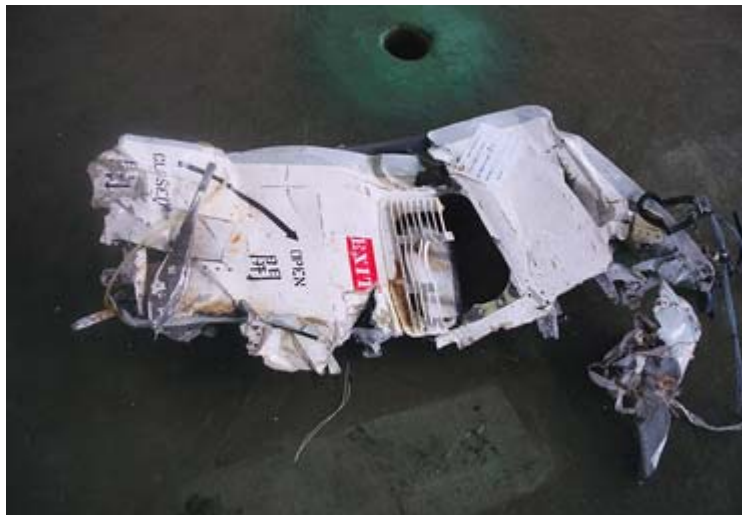
Figure 1.12-3 Right after door

- Right after door : The door handle was at close position. The front was seriously compressed and perpendicular to longitudinal ( refer to figure1.12-3 ) .

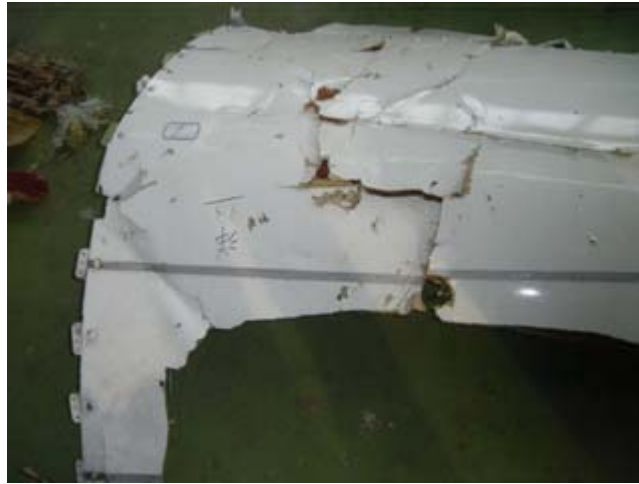
Figure 1.12-4 Tail cone

- Tail cone was seriously broken. The fracture edge was irregular. The lines of front wrinkle were perpendicular to longitudinal (refer to figure1.12-4).

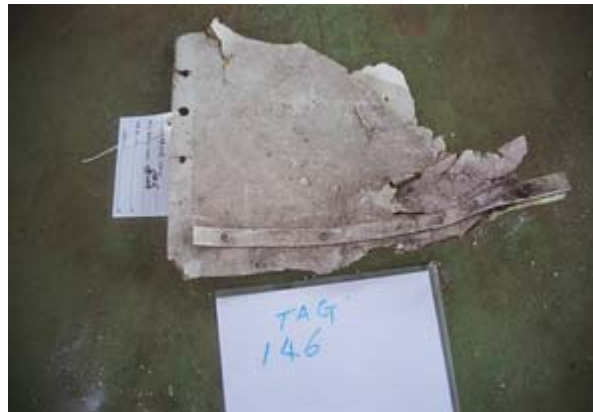
Figure 1.12-5 Cargo compartment partition

Cabin partition was seriously broken. Metal bar was bent and perpendicular to the longitudinal axis. (Figure 1.12-5) °

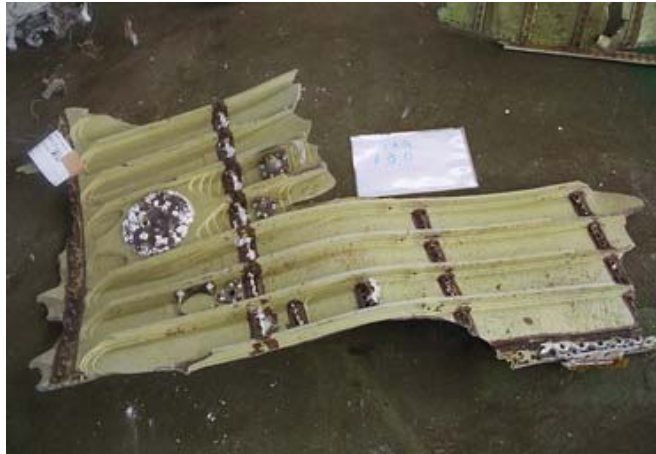
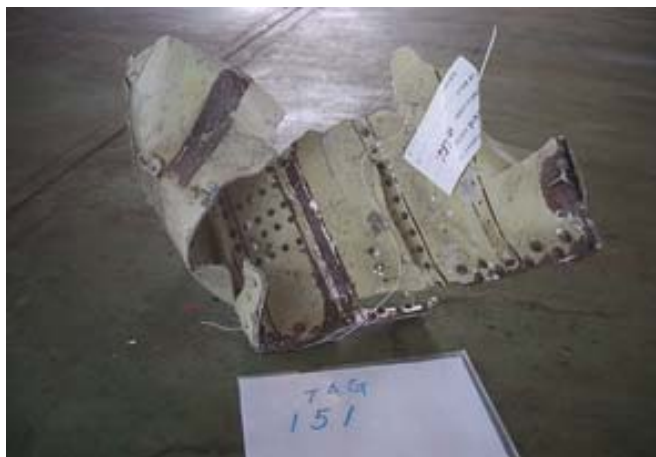
- Front spar: It's seriously broken and bended. The fracture edge was irregular. Wing root were bent downward and perpendicular to the longitudinal axis. Wing tip bent downward and 45 degree perpendicular to the longitudinal axis. Trailing edge structure broken and bent afterward. (Figure 1.12-6~8) °

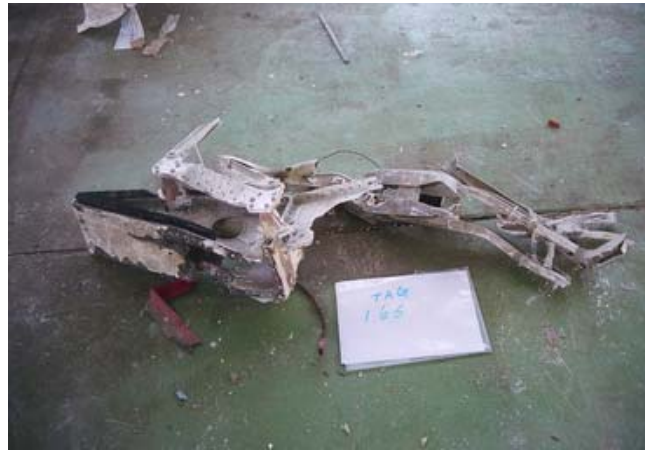
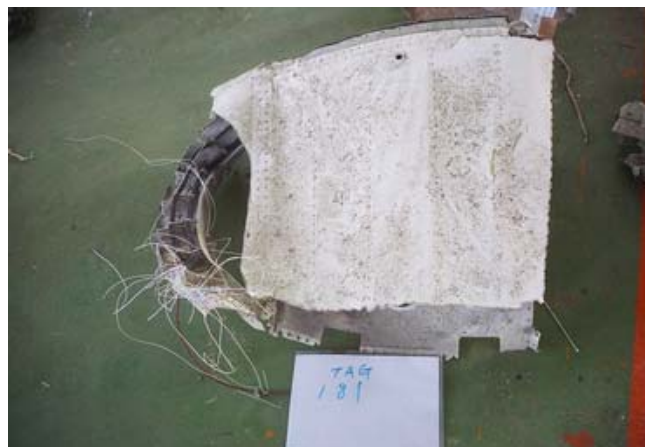
- Flap structure : Driven mechanism was broken. Honeycomb structure was seriously broken. The surface layer was separated from core structure. There was no impact marks found on surface. The leading edge was broken. The skin at front part was broken. The fracture surface was perpendicular to longitudinal (refer to figure1.12-9~11).

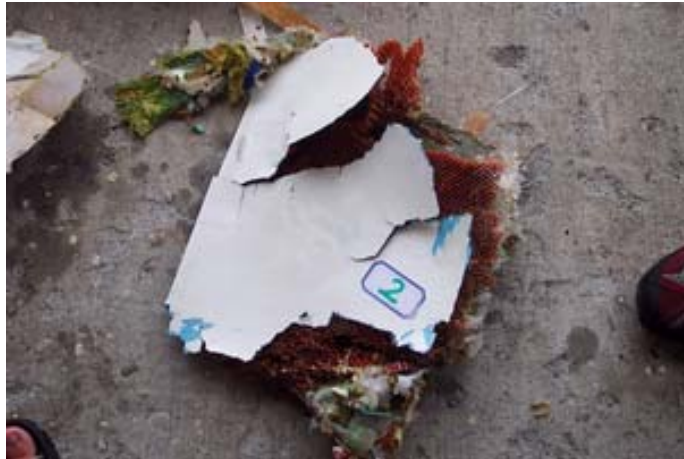
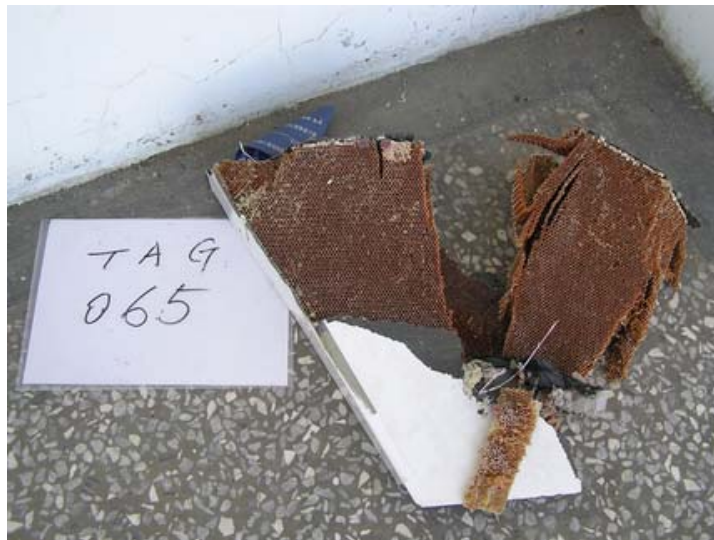
- Tail structure : The honeycomb structure of vertical stabilizer , rudder and elevator was seriously broken and delaminated. Fracture surface was irregular. The paint was peel off. Some dents and scratch found on surface. Separated window frame protruded into the honeycomb structure of rudder (refer to figure 1.12-12~16)

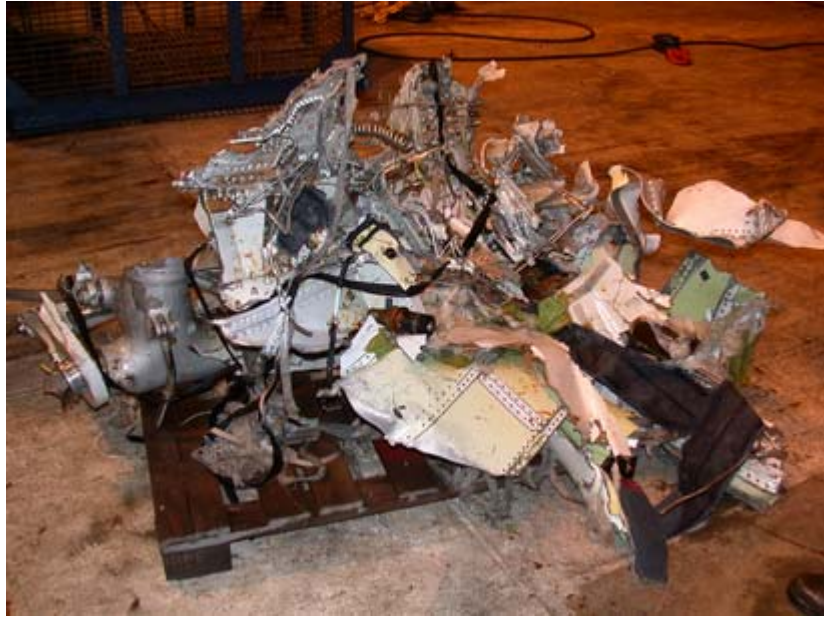
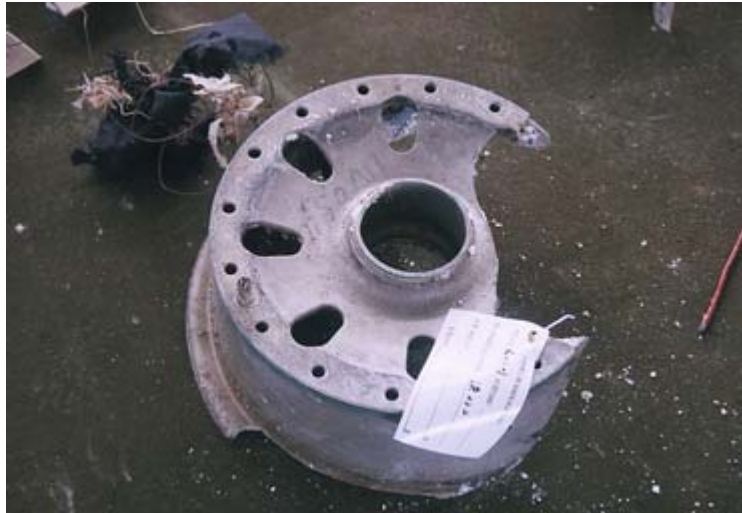
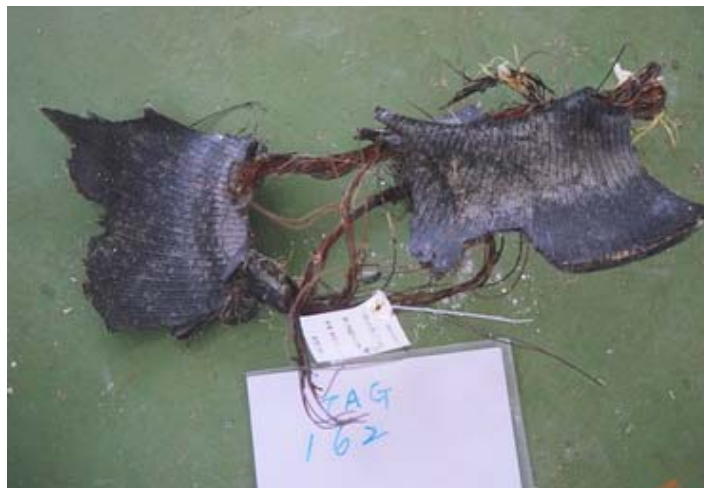
3. Body landing gear: The damage around the body landing gear including supporting structure broken, vicinity skin wrinkled, landing gear strut bended, wheel separated and broken, and tire broken (figure 1.12-17~21).

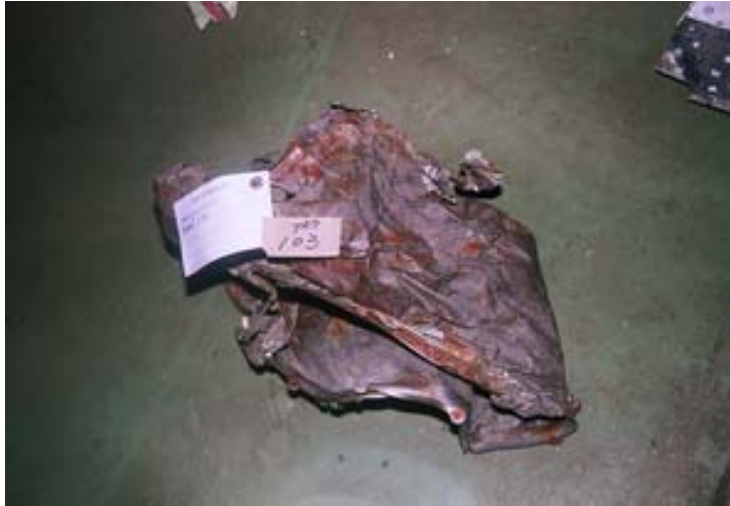
Figure 1.12-22 Exhaust pipe

- Power plant: The damage found on recovered power plant included exhaust pipe squeezed, tail cone separated but not broken, propellers broken, bended and separated (refer to figure 1.12-22~24)

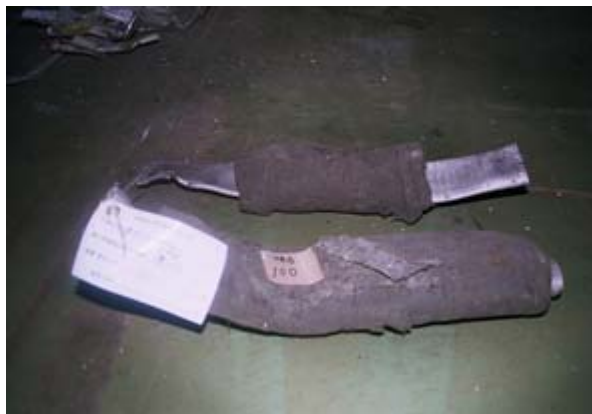
Figure 1.12-26 Pipes

- Pipes: The recovered pipes were small segments and flat (refer to figure 1.12-26).

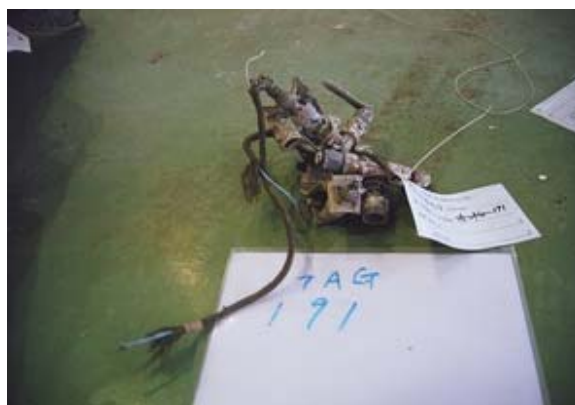
Figure 1.12-27 Wing de-icing regulator

- Wing de-icing regulator valve: The adjacent pipes were broken, but shape is still conserved (refer to figure 1.12-27).

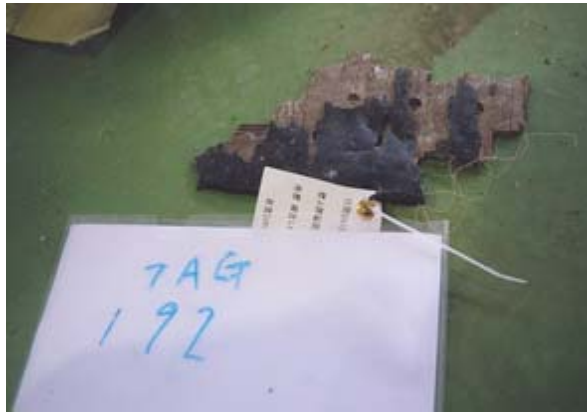
Figure 1.12-28 Wing de-icing boot

- Wing de-icing boot: It was broken into small pieces (refer to figure 1.12-28).

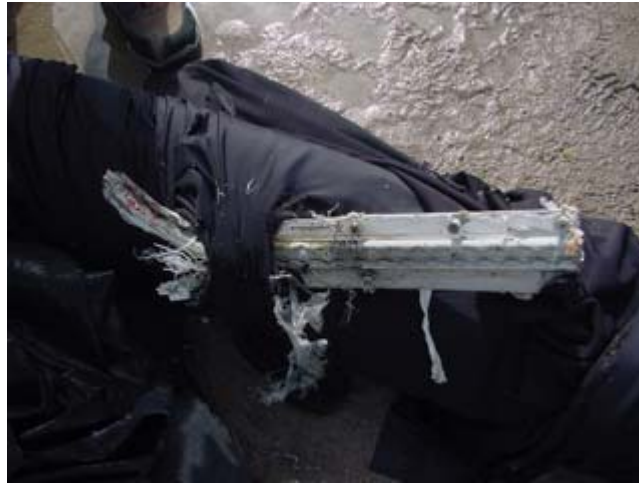
Figure 1.12-31 One roll of cloth was protruded by floor structure

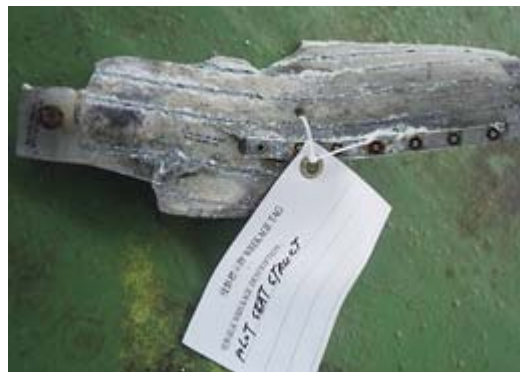
Figure 1.12-32 Pilot seat structure

- Pilot seat structure was seriously broken and bent (refer to figure 1.12-32).

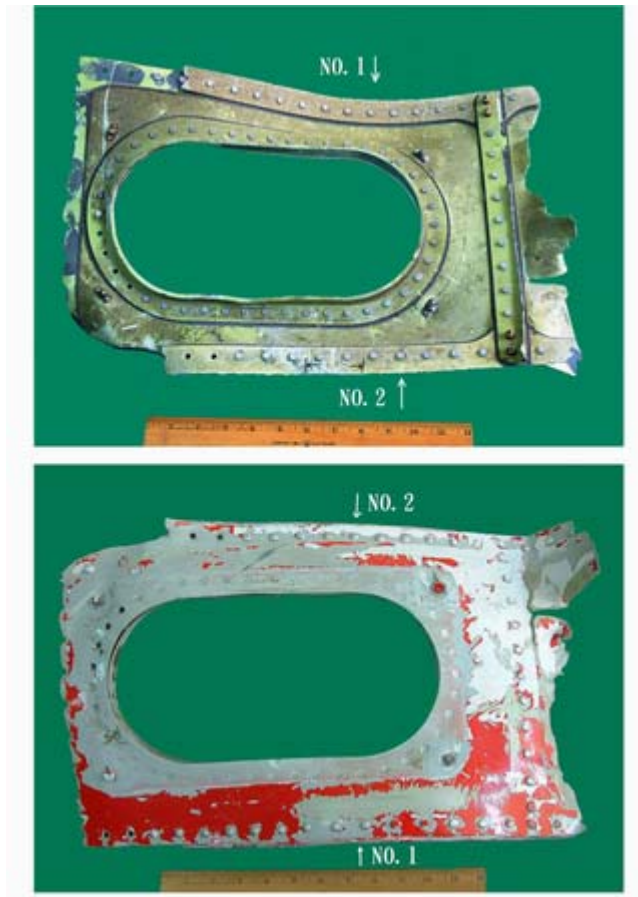
Figure 1.16-4 Wreckage with suspected fatigue crack

One window frame with fracture surface (refer to figure 1.16-4) was sent to CSIST for fatigue examination. (Refer to Appendix 14)

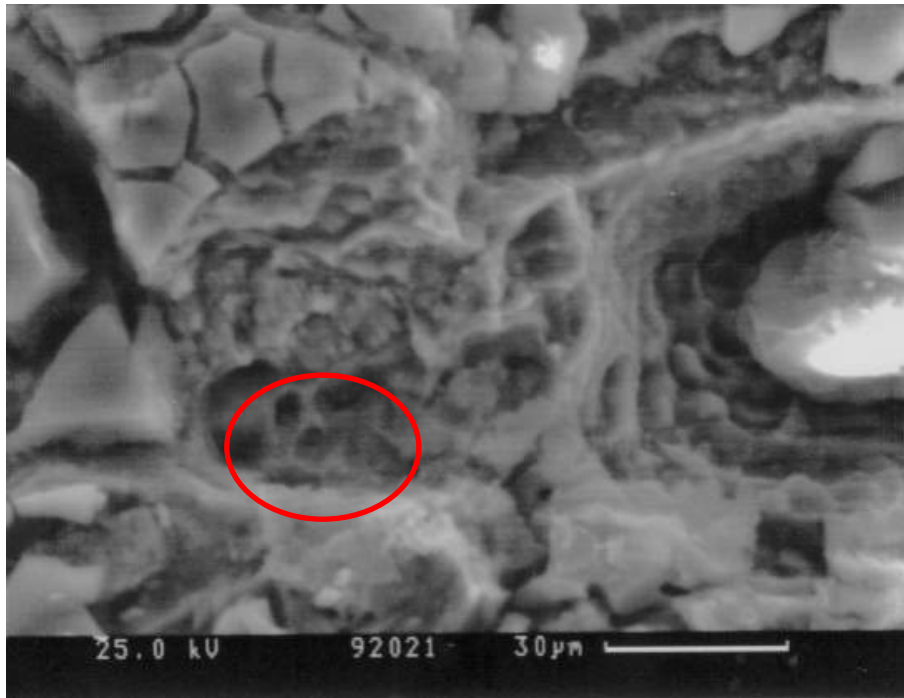
The surface of this sample was covered a layer of oxide which is adverse for SEM examination. This examination found dimple structure on fracture surface which due to overload damage (refer to figure 1.16-5).

Figure 1.16-5 SEM examination showing the dimple structure (790X) ◦

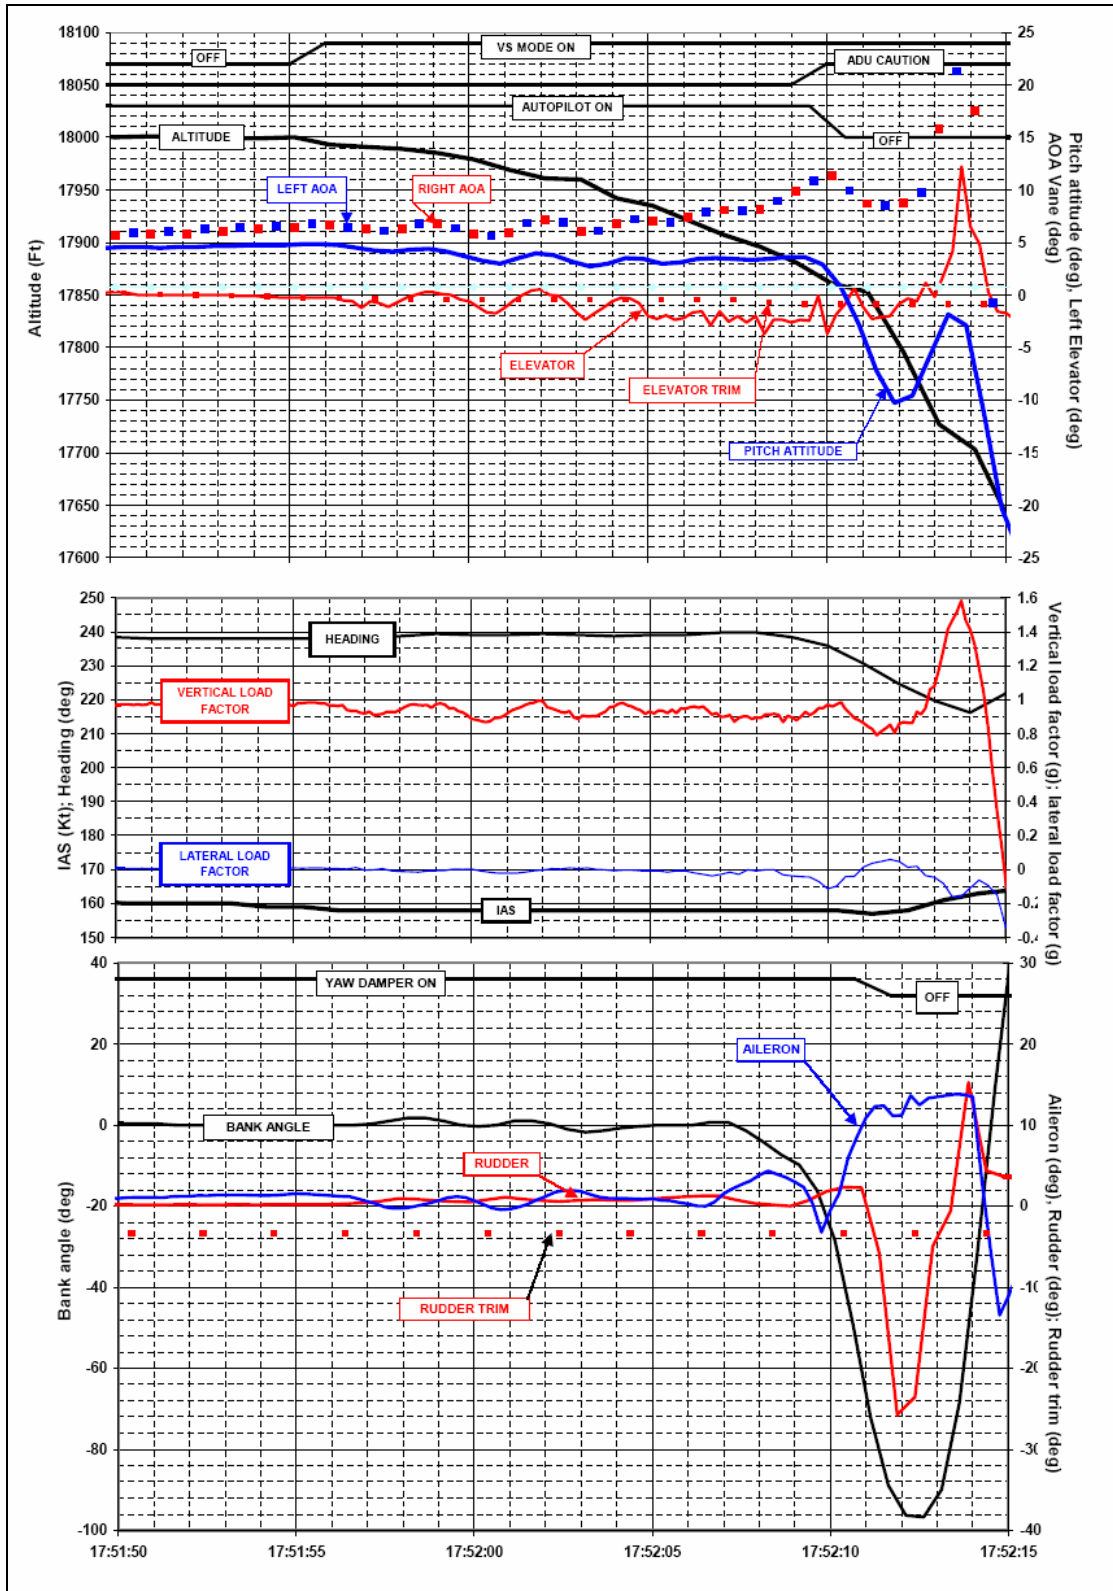
Figure 2.4-5 GE791 FDR data plot during the roll upset

12. During the 10s before the roll upset, the longitudinal and lateral stability has been modified by the severe ice accumulated on the wings producing the flow separation. Before autopilot disengaged, the aerodynamic of the aircraft (lift/drag) was degraded of about 40%. (2.4.4)
