## Report of the inquiry into the accident to a Fokker F.27, OY-APB, at Rønne airport on the 27th December 1969.

Aircraft type:	Fokker F.27 Mark 500.
Registration:	OY-APB.
Owner/Operator:	Maersk Air.
Crew:	Captain Gerrit Burger - injured Co-pilot Captain Leif Troest Jespersen - injured.
Passengers: (Pupils)	First officer Poul Erik Frimor - injured First officer Finn Vejen Bjerre - injured.
Place of accident:	Approx. 460 metres west of runway 29, Rønne airport.EKRN.
Date and time:	27th. Dec. 1969 at 15.55.

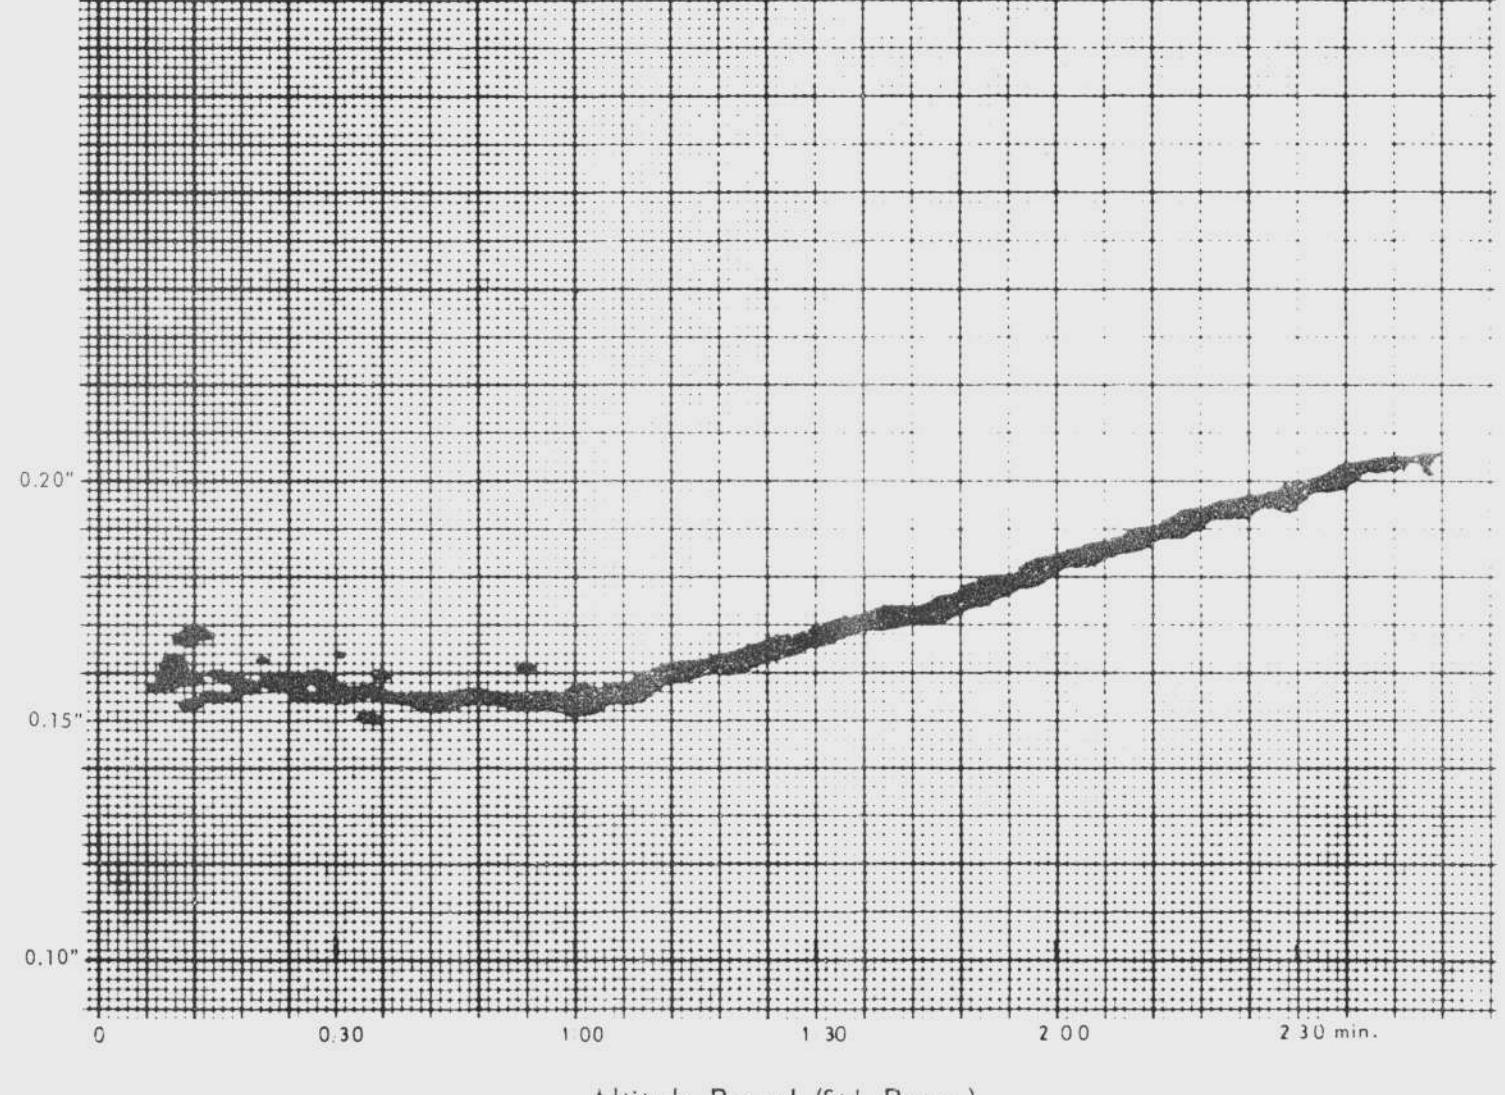
Altitude Record (Std. Press.) 25 times enlarged MAERSK AIR FOKKER F-27 ACCIDENT RØNNE AIRPORT DECEMBER 27, 1969. Flight Path according to Flightrecorder readout.

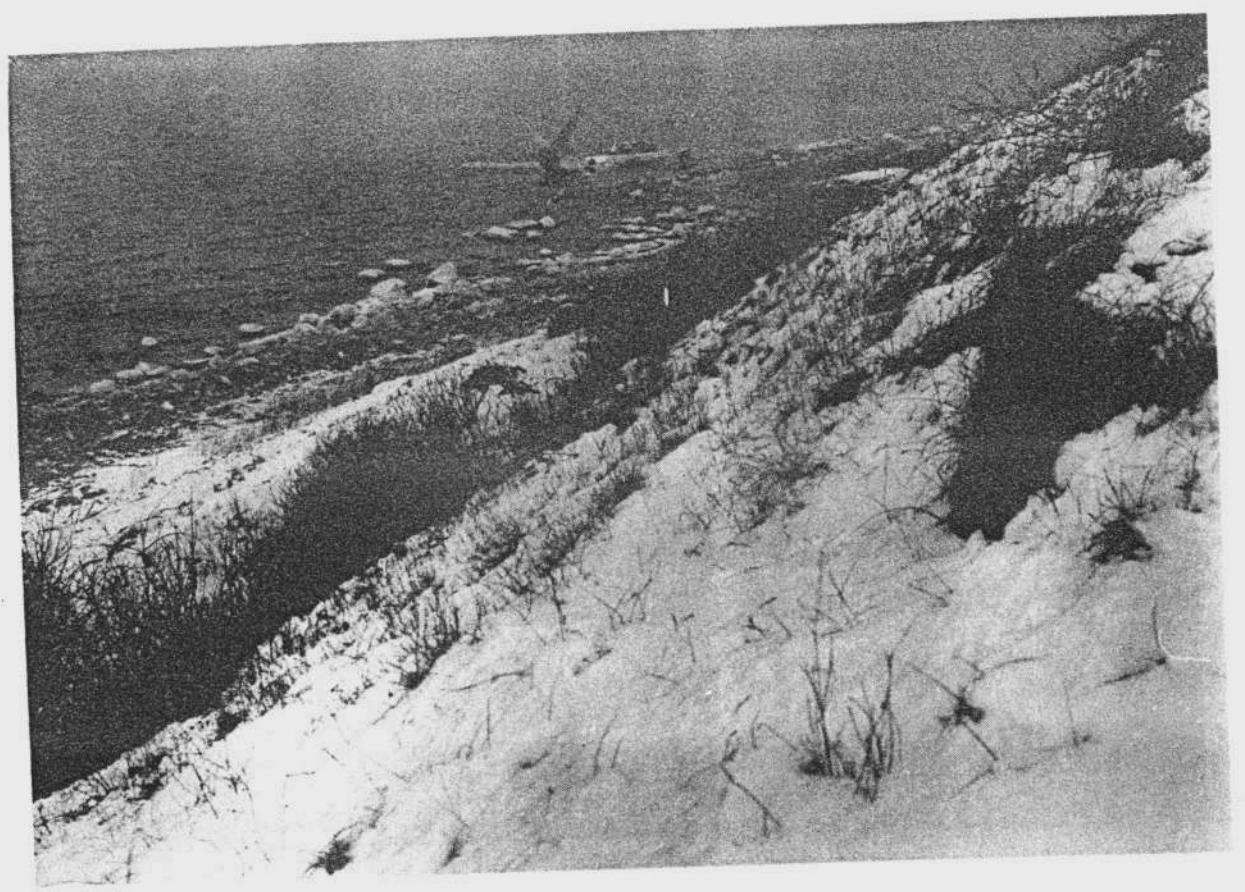
1. Accident site seen from east.

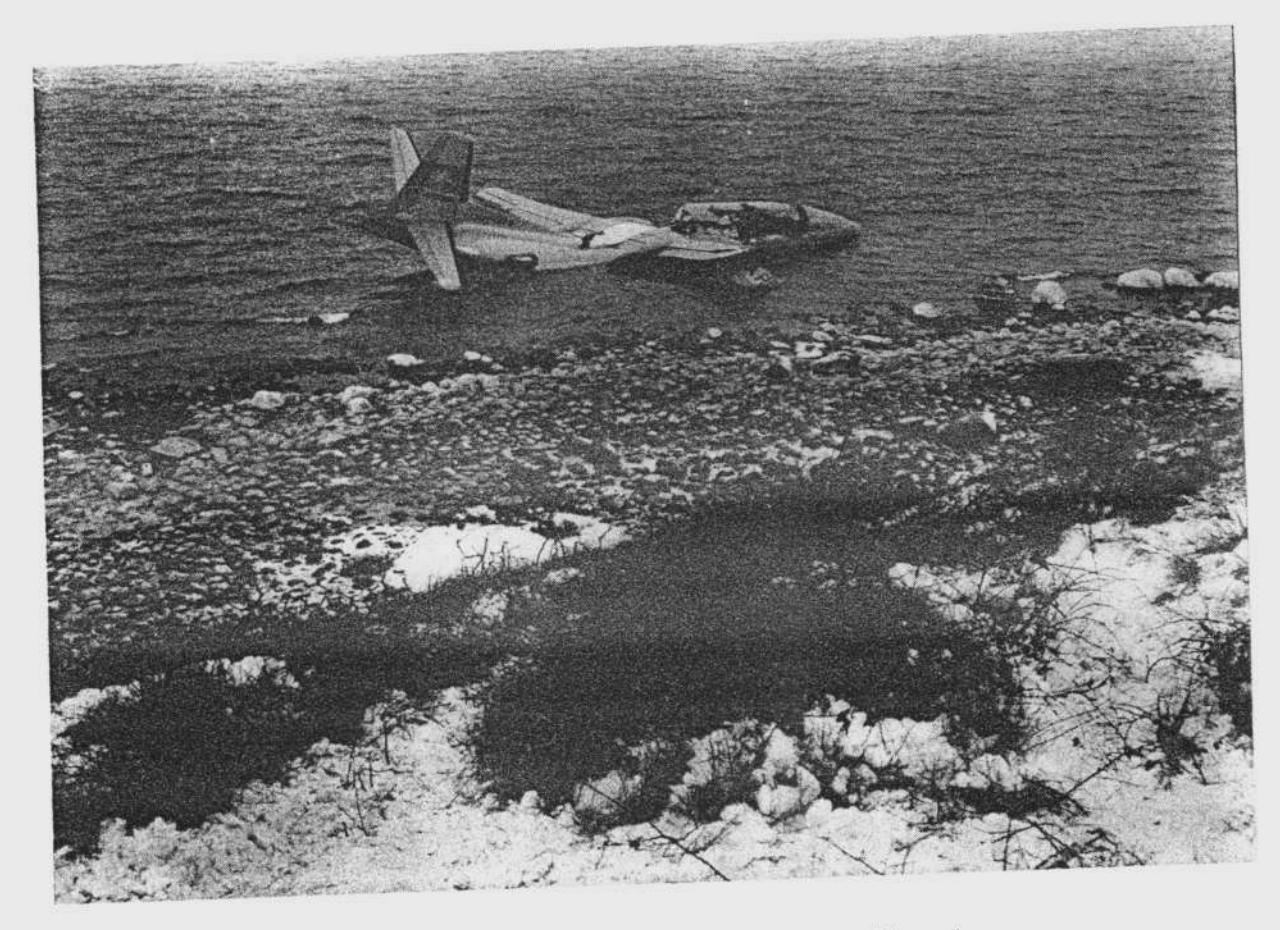
<sup>2.</sup> The aircraft wreck seen from southeast.

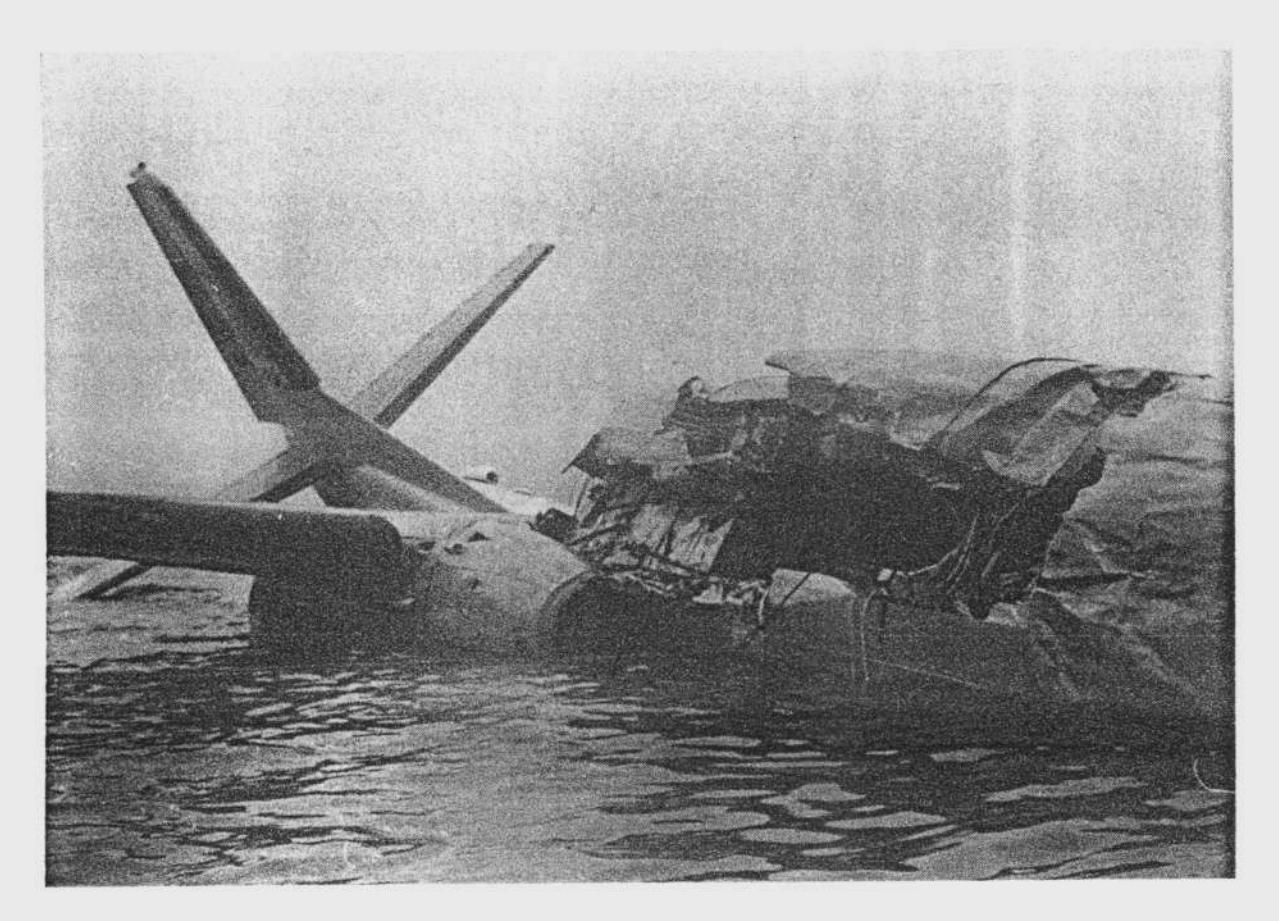
1.12.2. The forward section of the fuselage had broken from the remainder just in the front of the wing root and lay capsized in the water with the bottom turned towards land, attached only by wires and bunches of cables.

3. Notice the inverted position of the front fuselage and the torn up bottom structure.

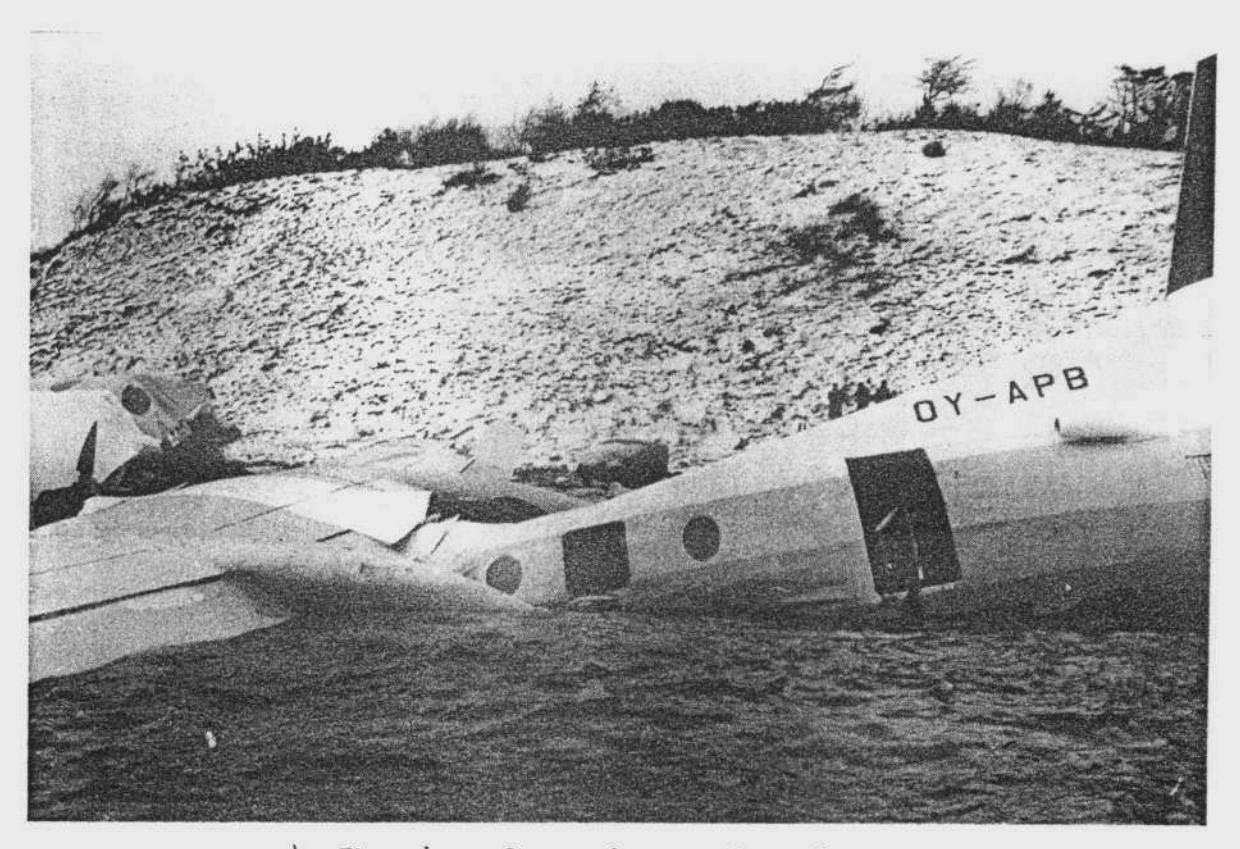
<sup>4.</sup> The aircraft wreck seen from the sea.

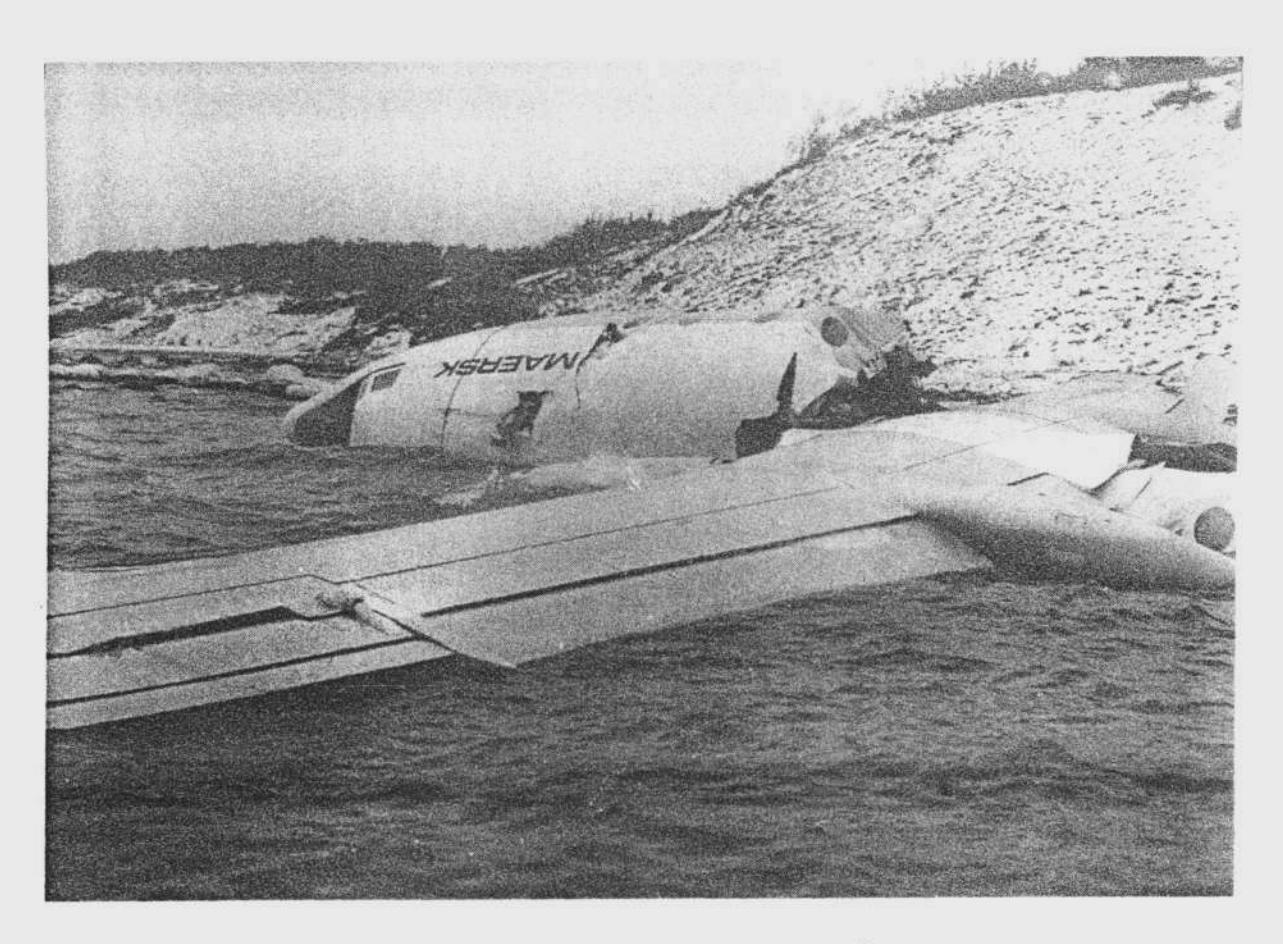
On the right side of the fuselage, two holes, approximately  $1 \ge 1/2$  metres, made by the right propeller, were seen. One hole was immediately above the front cabin window, the other was a little higher and a little further forward. It must be presumed that the rotation forces in the propeller, after this had parted from the engine, had caused it to fly over the fuselage and that in doing so, two propeller blades had penetrated the fuselage.

The traces of paint on blade no. 3 of the right propeller match the paint on the holes of the exposed fuselage mentioned in 1.12.2. It can therefore be established that blade no. 3 caused one of the holes in the fuselage. The bending forward of blade no. 3 towards the suction side of the propeller was probably caused after it had been torn off the engine. This is suggested by other indications and damage. The forward bending can have taken place as the blade penetrated the fuselage. If this is correct, then it was blade no. 2 which made the other hole and in doing so was bent forward. Blade no. 3 has then caused the hole over the window and blade no. 2 the hole a little higher and further forward. The propeller control units were examined both visually and on a testbench. No indications were found that these were not operating normally prior to the accident.

5. Notice the two holes caused by the R/H propeller in the inverted portion of the front fuselage.

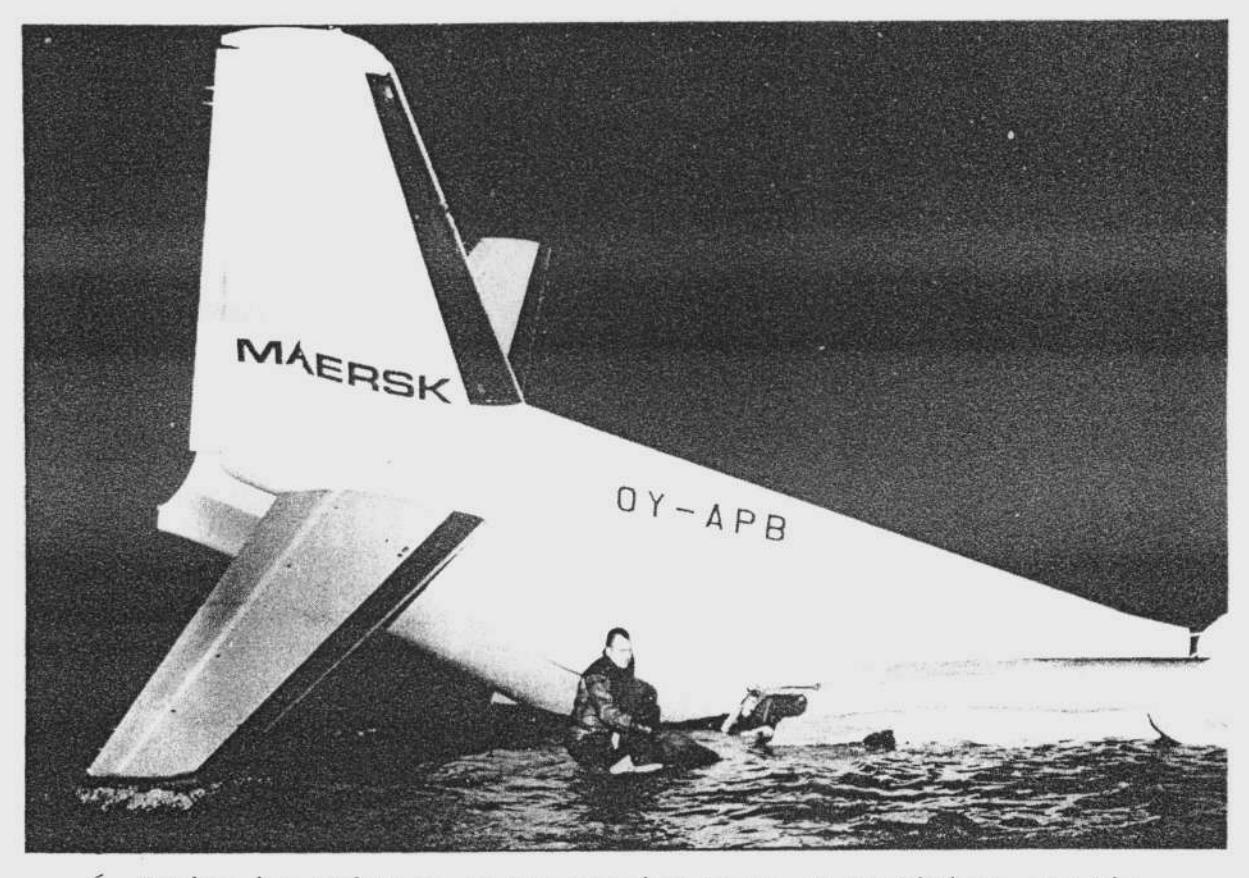
As mentioned in 1.12.5, ice formation was observed on the leading edges of the wings, stabilizers and fin. The amount of ice found on the morning of the 28th. may be considered to have been approximately the same as was present on the 27th. when the accident occurred, in view of the prevailing circumstances.

6. Notice ice build-up on the leading edges of stabilizer and fin.

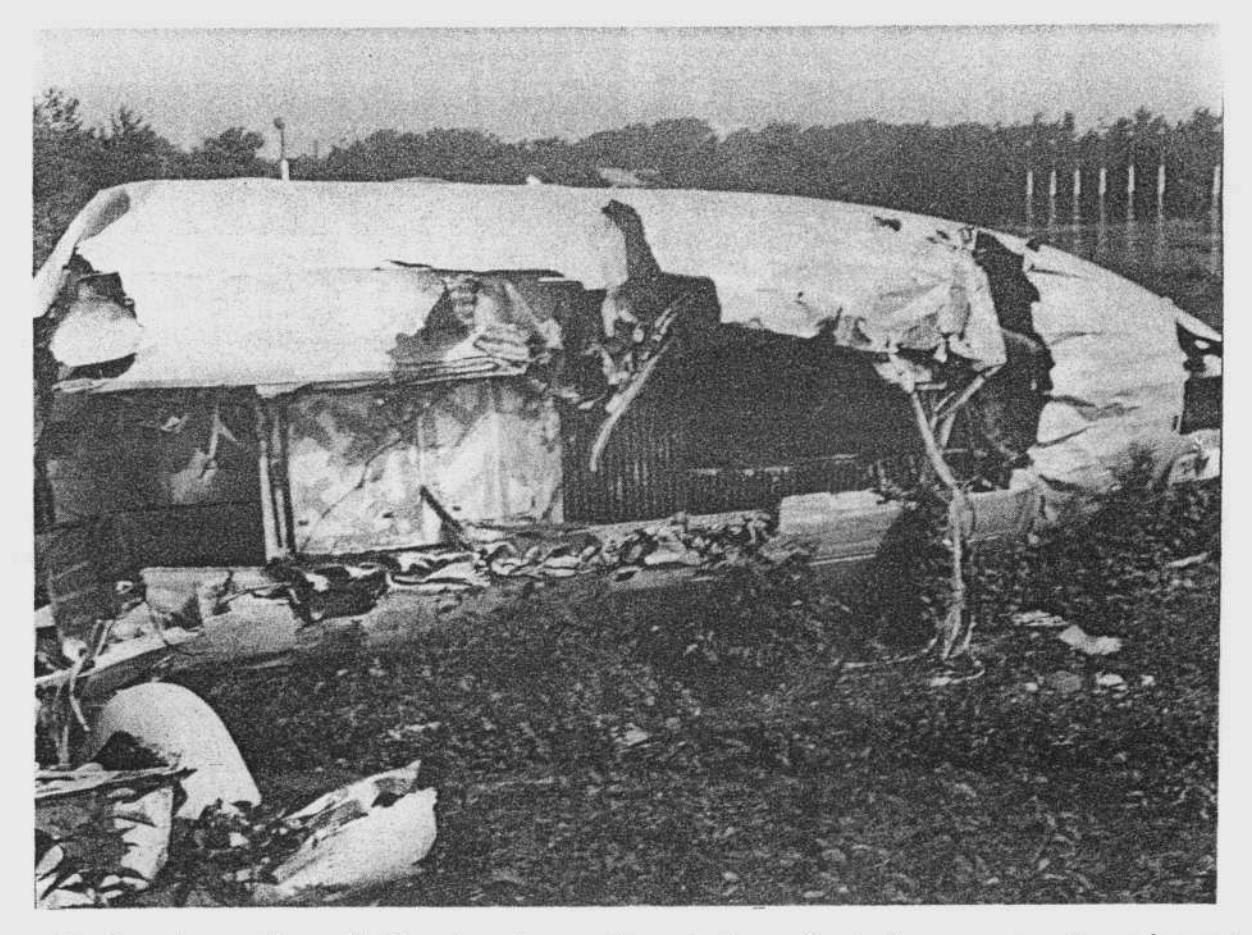
7. Front portion of the fuselage after being winched up on to the airport. Notice the torn up condition of the bottom structure between the crash beams. The crew escaped through the hole in the bottom.

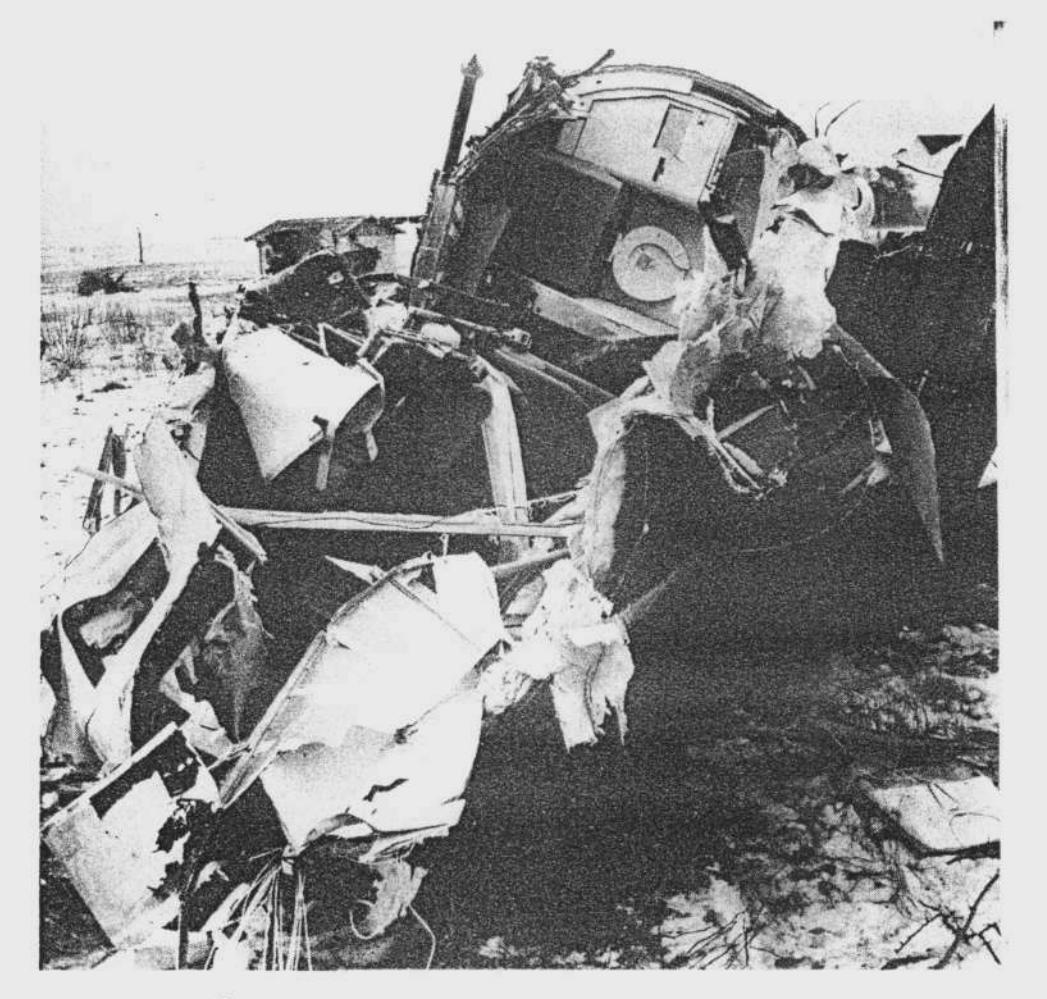
The rear section of the fuselage was split longitudinally between the two crashbeams. The tail section and the left side were broken off immediately behind the wing section in one piece, and the right side, from the rearmost emergency exit and foreward to just in front of the rear edge of the wing, was folded out under the wing in another piece. The remaining section of the fuselage below the central section of the wing was completely broken up and smashed. The bottom fuselage structure in the aft section of the aircraft was similar to the forward section in that it had been ripped up and partly torn off as far as the area just in front of the tail bumper, which was still intact on the structure, apparently without having been in contact with the ground during the impact.

8. The left side of the aft fuselage.

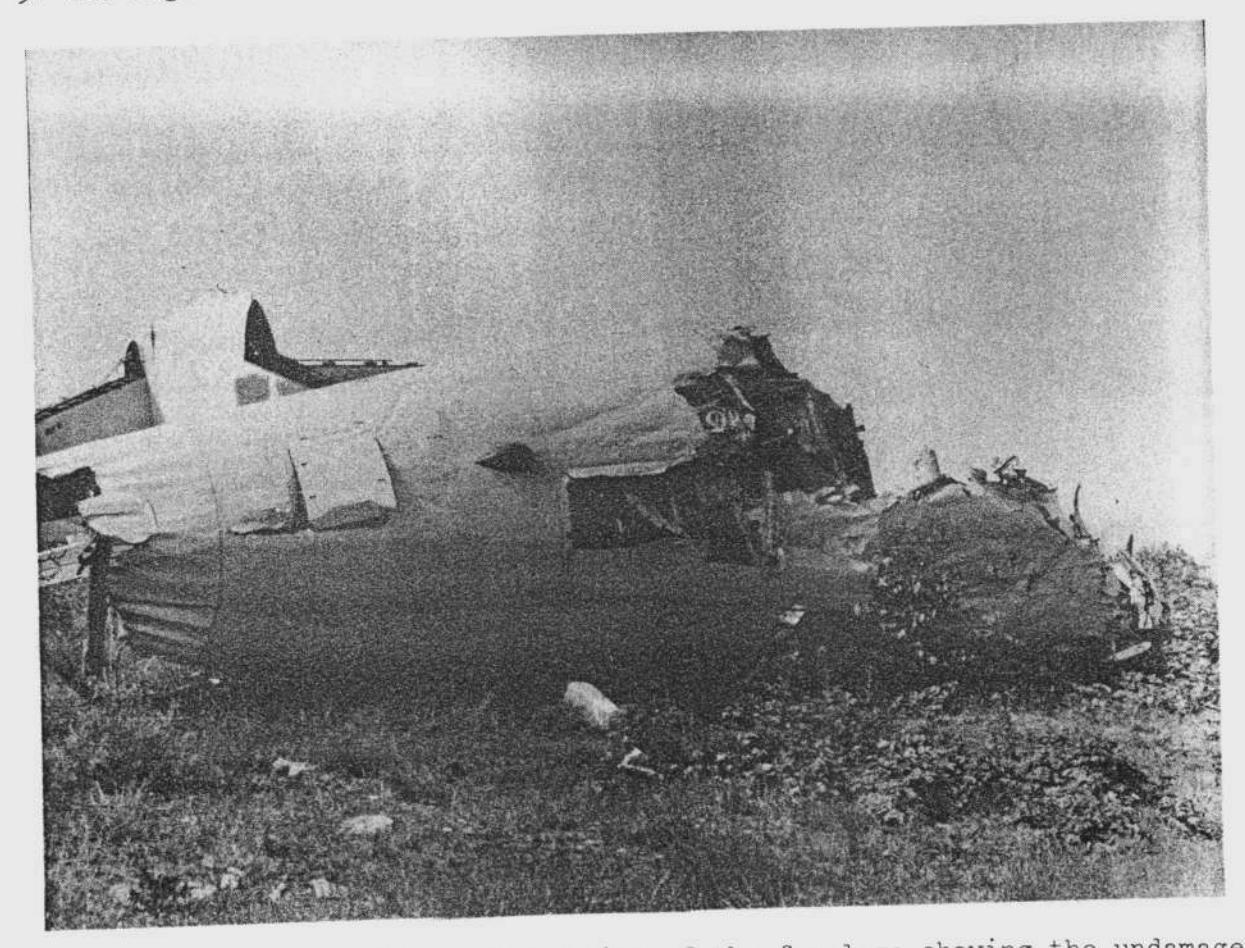
10. The lower side of the aft portion of the fuselage showing the undamaged tail bumper and the damage to the bottom structure.

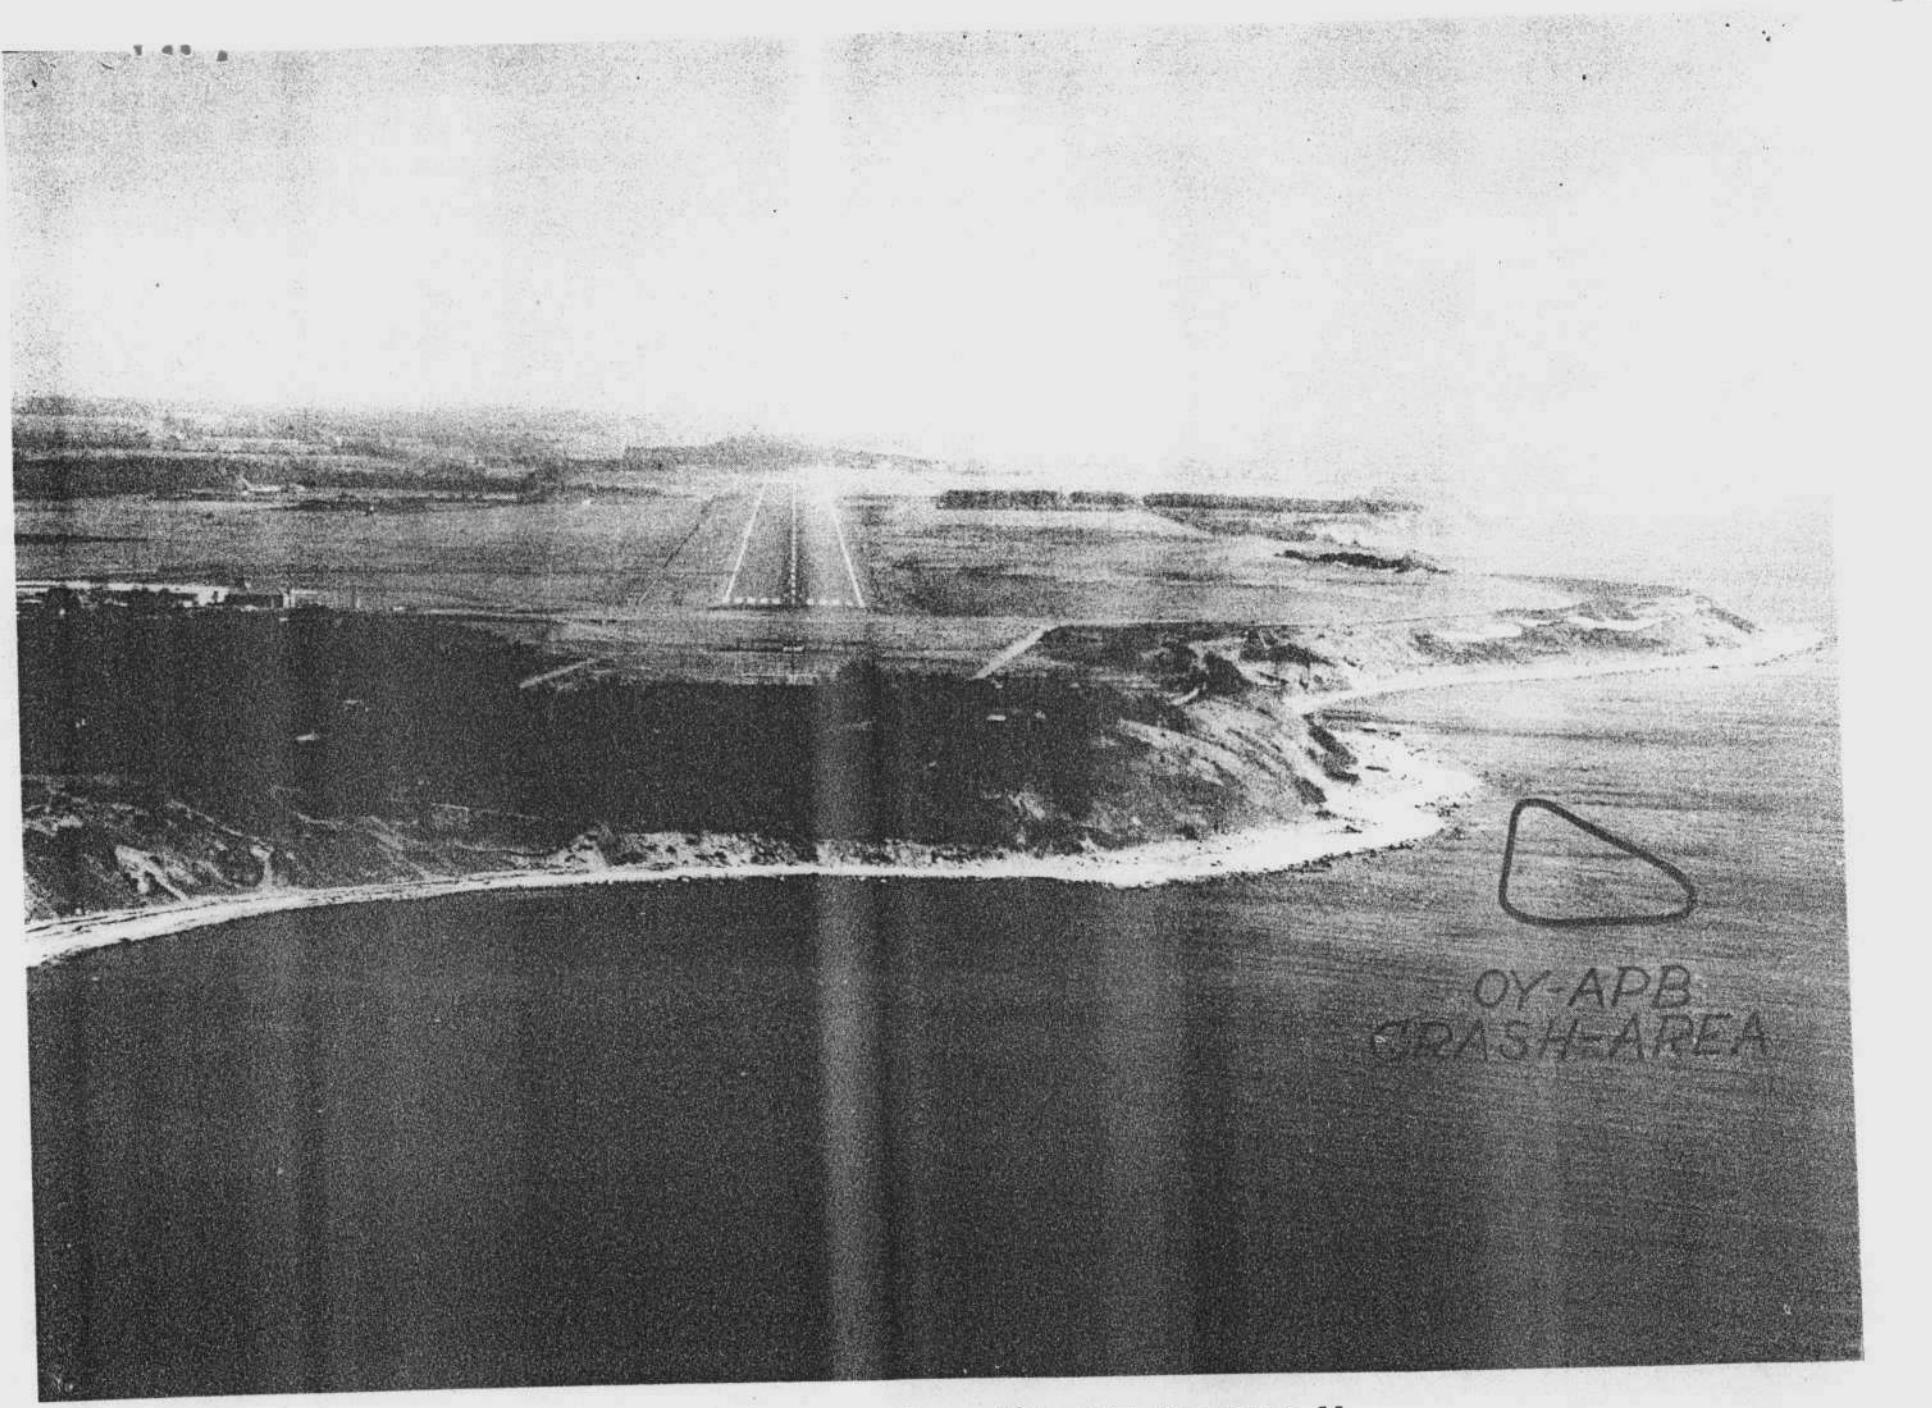
<sup>11.</sup> Crash area seen from glide path to runway 11.
