# REPORT

SL 2011/10

## WINTER OPERATIONS, FRICTION MEASUREMENTS AND CONDITIONS FOR FRICTION PREDICTIONS

### VOLUME II - MAIN REPORT

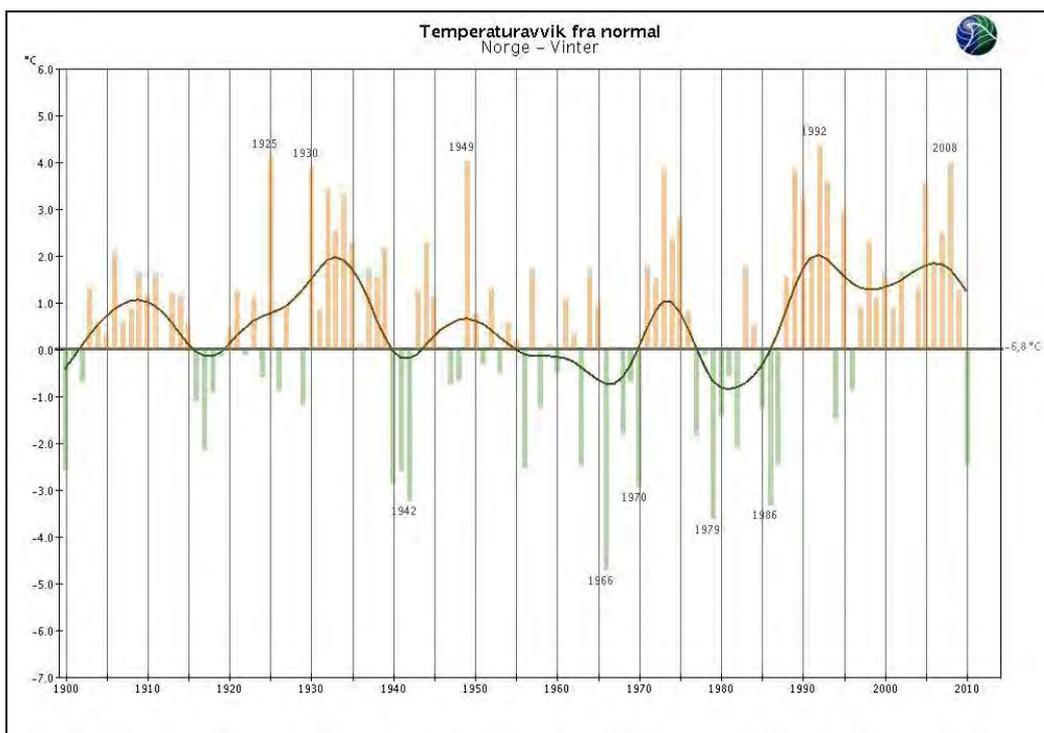
Figure 1: Annual deviation from mean winter (November-April) temperature in Norway. Normal period 1961-1990 (met.no). [Met.no/Winter temperature last 150 years/Norway](http://met.no/Winter%20temperature%20last%20150%20years/Norway)

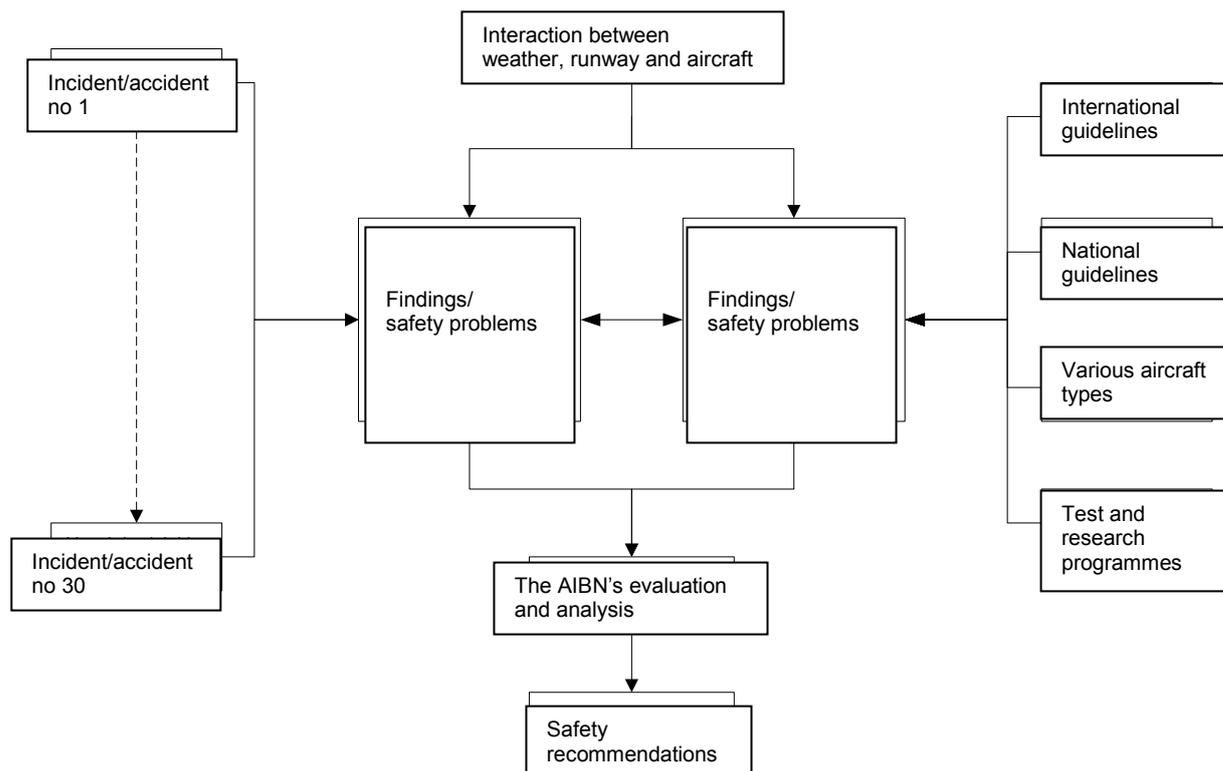
Figure 2: The AIBN's investigation process.

Figure 2 shows the AIBN's investigation process. In this theme investigation the AIBN has focused on the joint findings/safety problems from the 30 incidents/accidents relating to slippery runways that have been reported since 1999. One of the most significant findings from those investigations was that, under certain weather and runway conditions, there are substantial differences between measured/reported friction coefficients (FC) and airplane braking coefficients (ABC) or „aircraft  $\mu$ “ ( $\mu_{ac}$ ).

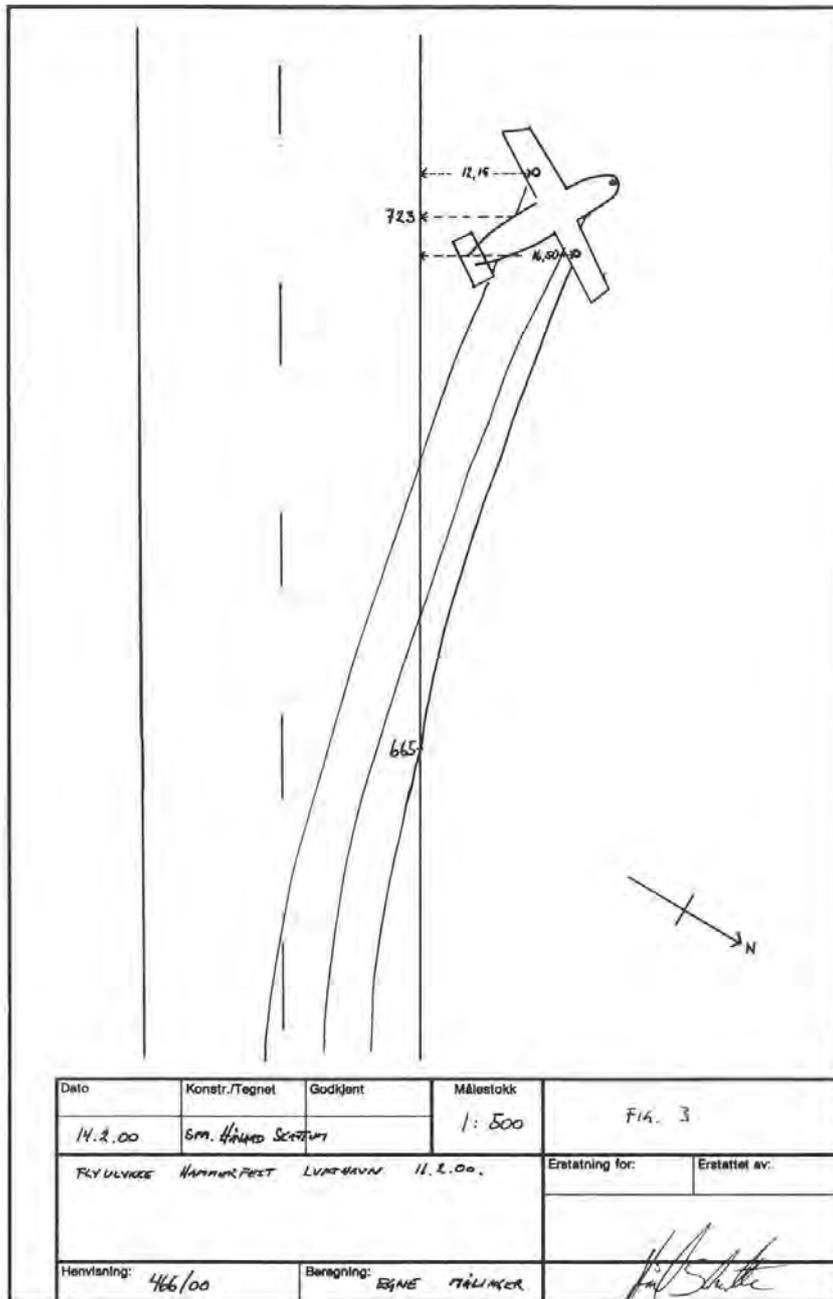
Wideroe DHC-8-103 skidded off the side of runway 23 while landing on a slippery runway in crosswind conditions.

Figure 3: Serious aviation incident with LN-WIL at ENHF on 11 February 2000.

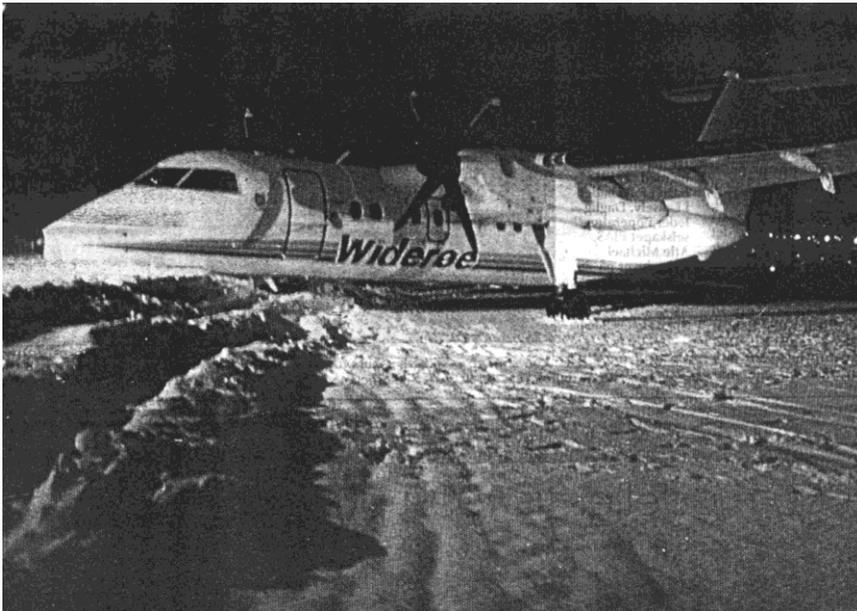
The runway was covered with compact snow and ice with 3-4 mm of slush on top. The runway had been sanded. Measured FC was 32-34-33 (Griptester/GRT)<sup>18</sup>. Actual ABC as deducted from FDR data was in the order of 0.05 (POOR).

Figure 4: Aviation incident with LN-WIL at ENHF on 11 February 2000.

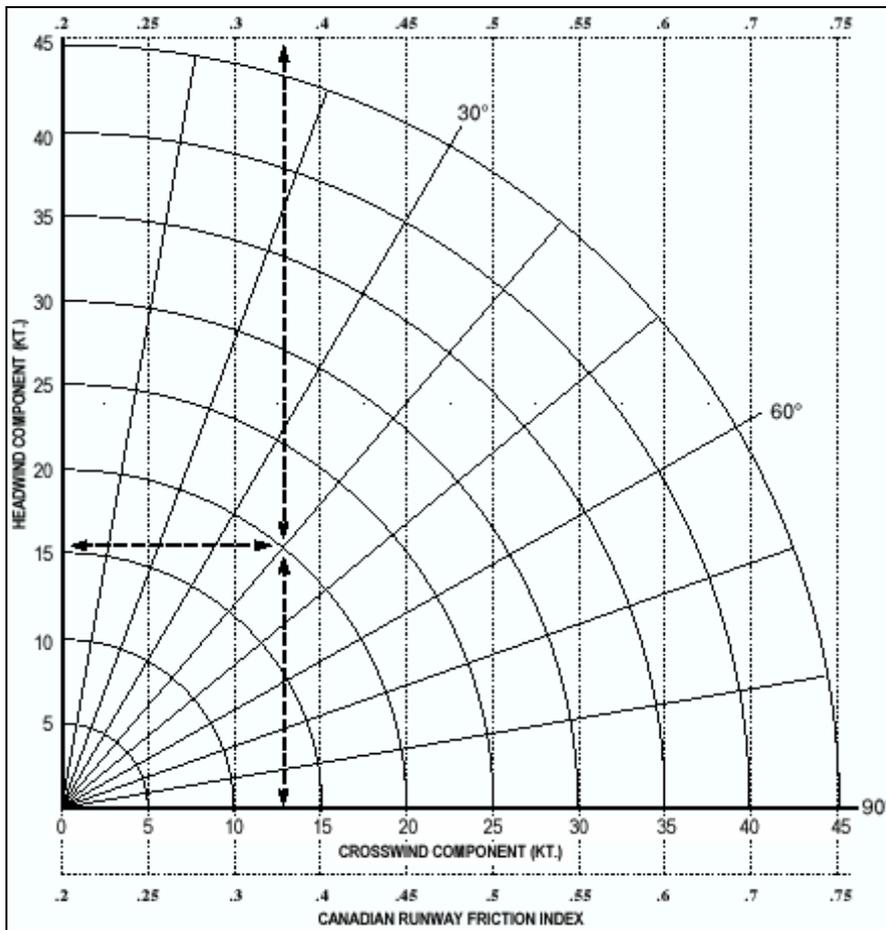
Figure 5: Crosswind Limits for Canadian Runway Friction Index (CRFI).

The intention behind this recommendation was that Widerøe's crosswind limits on slippery runways with measured FCs of less than 0.40 (GOOD), ought to be reduced to increase the safety margins on short runways. The AIBN judged that, since ICAO had already recommended a crosswind limit of max 10 kt on dry runways less than 1,200 m in length, an assessment should be carried out as to whether Widerøe should set the same crosswind limit on a shorter (800 m) runway with reduced friction of less than 0.40 (GOOD).

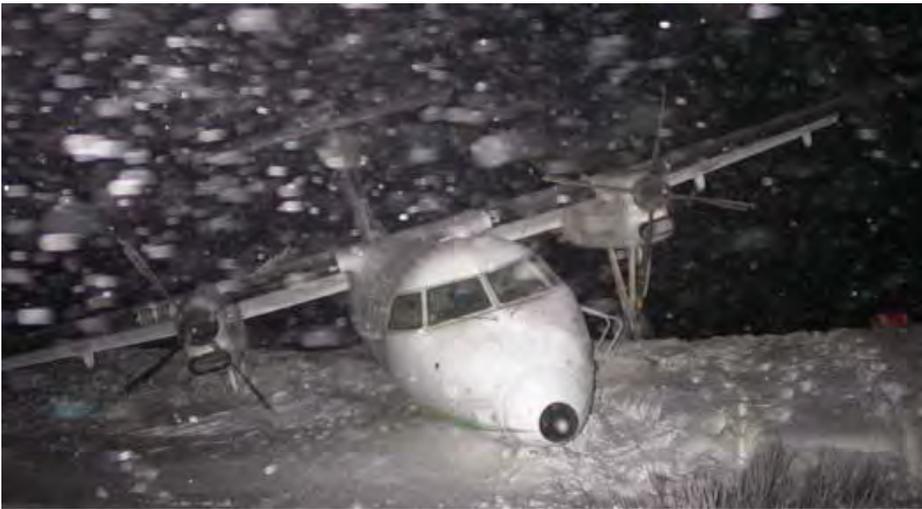
Wideroe DHC-8-103 skidded off runway 08 after landing on a slippery runway in crosswind conditions.

Figure 6: Aviation accident with LN-WIN at ENVD on 6 January 2003.

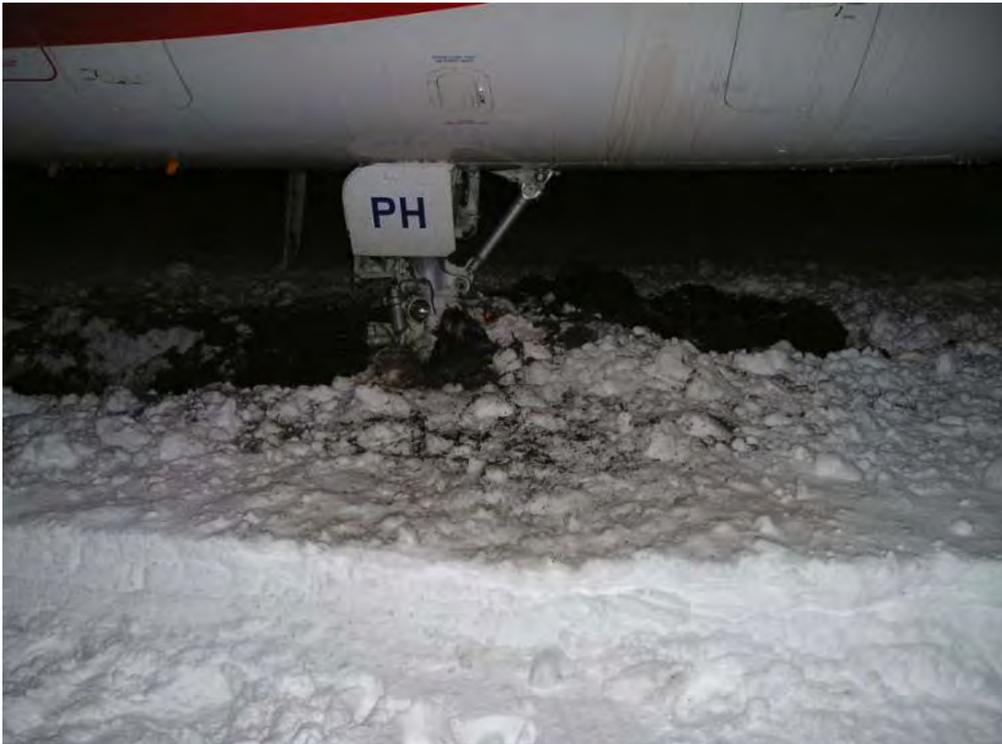
The runway was covered in sanded ice with 8 mm dry snow on top. Measured FC was 34-32-32 (Skiddometer/SKH). Actual „effective  $\mu$ “ was perceived by the crew as POOR.

Figure 7: Serious aviation incident with G-CRPH at ENEV on 25 November 2004.

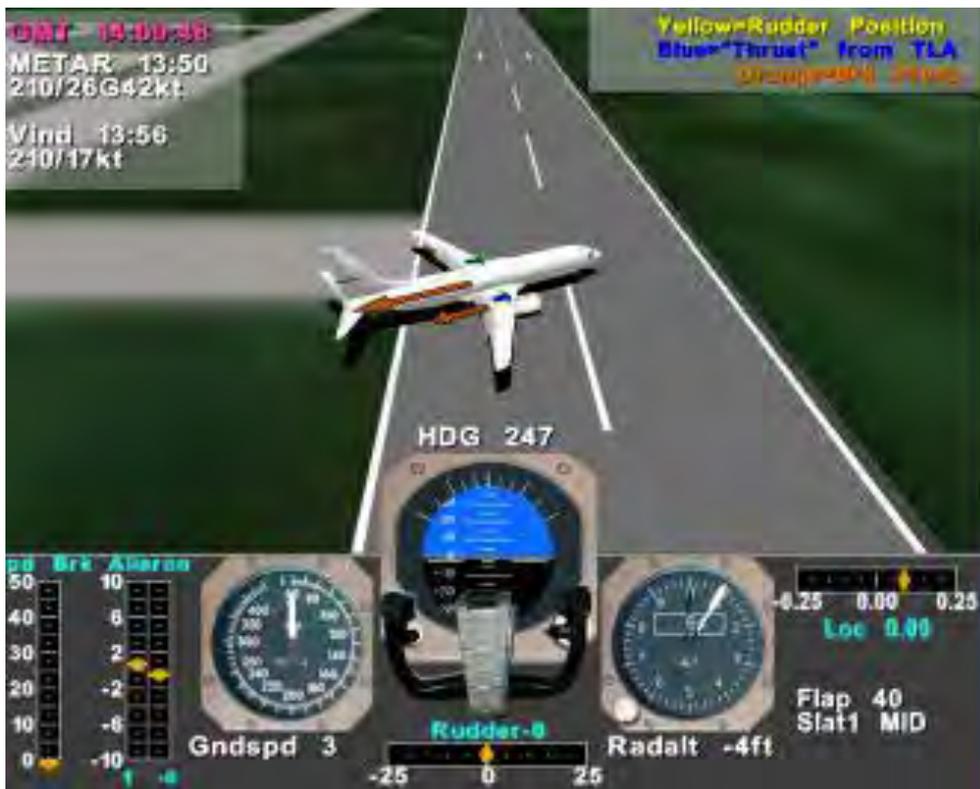
Figure 8: Serious aviation incident with LN-BRV at ENEV on 30 January 2005. Animation available at [www.aibn.no/aviation/reports/2011-10](http://www.aibn.no/aviation/reports/2011-10)

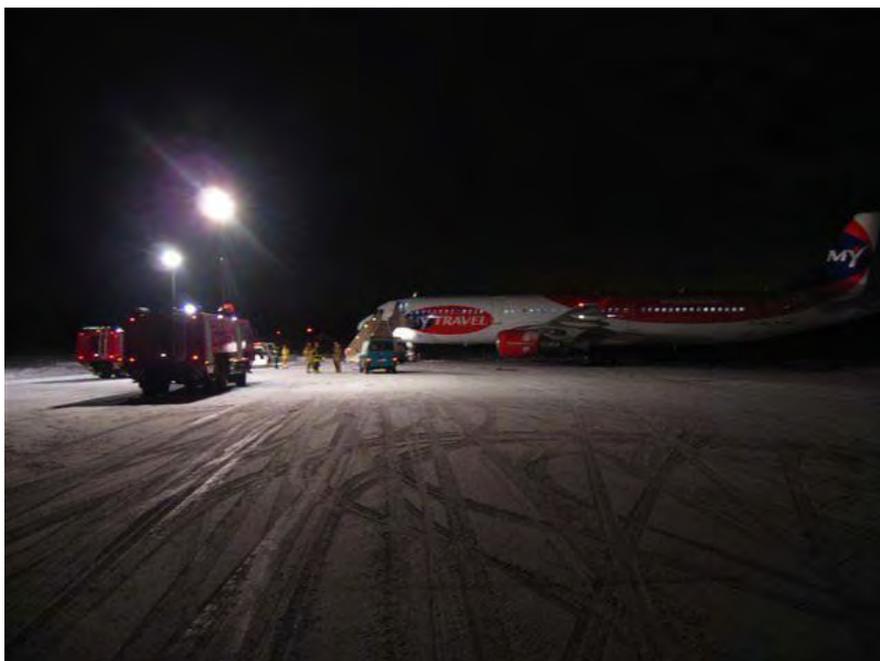
The runway was reported to be covered with 8 mm of wet snow. Measured FC was 32-33-31 (Skiddometer/SKH). Actual „effective  $\mu$ ” as deducted from FDR data was in the order of 0.05 (POOR).

Figure 9: Serious aviation incident with OY-VKA at ENTO on 26 March 2006 (AIBN). Animation available at [www.aibn.no/aviation/reports/2011-10](http://www.aibn.no/aviation/reports/2011-10)

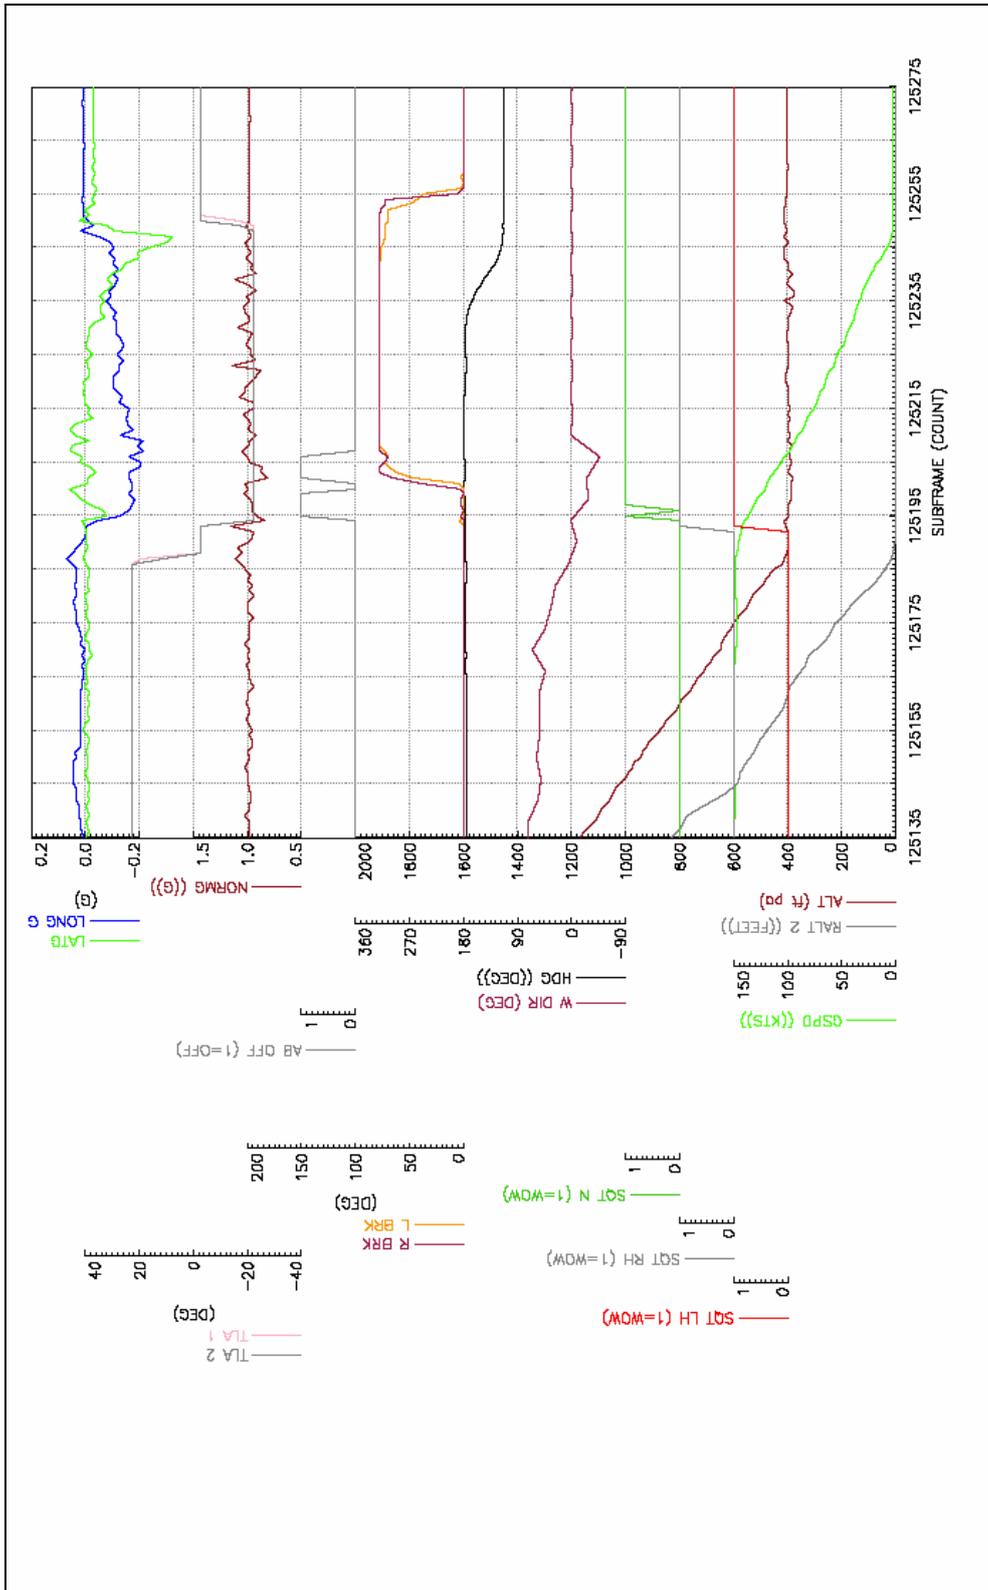
Figure 10: FDR data from OY-VKA (AIBN).

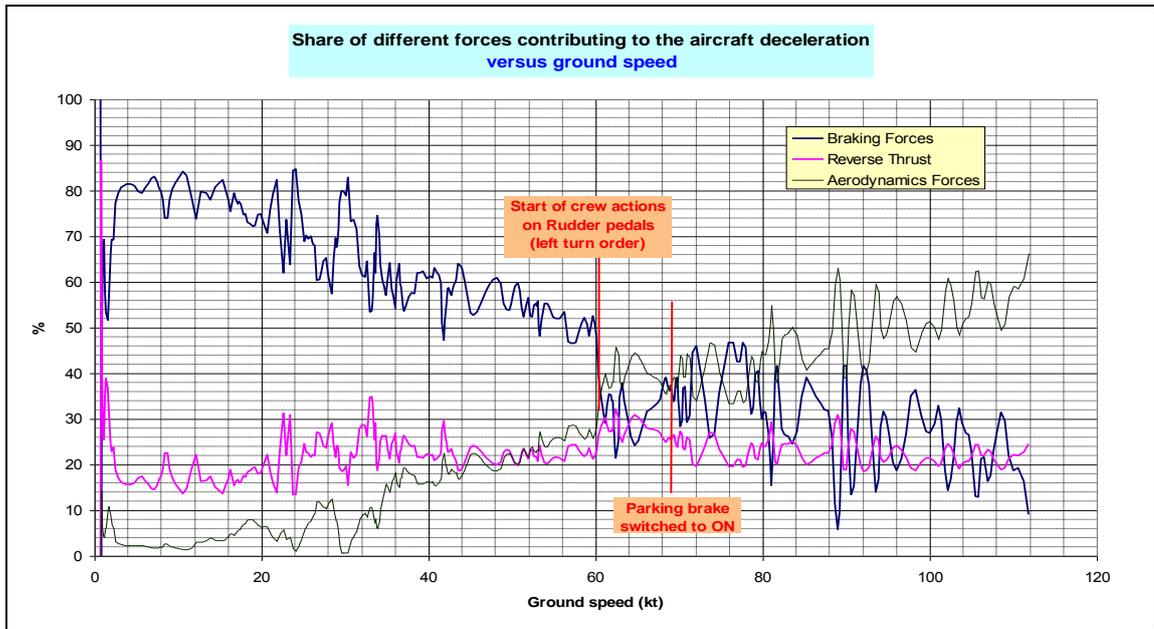
Figure 11: Graph showing the percentage distribution of braking forces from flaps/spoilers, from reversing and from wheel brakes for OY-VKA (AIBN).

Figure 11 shows the relative braking power that can be ascribed to the three braking forces air resistance, reverse thrust, and wheel braking, when braking on a contaminated runway with an „effective  $\mu$ “ in the order of 0.05. At this low friction level the „effective  $\mu$ “ and ABC are of the same order (Boeing POOR). The data concerns a relevant runway excursion in Norway (OY-VKA, RAP 2010/05, see 1.1.22). The graph shows that maximum reverse thrust accounts for approximately 20 % of the total braking power given the available POOR friction, and remains almost constant down to a ground speed of 20 kt. It also shows that the wheel brakes contribute 20-30 % during the first phase of the braking process. Although the FDR data is from an Airbus A321, it is considered relevant in general. The engine and reverser characteristics are similar if not identical, the anti-skid efficiency are of the same order and the aircraft aerodynamic layout are not much different.

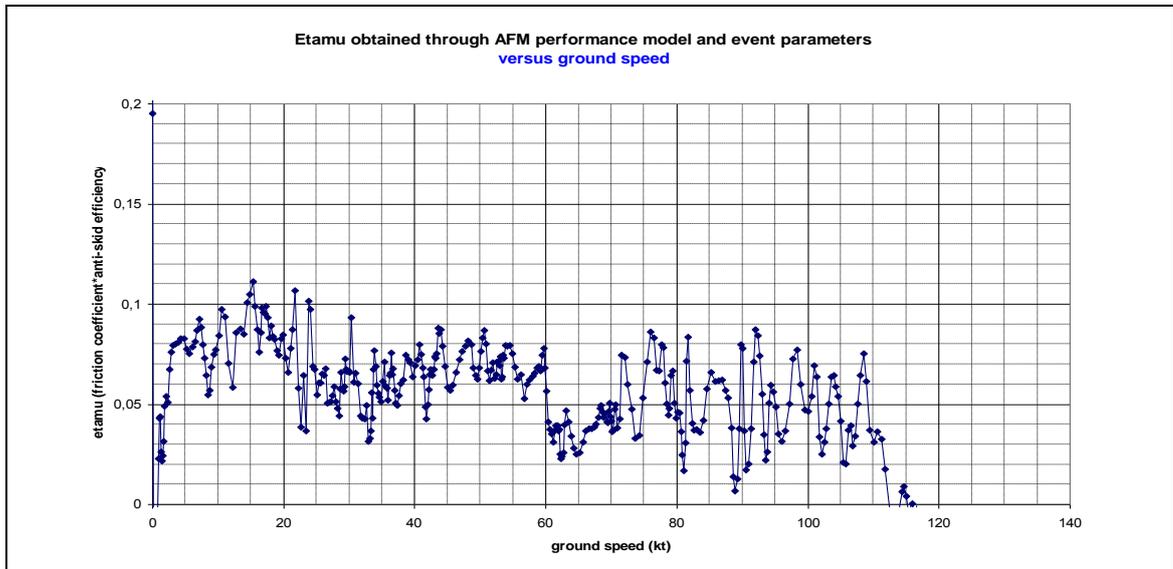
Figure 12: Graph showing the aircraft's effective braking coefficient for OY-VKA (AIBN).

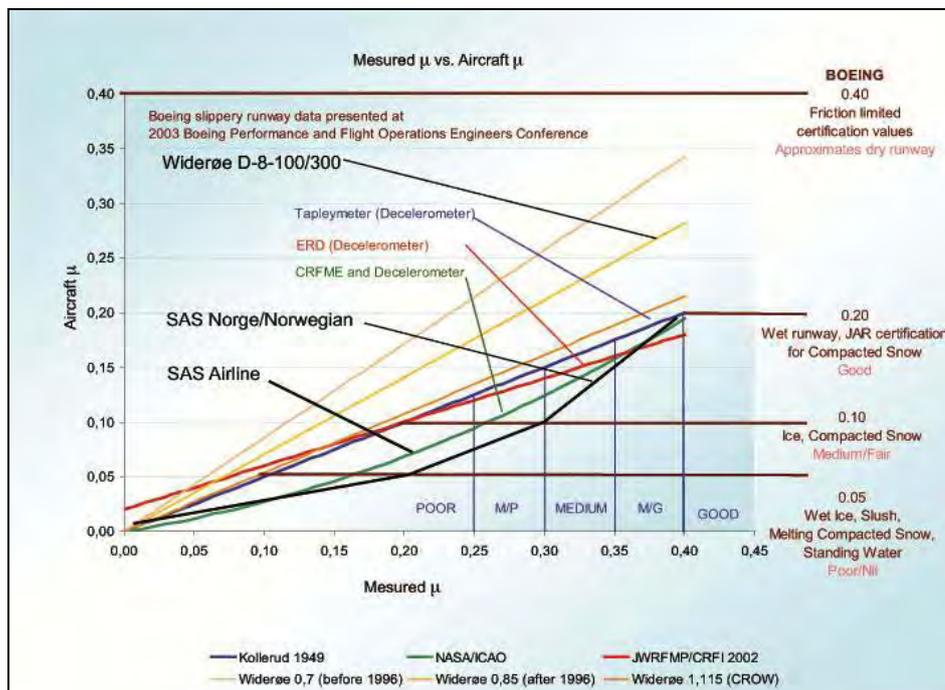
The first documented correlation curve based on comparative testing of friction measuring devices (decelerometer) and aircraft (DC-4, DC-6, DC-6B) were carried out by Kollerud (1949-54, see Figure 13).

Figure 13: Measured  $\mu$  (FC) vs. Aircraft  $\mu$ .

If the constant 1.115 is used as the denominator, Bombardier's correlation curves become almost identical to „ $aircraft \mu = 0.6 \mu_{measured\ contaminated}$ ” for DHC-8-100/300 and „ $aircraft \mu = 0.5 \mu_{measured\ contaminated}$ ” for DHC-8-Q400, respectively. Figure 13 (and Figure 9 in Appendix G) shows that use of the corrected value for „ $\mu_{measured\ dry}$ ” in Wideroe's correlation formulas, results in „ $aircraft \mu$ ” values that correspond to Kollerud's and JWRFP's values. However, the AIBN's findings suggest that „ $aircraft \mu$ ” for propeller aircraft may be somewhat higher than for turbojet aircraft. This is also indicated by test data from JWRFP (see Figure 3 and Table 4 in Appendix G). This may be supported by earlier tests that indicated that lower landing weights resulted in a higher friction coefficient, but not to such an extent as indicated by the Wideroe correlation curve as shown in Figure 13. See Figure 14 and Appendix V.

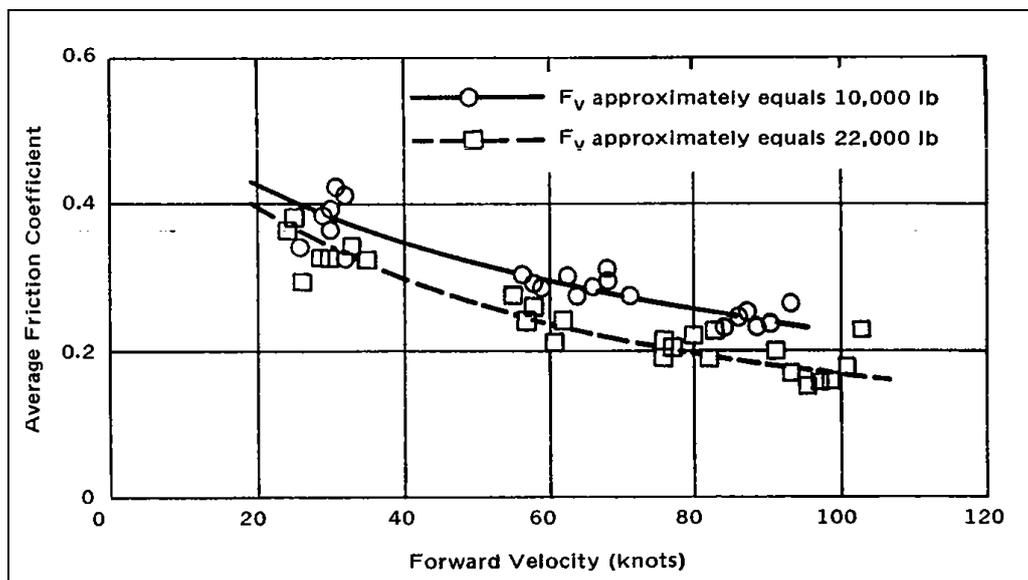
Figure 14: Average Friction Coefficient vs Velocity and Wheel Vertical Load (Horne and Leland, 1962. Appendix V).

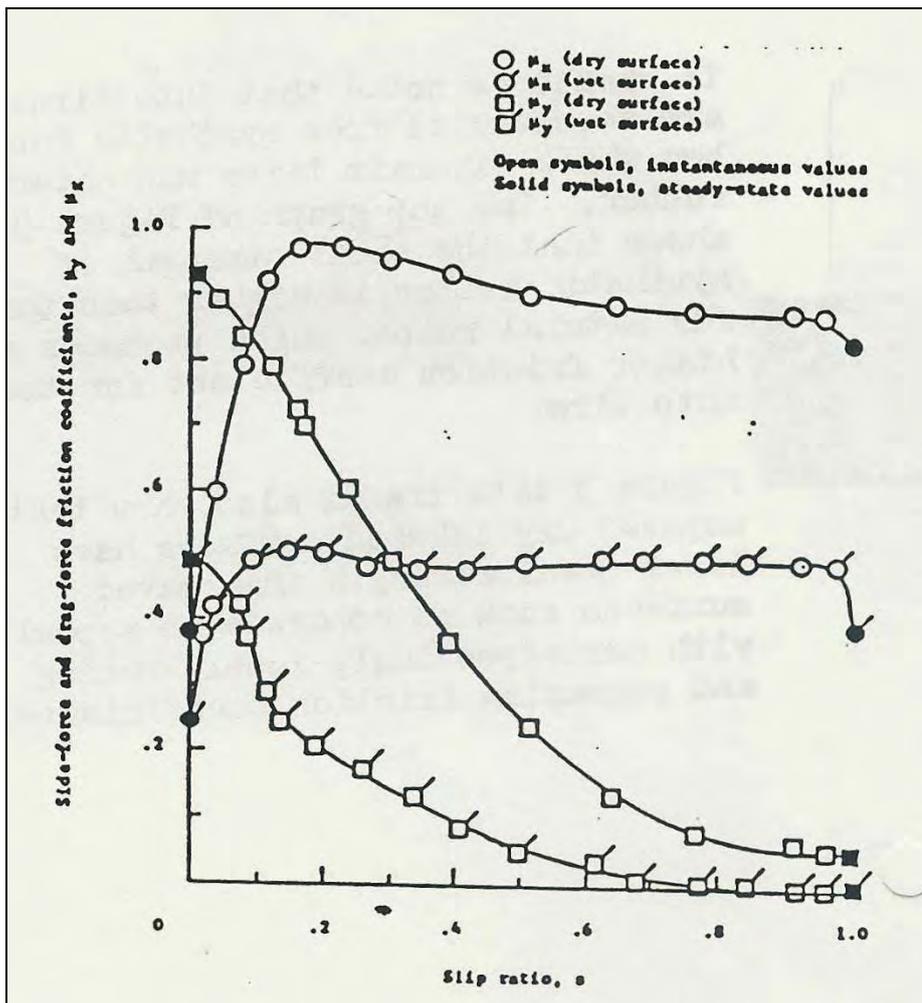
When braking and steering (cornering) at the same time, aircraft braking friction will be at the expense of aircraft cornering friction. The cornering friction is reduced by an increasing slip ratio. This is shown in Figure 15. It occurs when turning the aircraft and in connection with crosswind landings, when cornering friction is required in order to keep

the aircraft on a straight path along the runway centre line at the same time as the crew is applying the brakes.

Figure 15: Cornering friction (W. B. Horne, NASA 1990).

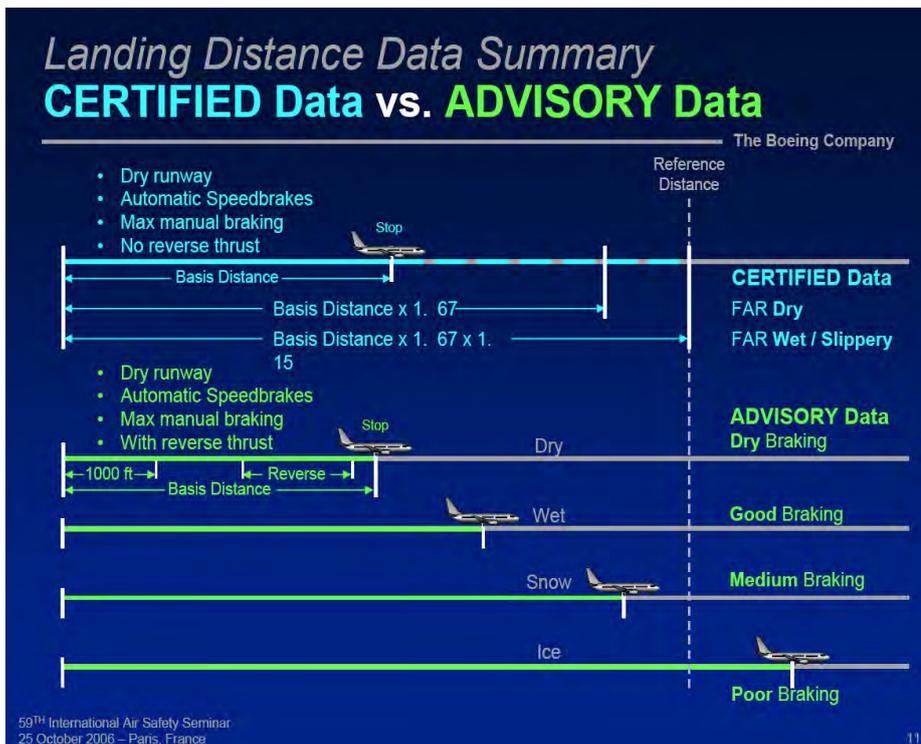
The JAA requirements at the time of certification of the B737NG called for a 7 seconds „flare“ distance and a 7 % speed bleed off from Vref@50 feet Threshold Height (THT) to touchdown on a contaminated runway. This is a much longer „flare“ distance than on a dry runway (4.5 sec / 1 % speed bleed off). Since the flight crews try to aim for the same touchdown point, there are some hidden theoretical margins in the landing calculations for a contaminated runway. These data are published in the AFM and all electronic performance databases, but in the printed Flight Crew Operator Manual (FCOM) Boeing calculates with a fixed flare distance of 1000 feet (300 m).

Figure 16: Boeing’s Certified Data vs. Advisory Data (Boeing, 2006).

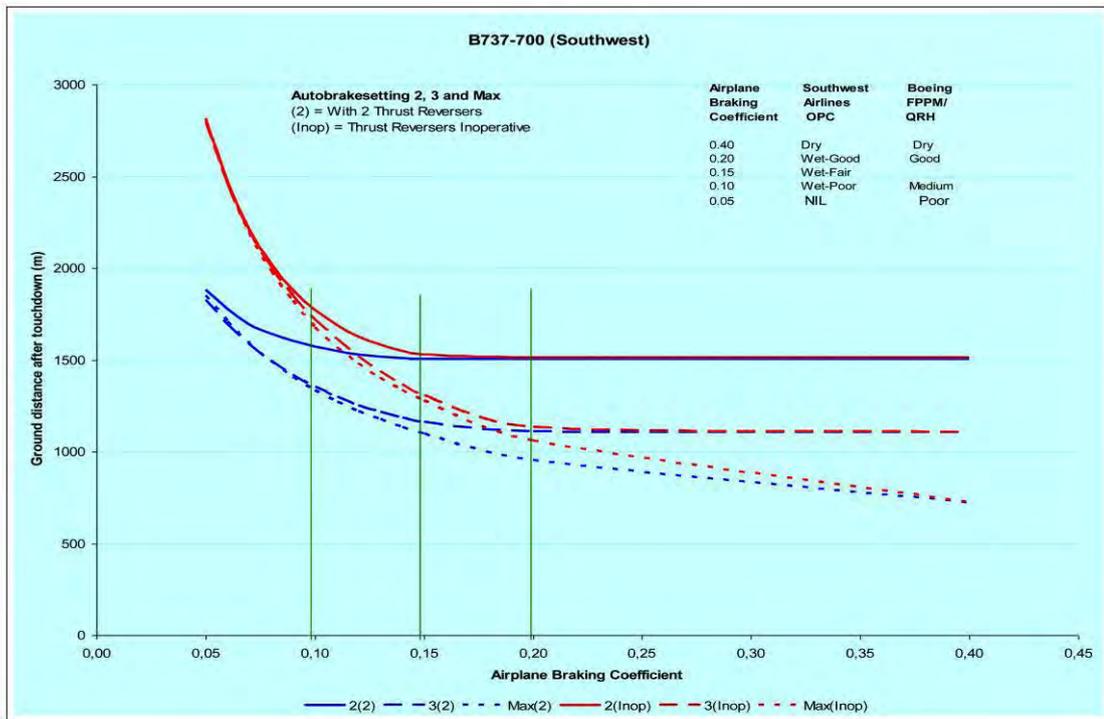
Figure 17 shows the effect of various autobrake settings combined with the use of both, or without thrust reversers. The data is from Southwest’s runway excursion in the USA. The blue lines are for use of both thrust reversers, while the red lines are for use without thrust reversers. The figure shows that it was not possible to plan for landing with an ABC of 0.05 (Boeing POOR). However, it was possible to plan for landing without the use of thrust reversers with an ABC of 0.10 (Boeing MEDIUM). Landing with the use of one thrust reverser could be planned on a 2,400 m long runway. The figure also shows that, with an ABC of less than 0.10 (Boeing MEDIUM), it makes no difference to the braking distance whether autobrake setting 3 (7 ft/sek<sup>2</sup>) or Max (14 ft/sek<sup>2</sup>) is chosen. This is because the effective braking is friction limited.

Figure 17: The effect of thrust reversers versus Airplane Braking Coefficients (NTSB).

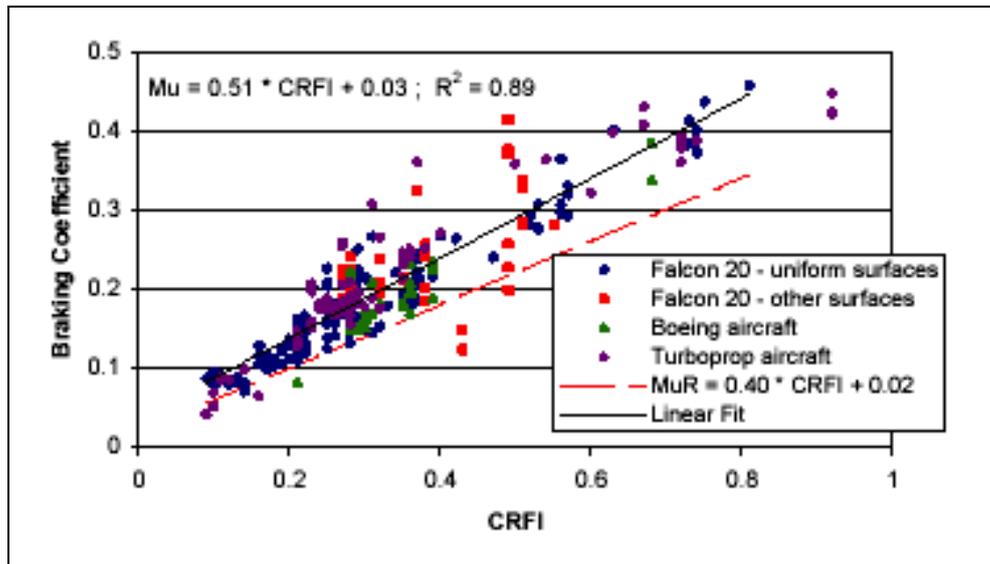
Figure 18: TC's correlation curve between CRFI and Braking Coefficient (aircraft  $\mu$ ).

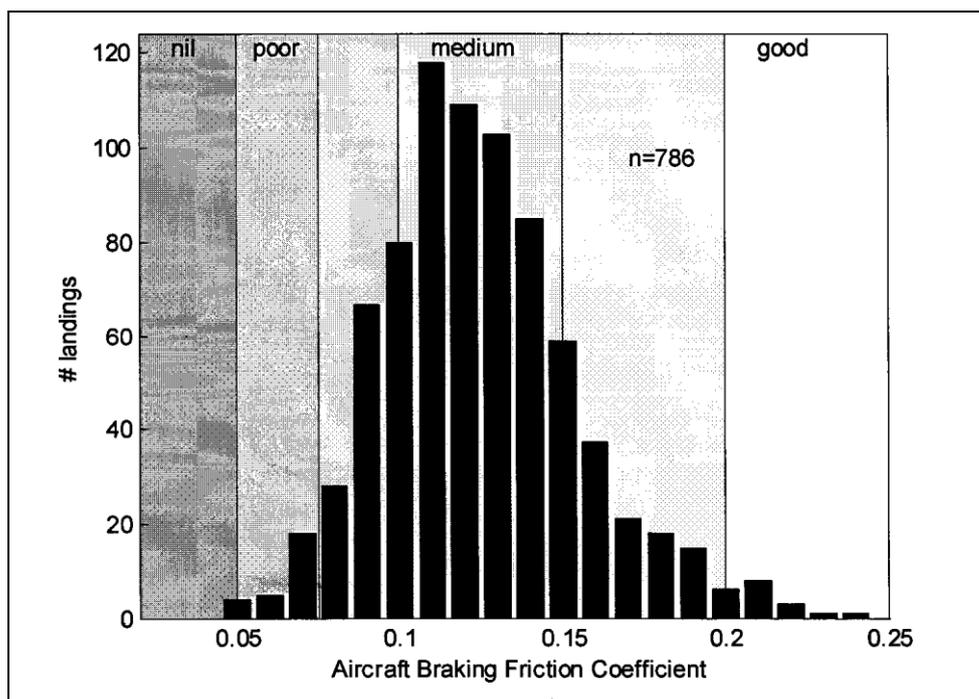
Figure 19 show measured ABCs from B737 during the IRIS program. It shows the spread in ABC in the ranges of GOOD (ABC ≥ 0.20), MEDIUM (ABC 0.10 – 0.19) and POOR (ABC < 0.10) under wet or moist conditions..

Figure 19: Aircraft Braking Coefficient measured under wet or moist conditions including Dew Point Spread ≤ 3 K.
