The Transportation Safety Board of Canada (TSB) investigated this occurrence for the purpose of advancing transportation safety. It is not the function of the Board to assign fault or determine civil or criminal liability.

1.0 Factual Information

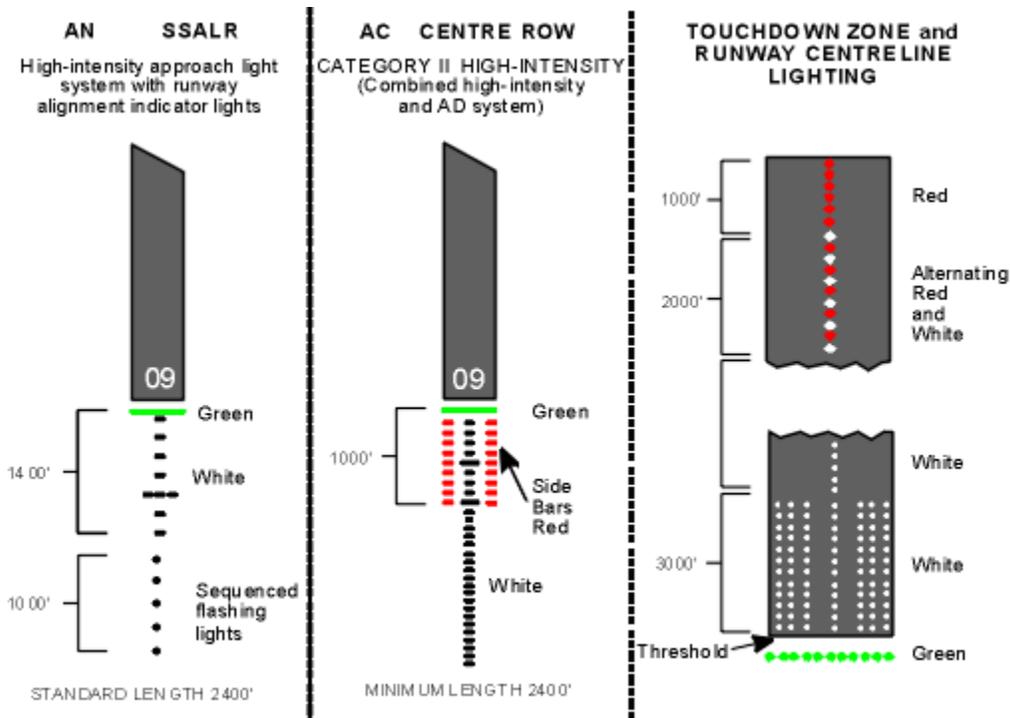
Figure 3 - Approach and runway lighting

The CL-65 aircraft met all of the requirements for Category II approaches; however, the Fredericton airport facilities and ILS installation were not suitable for Category II approaches. Runway 15 was equipped with AN type approach lighting (see Figure 3), and did not have touchdown zone or runway centre line lighting. The flight crew were qualified to fly to Category II limits, but only if the captain was flying the aircraft with the autopilot coupled.
