## Report of the inquiry into the accident to a Fokker F.27, OY-APB, at Rønne airport on the 27th December 1969.

Aircraft type:	Fokker F.27 Mark 500.
Registration:	OY-APB.
Owner/Operator:	Maersk Air.
Crew:	Captain Gerrit Burger - injured Co-pilot Captain Leif Troest Jespersen - injured.
Passengers: (Pupils)	First officer Poul Erik Frimor - injured First officer Finn Vejen Bjerre - injured.
Place of accident:	Approx. 460 metres west of runway 29, Rønne airport.EKRN.
Date and time:	27th. Dec. 1969 at 15.55.

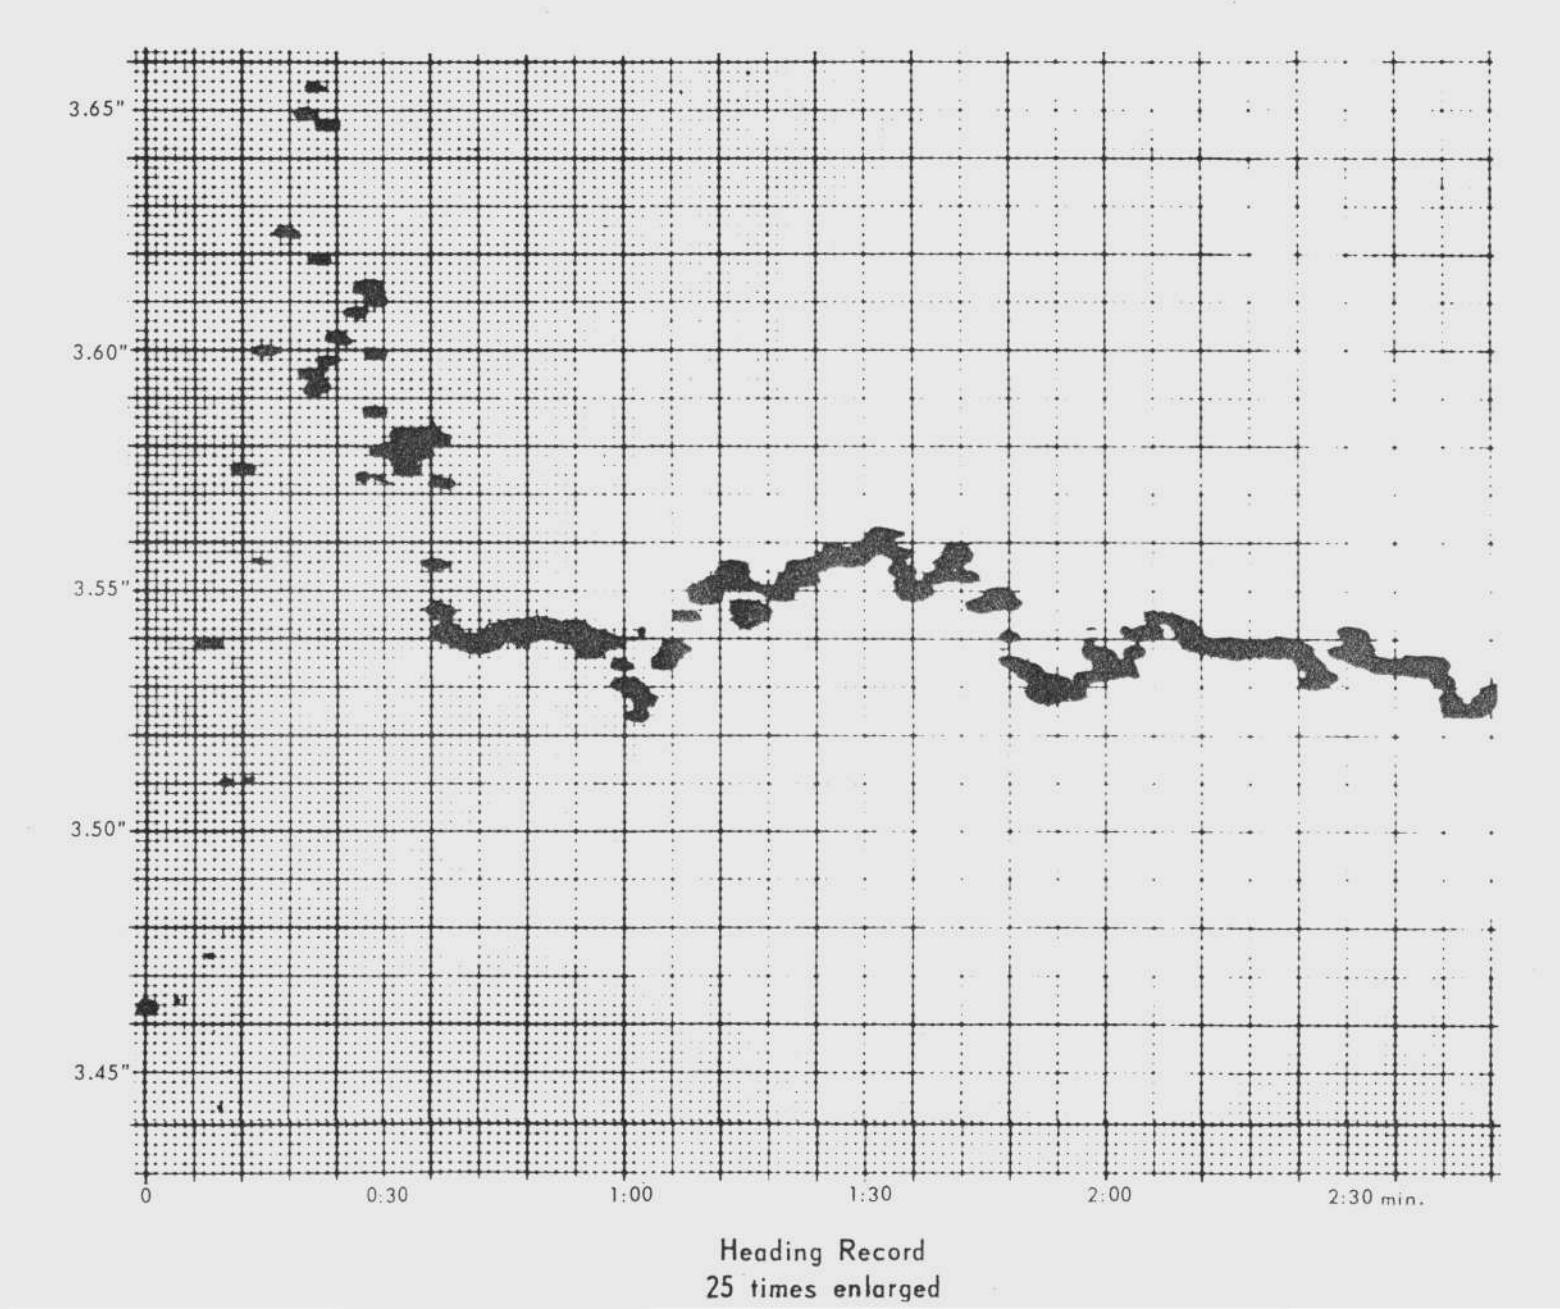
## OY - APB Flight Data Recorder Sensor P/N 100435

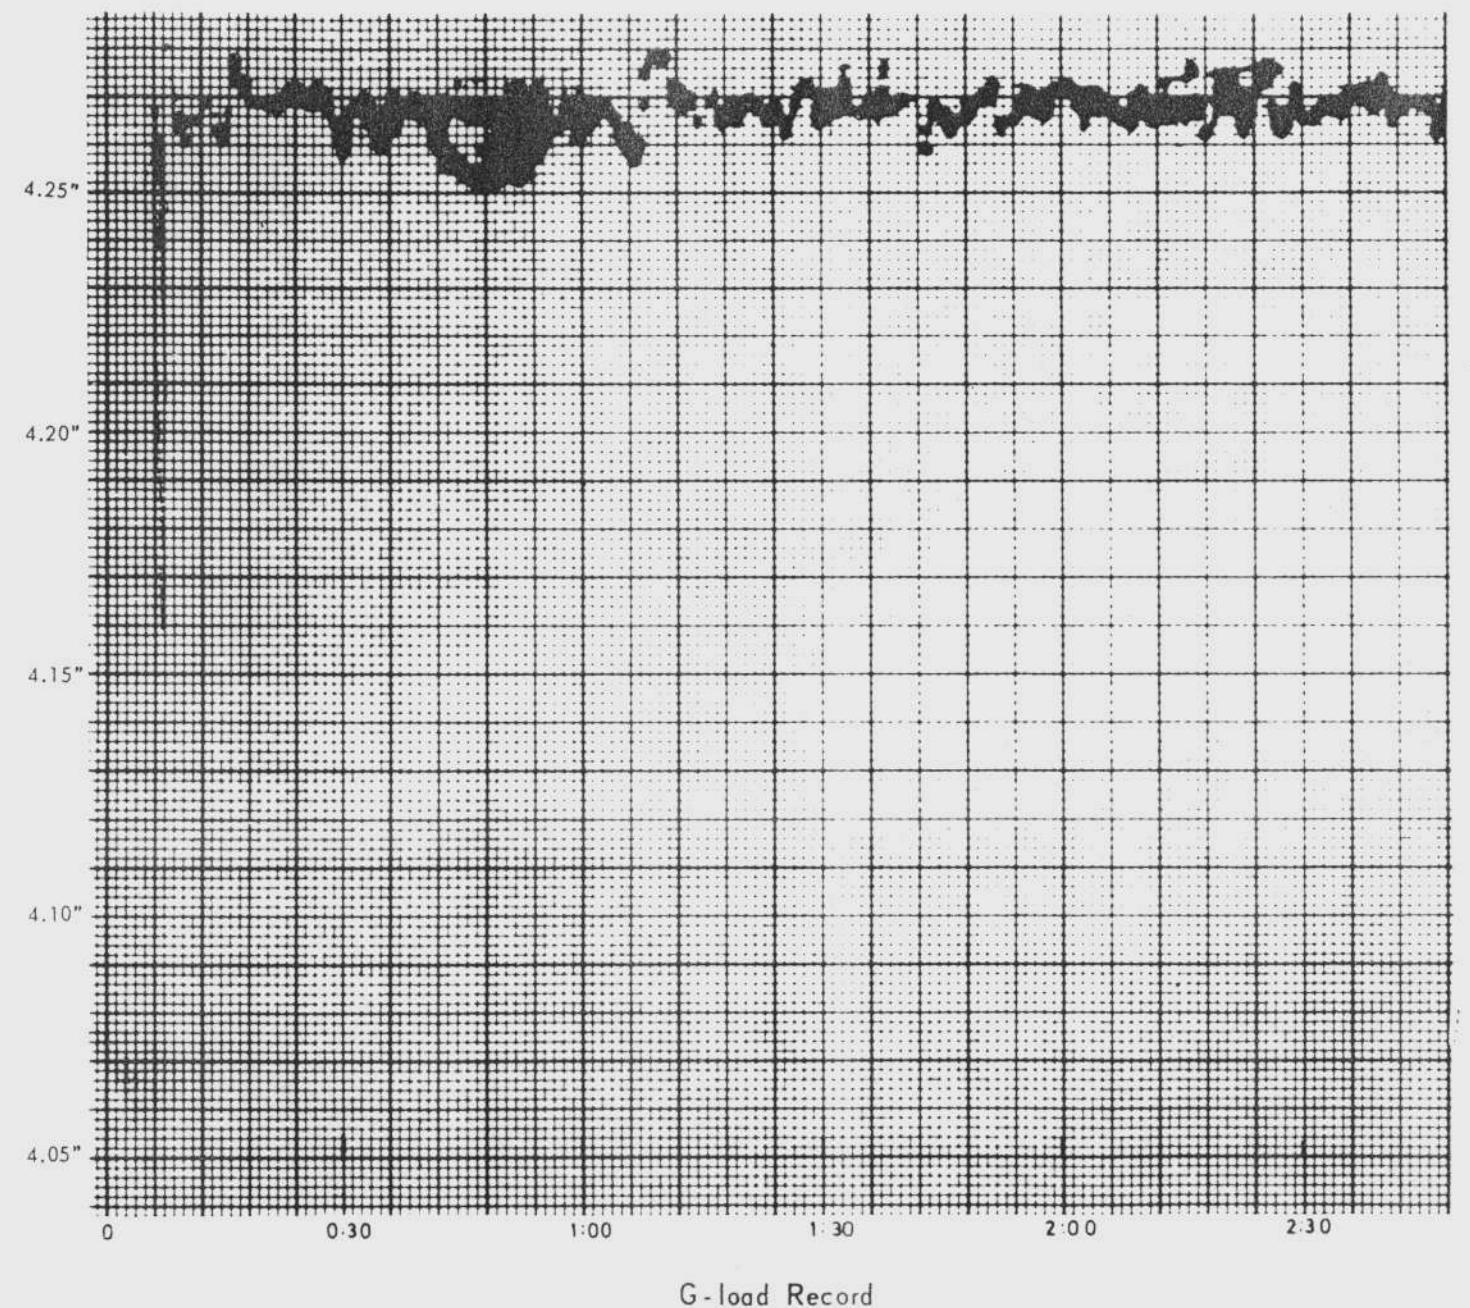
25 times enlarged

OY - APB Flight Data Recorder Sensor P/N 100435

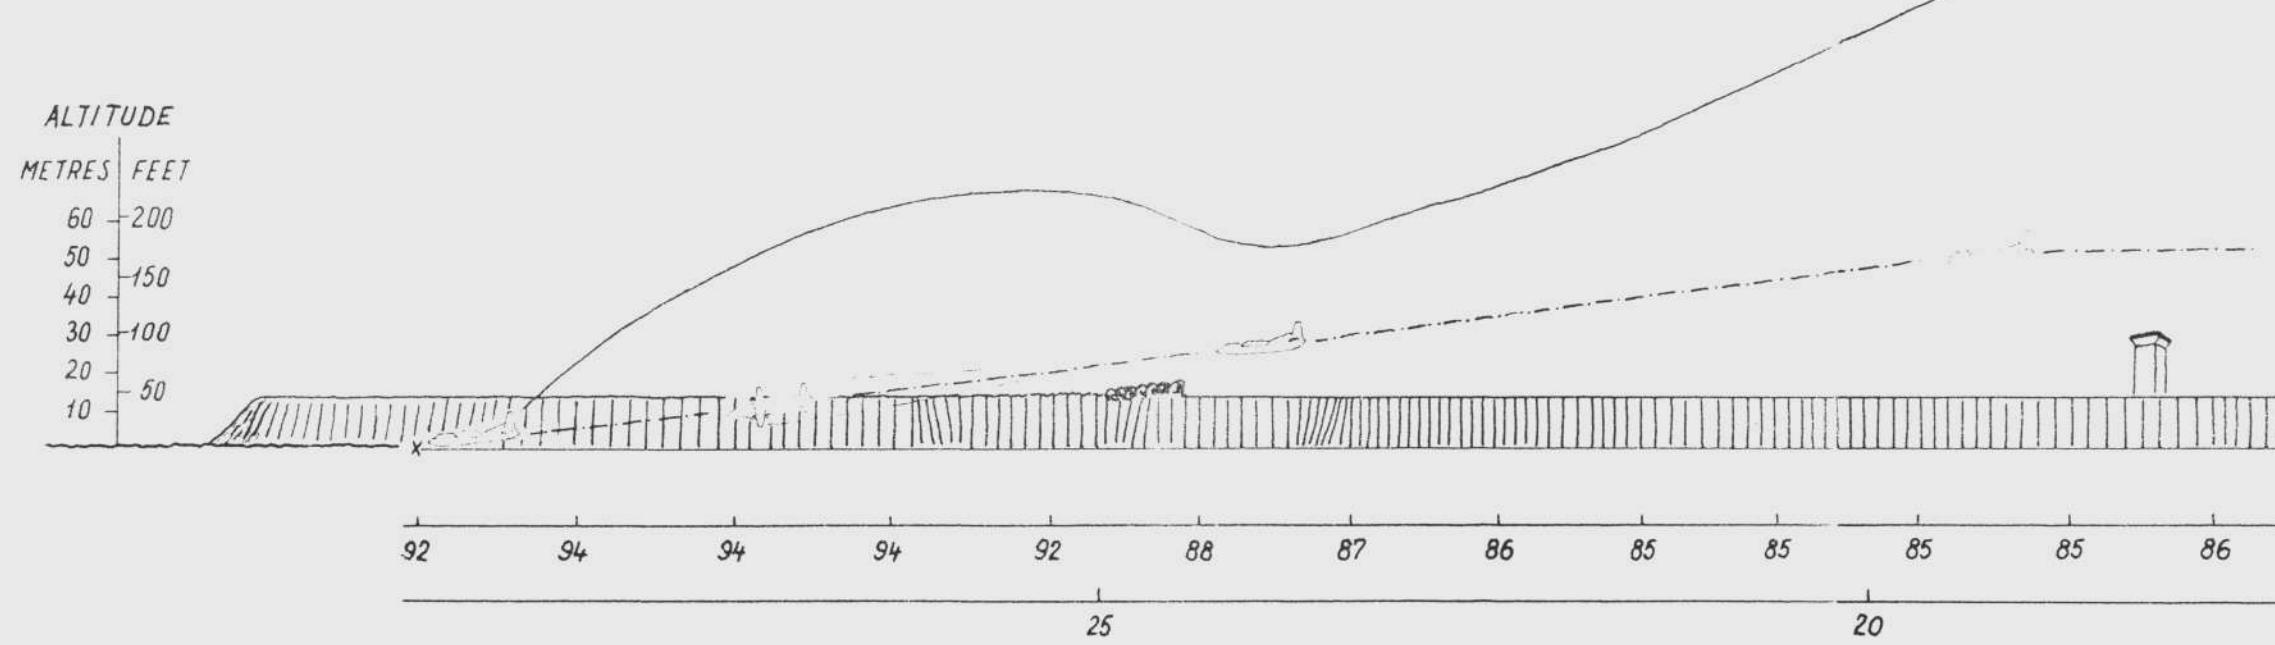
Altitude Record (Std. Press.) 25 times enlarged MAERSK AIR FOKKER F-27 ACCIDENT RØNNE AIRPORT DECEMBER 27, 1969. Flight Path according to Flightrecorder readout.
