# AIRCRAFT ACCIDENT REPORT

OZARK AIR LINES, INC.

DOUGLAS DC-9-15, N974Z

DECEMBER 27, 1968

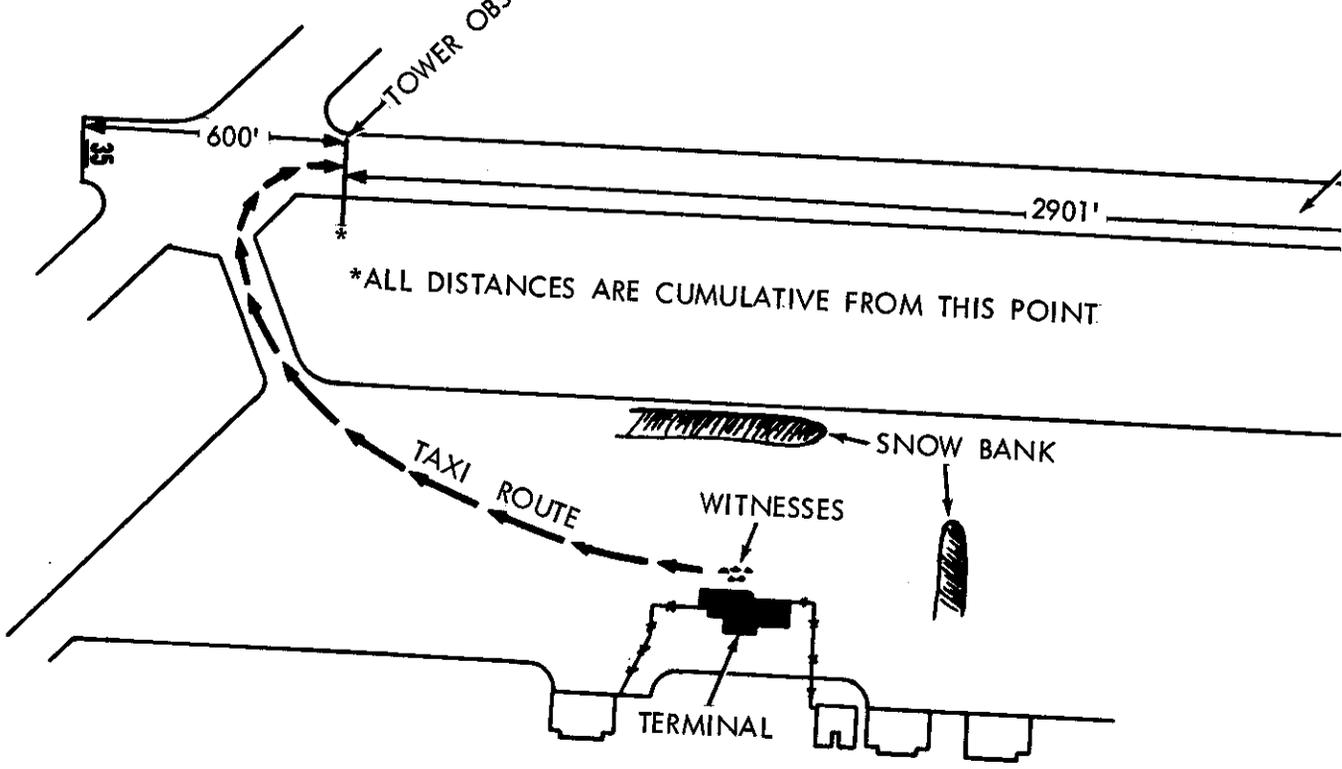
TOWER OBSERVED BEGINNING OF TAKEOFF ROLL

IN ALTITUDE TRACE--IAS 133 KTS--TIME 25  
 ED DISTANCE TO V1 136 KTS--26 SEC.  
 PUTED PERFORMANCE DISTANCE TO V1 - 31.2 SEC.  
 MANUFACTURERS COMPUTED PERFORMANCE DISTANCE TO LIFTOFF--IAS  
 148 KTS--33.9 SEC.  
 COMPUTED FLIGHT RECORDER DISTANCE TO VLO 148 KTS--31 SEC.  
 APPROXIMATE TOWER OBSERVED LIFTOFF
