PB91-910410
NTSB/AAR-91/09

AIRCRAFT ACCIDENT REPORT

RYAN INTERNATIONAL AIRLINES

LOSS OF CONTROL ON TAKEOFF

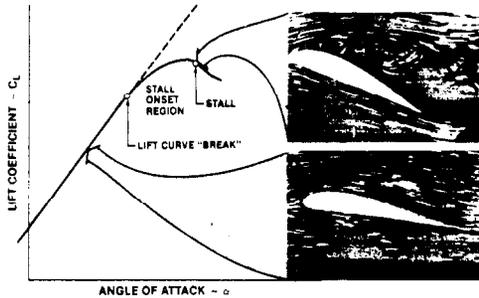
Figure 2. Airflow Over an Airfoil and Its Effect on Lift

The most predominant adverse effect of ice contamination is on the lifting characteristics of the wing. It may be recalled that wing lift coefficient varies with angle of attack, as shown in Figure 2. Under normal conditions, the airflow over a wing smoothly follows the shape of the wing, as shown in the lower photograph, and lift varies directly with the angle of attack. At some fairly high angle of attack, the airflow begins separating from the wing, causing the lift curve to become nonlinear, or "break." When the airflow is essentially fully separated, as shown in the upper photograph, the wing is considered fully stalled. Between the point where the airflow begins separating and full stall is a region often called "stall onset," where flight characteristics become increasingly degraded as the angle of attack increases.

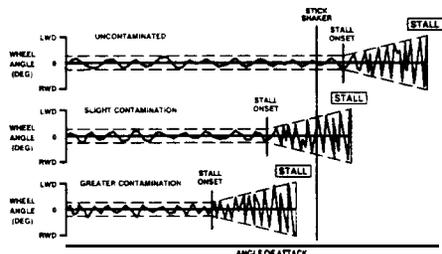
Figure 5. Effect of Wing Ice Contamination on Lateral Control Characteristics

During a normal takeoff, the aircraft speed schedules are established for angles of attack below that for stall onset or activation of stall-warning devices dependent on angle of attack, such as a stick shaker (Figure 5a). However, for an airplane with ice contamination, not only does stall onset occur at a lower than normal angle of attack, the airplane angle of attack must be increased in order to produce the required lift at normally scheduled speeds (Figure 5b). This compounding effect rapidly results in the aircraft's operating into the "stall onset" pan of the lift curve (described earlier), and the increasingly unsteady airflow over the wing results in correspondingly degraded lateral stability, requiring larger and larger control wheel inputs to keep the aircraft from rolling off. As the amount of contamination increases, the airplane becomes increasingly unstable, eventually stalling without stick shaker activation at speeds normally scheduled for takeoff (Figure 5c).

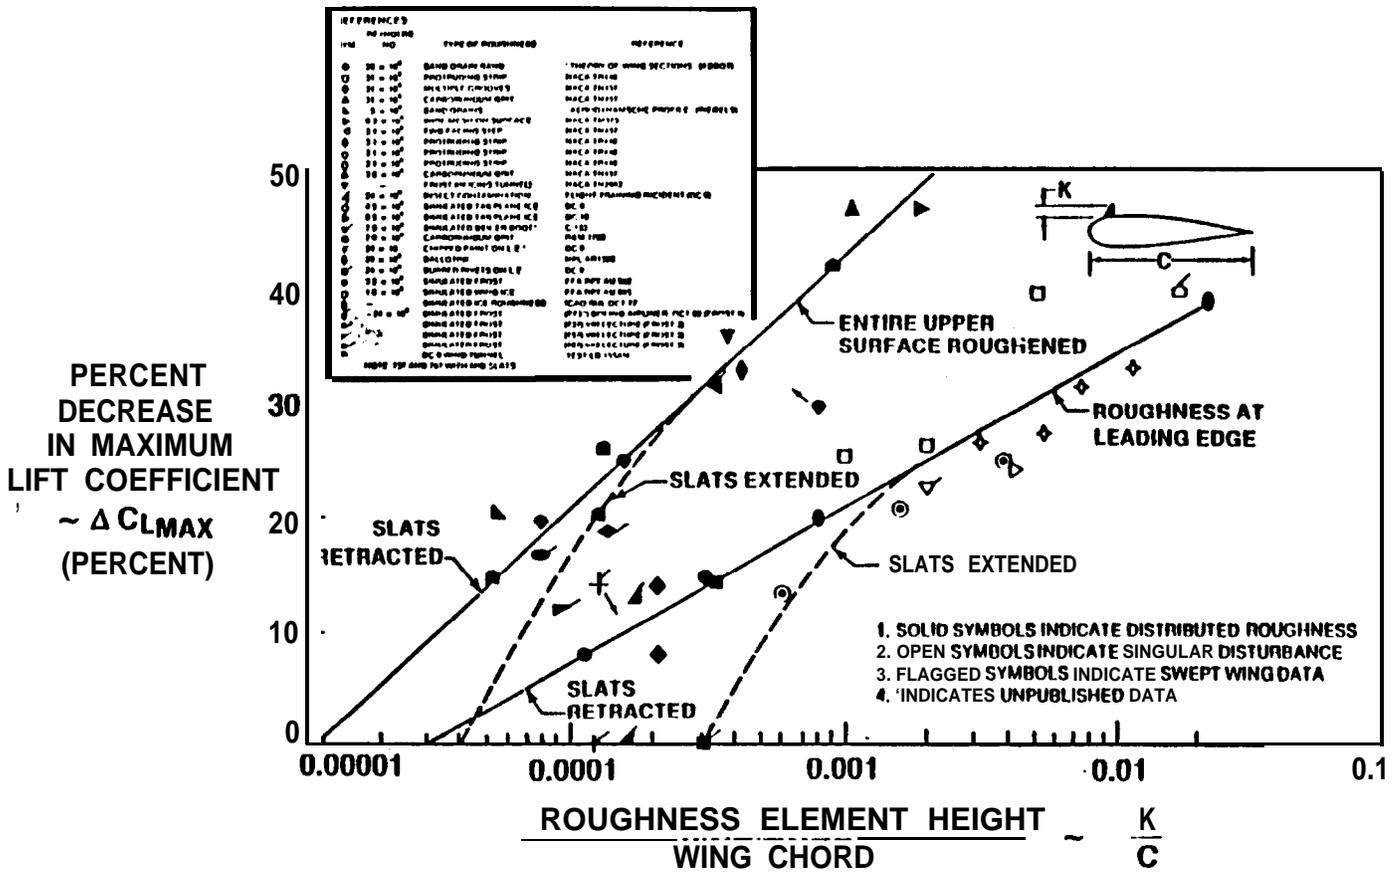
A CORRELATION OF THE EFFECT OF WING SURFACE ROUGHNESS ON MAXIMUM LIFT COEFFICIENT

The lower line in Figure 6 shows the lift loss due to a localized strip or narrow band of contamination on the leading edge. Much of the data for the lesser amounts of contamination have been obtained from maintenance or flight training experience where some form of contamination such as insect debris, chipped paint, or burred rivets caused premature stall when the slats were retracted, but caused little or no noticeable effect when the slats were extended. Wind tunnel data indicate that as the contamination on the leading edge becomes larger, such as for in-flight ice

The upper line in Figure 6 shows the lift loss due to roughness on the entire upper surface of the wing, such as might be caused by frost, snow, or freezing drizzle while the aircraft is on the ground. Of particular note is the very large degradation for even the smaller amounts of contamination. Also of interest are the relatively recent data developed by Boeing during flight testing of second- and third-generation transport aircraft with slats extended. These data suggest that with essentially the entire wing upper surface covered with even small amounts of contamination, slat extension provides little or no recovery of lift losses.
