# **NATIONAL TRANSPORTATION SAFETY BOARD**

## **AIRCRAFT ACCIDENT REPORT**

**CONTINENTAL AIRLINES, INC., FLIGHT 1713  
McDONNELL DOUGLAS DC-9-14, N626TX  
STAPLETON INTERNATIONAL AIRPORT  
DENVER, COLORADO  
NOVEMBER 15, 1987**

**NTSB/AAR-88/09**

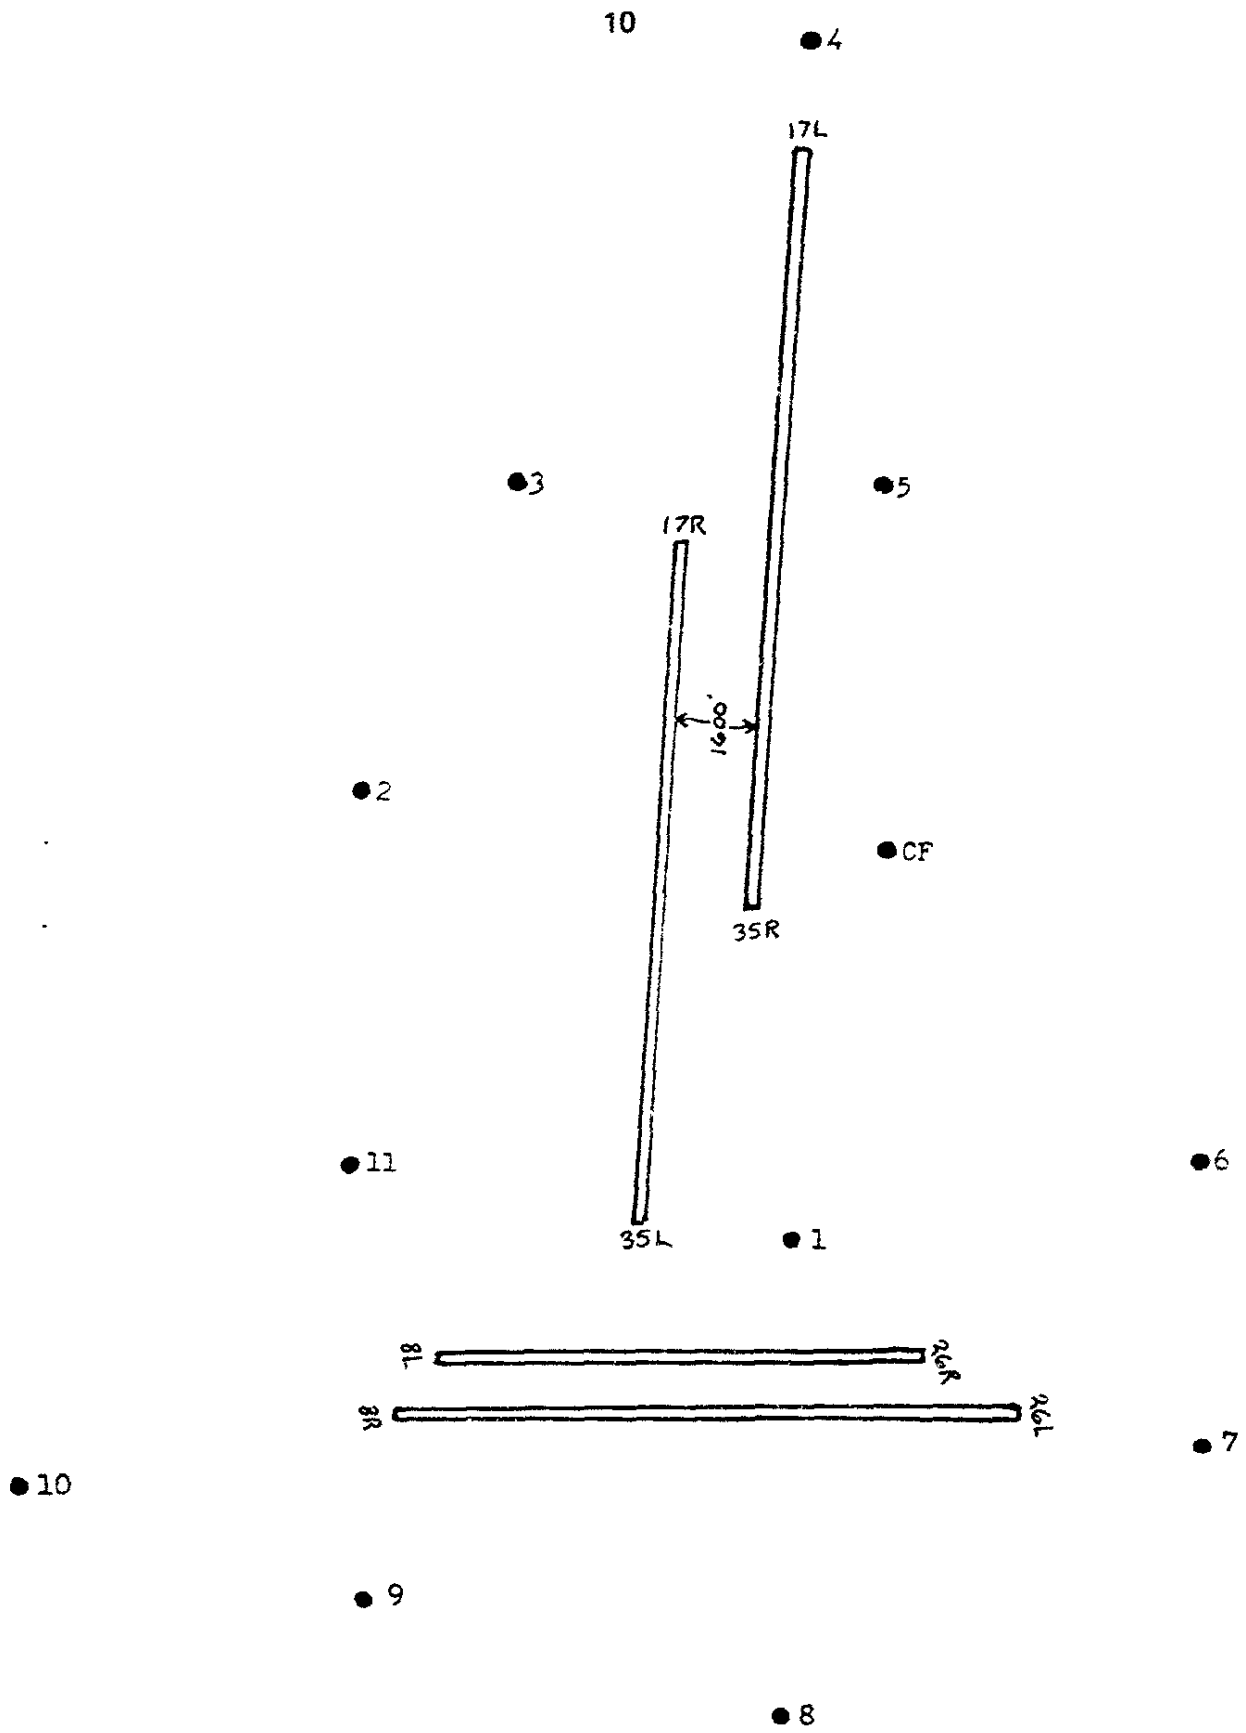
Figure 1.—Wind sensor locations.

The winds recorded from the low level wind shear alert system (LLWAS) were provided by the FAA for 1410:04 to 1419:44. Observations were taken from each sensor at approximately 7-second intervals. (See figures 1 and 2.)
