# **GE 791 Occurrence Investigation Report**

**IN-FLIGHT ICING ENCOUNTER AND CRASH INTO THE SEA  
TRANSASIA AIRWAYS FLIGHT 791**

**ATR72-200, B-22708**

**ASC-AOR-05-04-001**

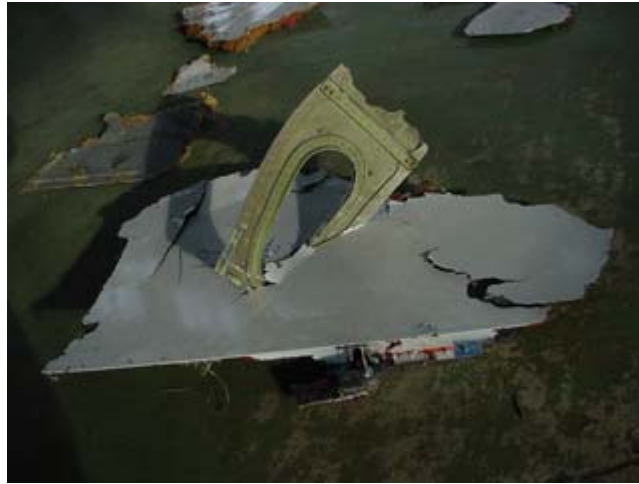
Figure 1.12-15 Window frame stuck into rudder

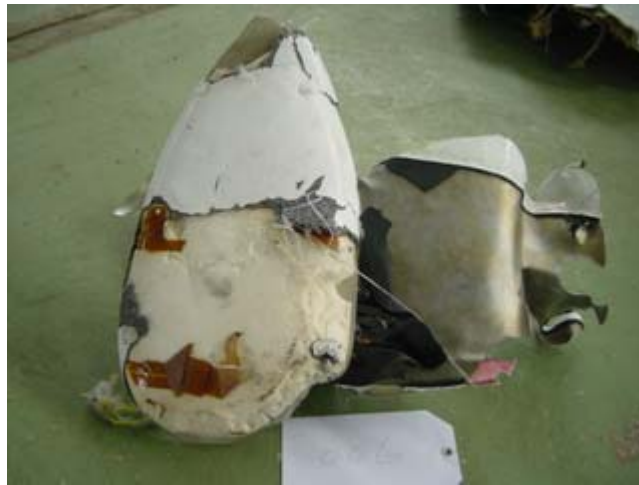
Figure 1.12-25 ADF antenna

- ADF antenna: The antenna was separated from body. The shape is still conserved. The front skin was delaminated (refer to figure 1.12-25).

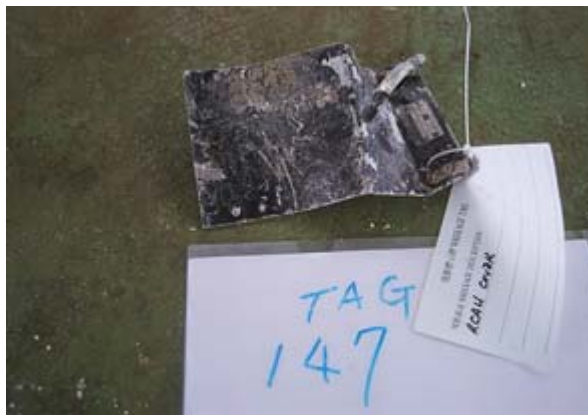
Figure 1.12-29 RCAU case

- Remote Control Audio Unit (RCAU) metal case: The case was separated from the unit. The leading edge of the case was bended and wrinkled (refer to figure 1.12-29).

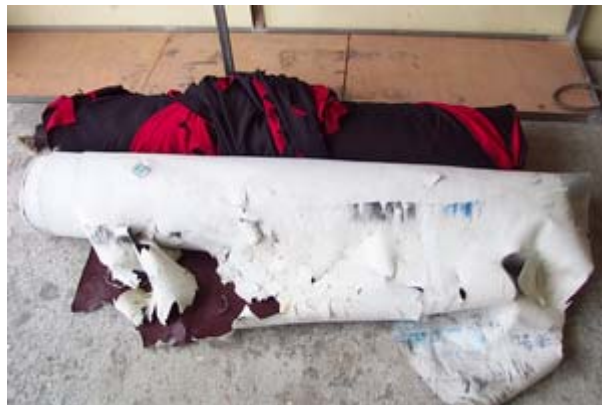
Figure 1.12-30 Cargo (cloth)

- Cargo (cloth) : There is no fire phenomenon on the cloth. One roll of cloth was protruded by floor structure (refer to figure 1.12-30~31).

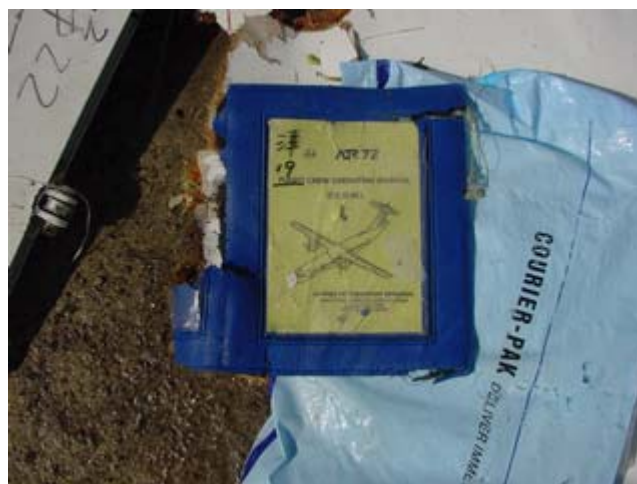
Figure 1.12-33 Flight crew operation manual

- Flight operation manual: The cover of flight crew operation manual was recovered (refer to figure 1.12-33).

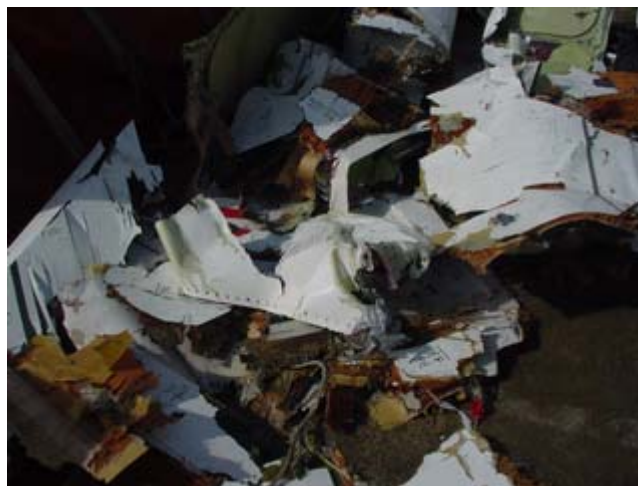
Figure 1.18-10 Floating wreckages

Floating wreckage: The floating wreckages found by Navy and Coast Guard was 87 pieces. Most of them are honeycomb of wing trailing edge, flaps, rudder, and elevators engine cowlings and so on (refer to Figure 1.18-10). Some of them are clothing. The biggest one was number 55, which was a roll of clothing (210 cm X 17 cm). The smallest one is a taco meter of engine rpm (10cmX1cm)

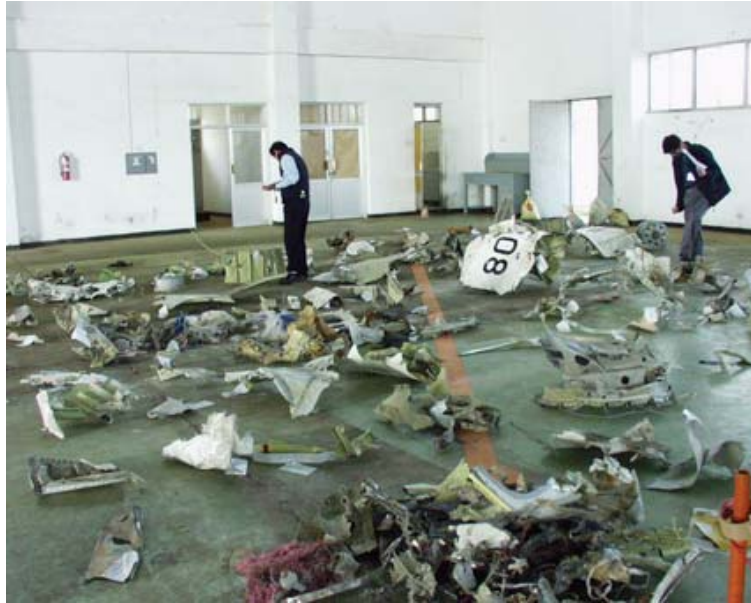
Figure 1.18-11 Underwater wreckage recovered by trawling operation

Underwater wreckage : The Ocean Hercules recovered 10 pieces of wreckage and trawling operation recovered 102 pieces. Most of them are from wing structure, fuselage skin, landing gears, wheel, stringer and frame (refer to Figure 1.18-11). The biggest piece is a cargo floor (no.198 with size of 205cmX135cmX6cm). The smallest one was fuselage skin (no.152 with size 24cmX8cmX0.2cm).

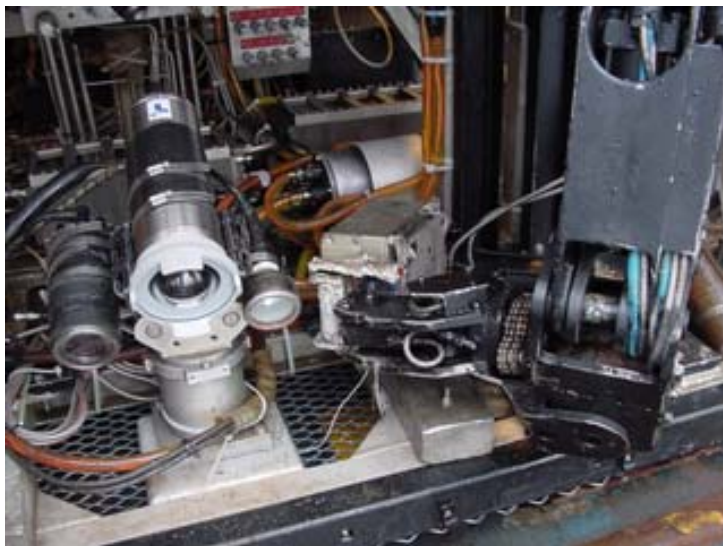
Figure 1.18-25 FDR recovered by ROV

At 0626 on January 12, 2003, ROV discovered the FDR fore part and pinger, its orange casing came off. At 0800, ROV mechanical arm salvaged the FDR (Figure 1.18-25,26), and subsequently discovered wreckages such as: Brake disk, Engine mounting, Engine casing, Landing gear#2, Large engine part, Generator, etc. Work continued until 1630 when current became strong. The FDR was ferried to shore by Coast Guard vessel, and taken to ASC Lab by IIC.

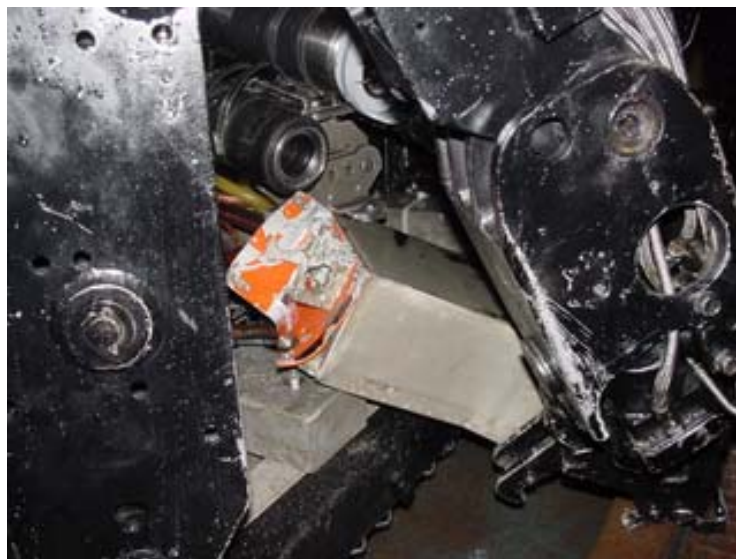
Figure 1.18-27 CVR recovered by ROV

At 0140 on January 14, 2003, ROV discovered CVR fore part ( Crash Survivable Unit, CSU ) , its pinger being lost, and without the orange casing. At 1900 ROV mechanical arm salvaged CVR (Figure 1.18-27,28), and subsequently discovered wreckages.

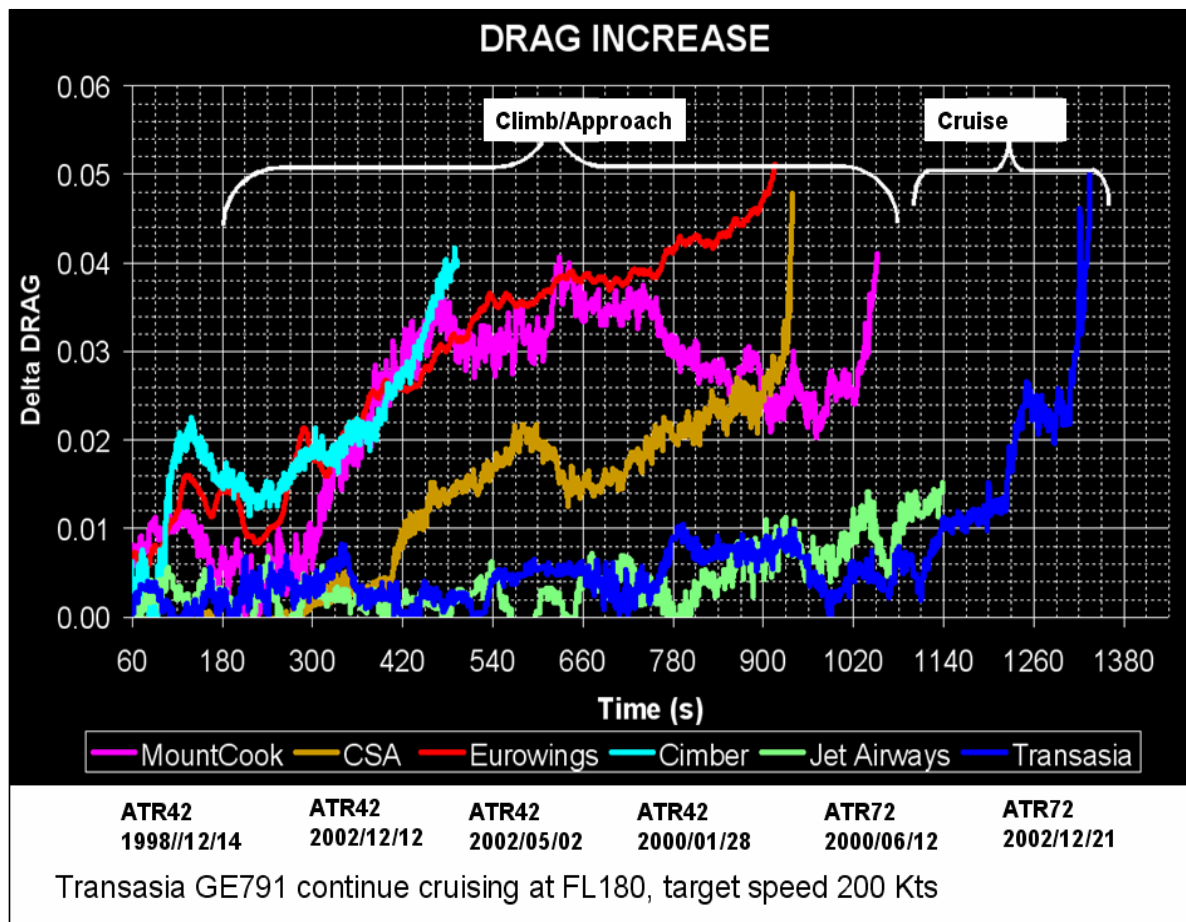
The Roselawn accident is not included into Figure 2.4-1, because of the very small amount of drag created by severe ice, in fact the ice accumulated was only in front of aileron and the roll upset was created by the influence of this ridge on the aileron hinge moment variation. All the other events presented a very high drag increase with large speed penalties.

Figure 2.4-1 Aircraft extra drag due to ice versus time after Roselawn (1998~2002)

The Safety Council believes that ATR 42 /72 after prolonged exposure to severe icing conditions and continuously activated the airframe de-icing, icing accretion may caused drag increased to 500 counts, and caused the aircraft upset or stall.

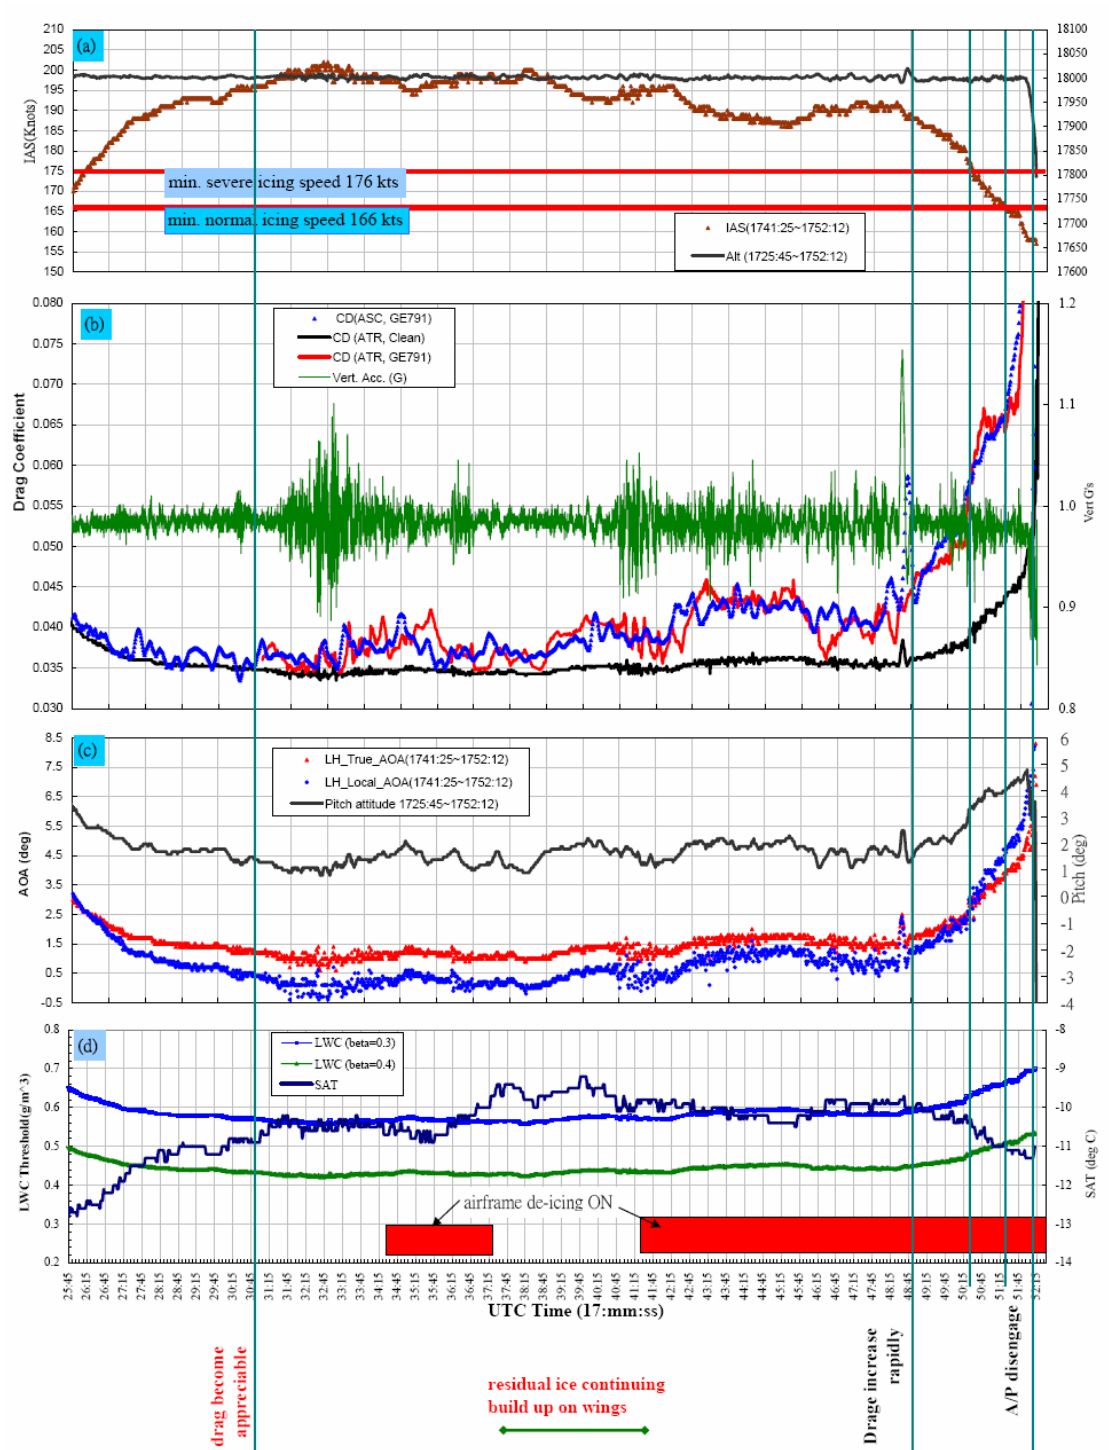
The effect of ice accretion increased the drag of about 500 counts, lift-drag ratio loss was about 64% and the indicated airspeed decayed in about 1 min and 50 sec. from 176 knots (Minimum severe icing speed) to 158 knots.

The Safety Council, after analysis of FDR and CVR data, believes that the GE791 probably encountered a severe icing condition, which was worse than icing certification requirements of FAR/JAR 25 Appendix C.

Figure 2.4-3 GE791 performance data plot due to ice accretion versus time (airspeed, altitude, OAT, drag, and severe icing threshold value of LWC)

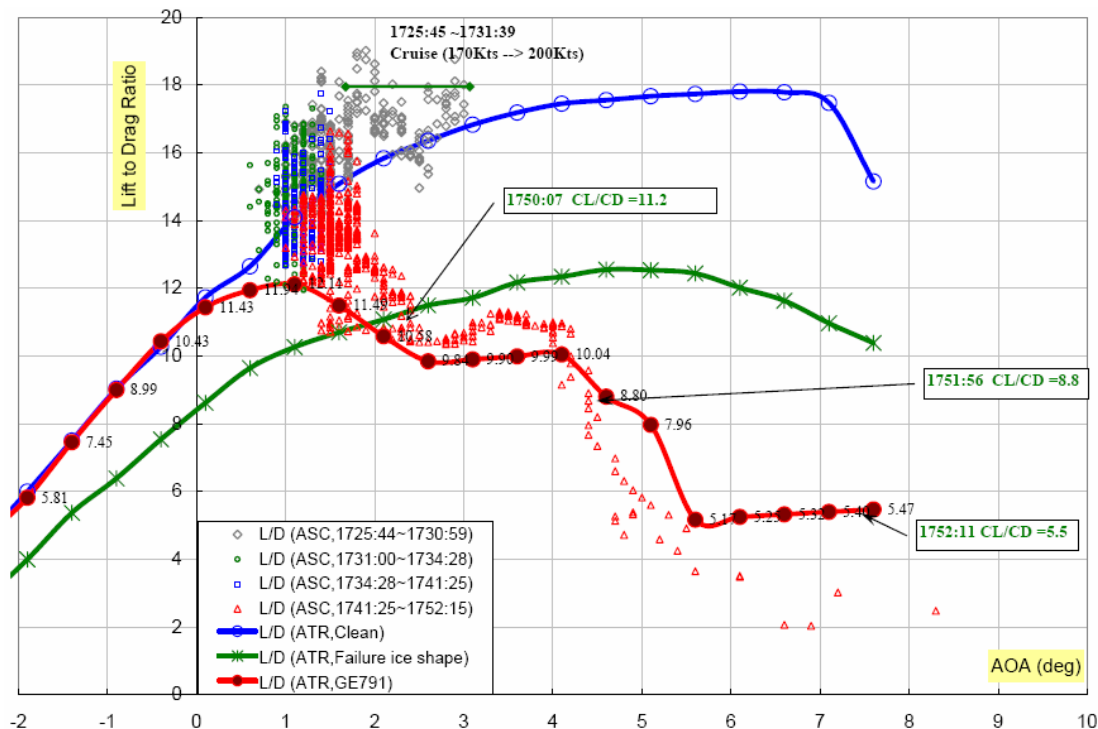
Figure 2.4-4 The lift-drag ratio of the GE791 due to ice accretion versus true AOA

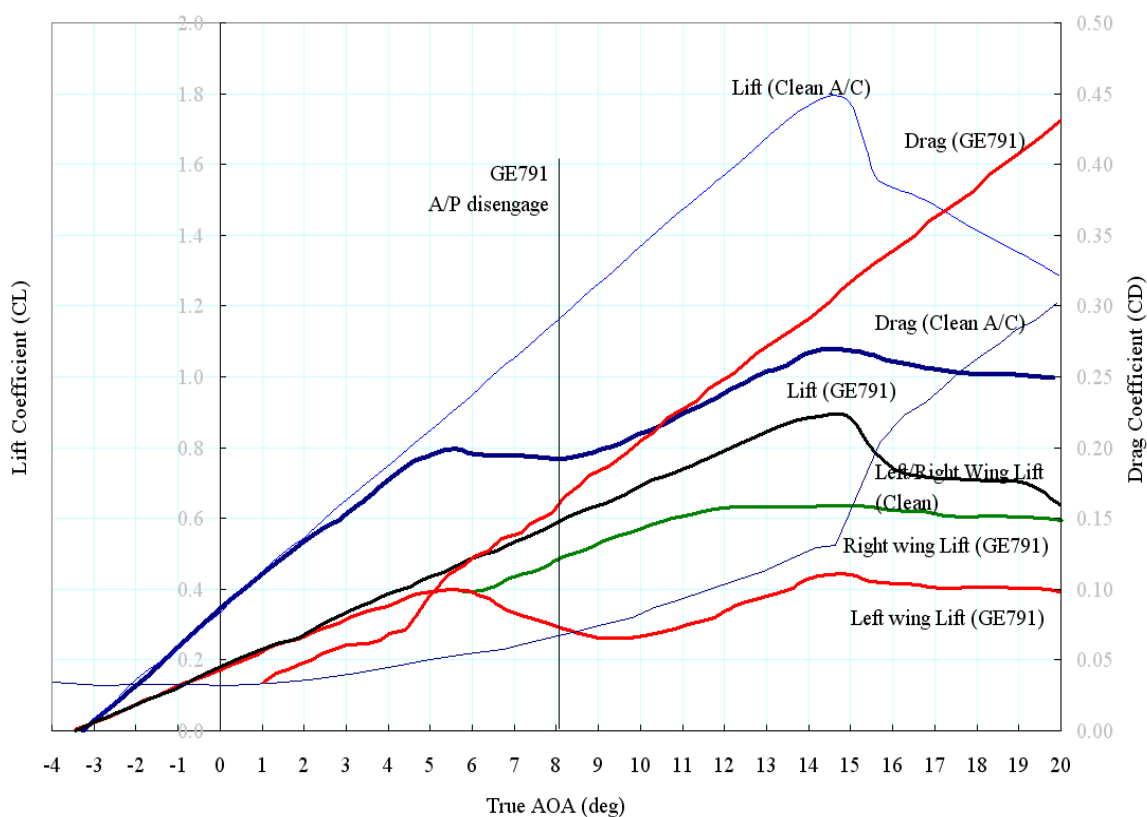
Figure 2.4-6 The lift and drag coefficients versus true AOA (ATR72 clean and GE791 ice polluted)

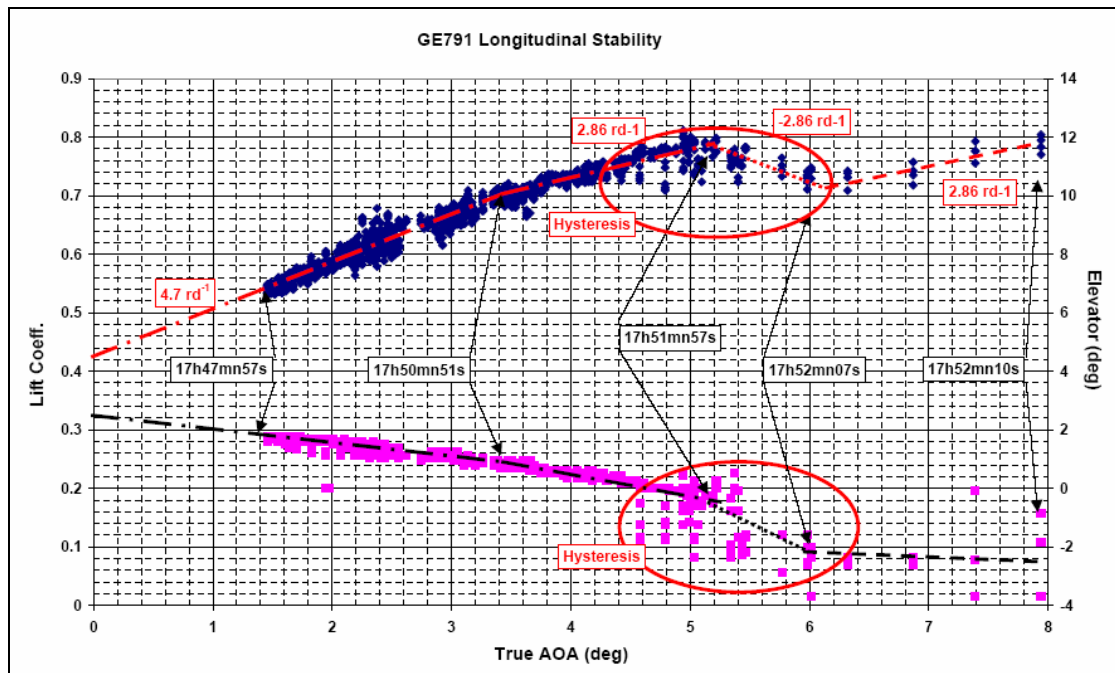
During the 10s before the roll excursion (0151:57 to 0152:07) the longitudinal and lateral stability has been modified by the ice accumulated on the wings producing the flow separation. In particular the application of recovery procedures using a significant reduction of aircraft AOA (3°) by a pitch down elevator input or flaps extension (15) lead the aircraft in a situation where all aerodynamic parameters are nominal.

Figure 2.4-8 GE791 longitudinal stability (derived from FDR data)

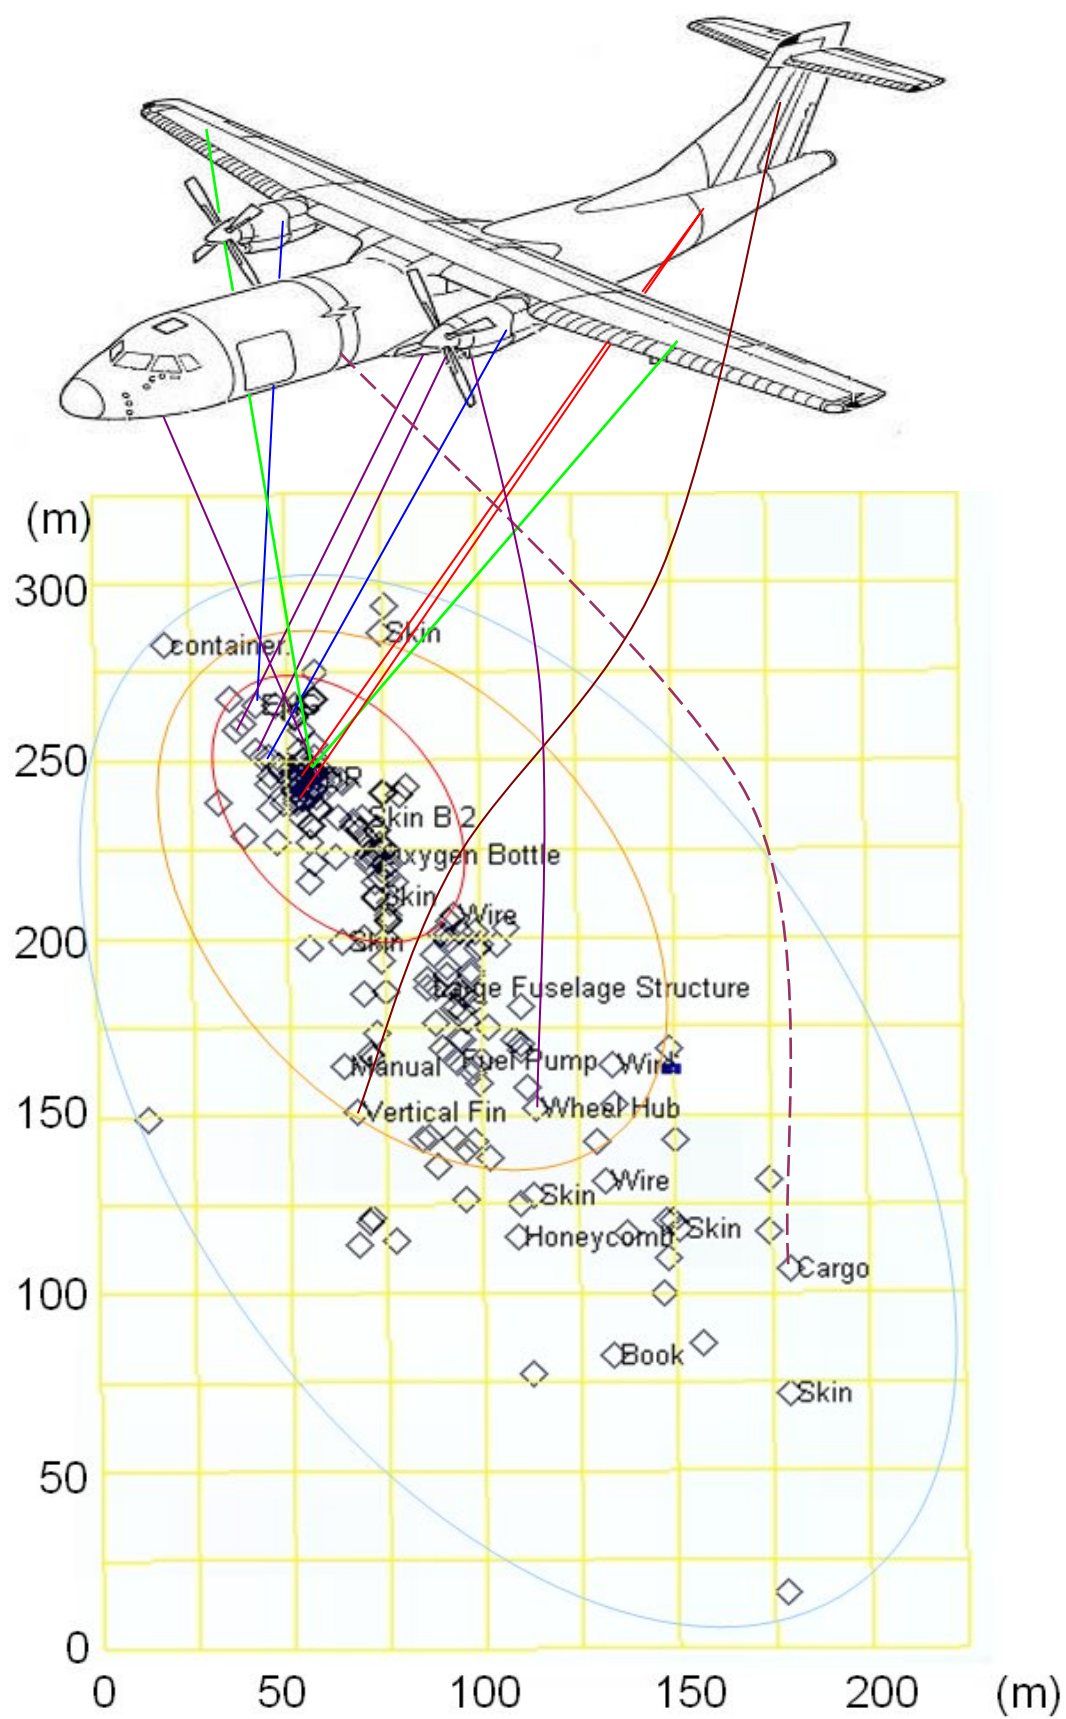
Figure 2.6-1 Wreckage scattering observed from ROV

Observation made by remote operating vehicle indicates that the wreckage including structure and components of accident aircraft are distributed within an area of 200 by 300 meter ( Figure 2.6-1 ) .

The pilot seat strut, wheel and tire of the landing gear, all above strong structures were burst apart, exhibit that the diving speed of the aircraft was very high during the water impact.

Total 199 pieces of wreckage were examined. There were no evidence of slow growth damage, i.e., no structure fatigue damage was found. All the structure failure was cause by over load damage and occurred during water impact.
