AIAA 2003-21

**Inflight Icing Educational  
Objectives for Air Carrier  
Pilots**

**41st Aerospace Sciences Meeting & Exhibit**  
**6-9 January 2003**  
**Reno, Nevada**

# INFLIGHT ICING EDUCATIONAL OBJECTIVES FOR AIR CARRIER PILOTS

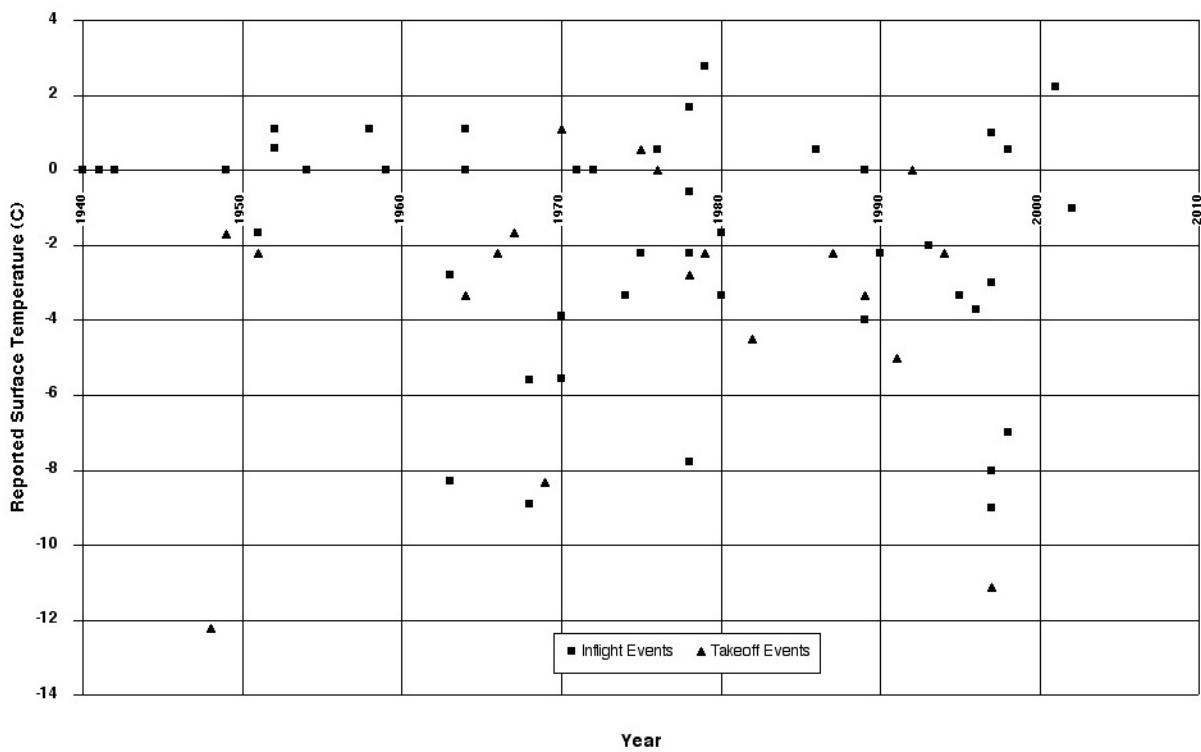
**Figure 8 - Distribution of Reported Surface Temperature**

A final aspect of this analysis must be meteorological. With respect to those events which occurred in close proximity to the surface (low altitude events), the reported surface weather observations were evaluated. For these events, the average surface temperature was -1.76C, with a median of -0.28C (Figure 8). The range was from -9.0C to 2.8C. In the case of the ground icing accidents, these numbers are not too different; the average surface temperature is -3.37C and the median is -2.21C, with a range from -12.2C to 1.1C.
